Learning from Accidents

Third edition

Trevor Kletz

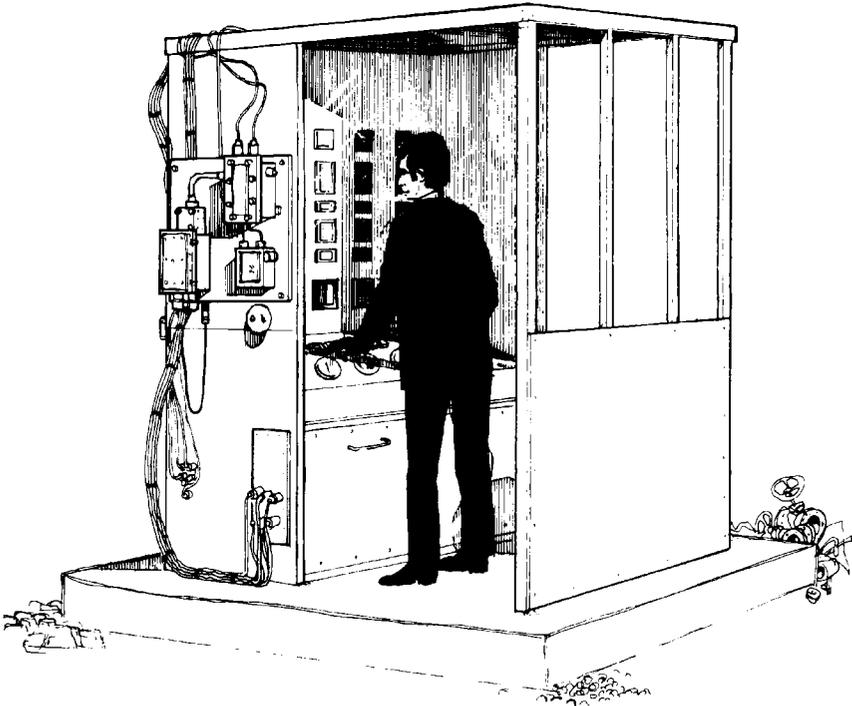
Figure 2.2 Instruments controlling the drying unit were located in this outdoor panel. Electrical equipment was purged with nitrogen

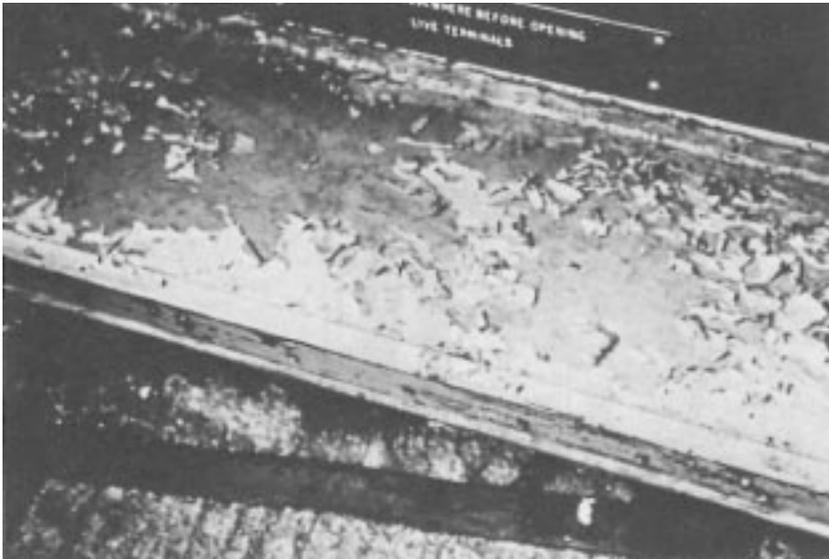
Figure 2.3 This view of the cabinet's inside shows paint attacked by solvent, suggesting that vapour had been getting in for some time

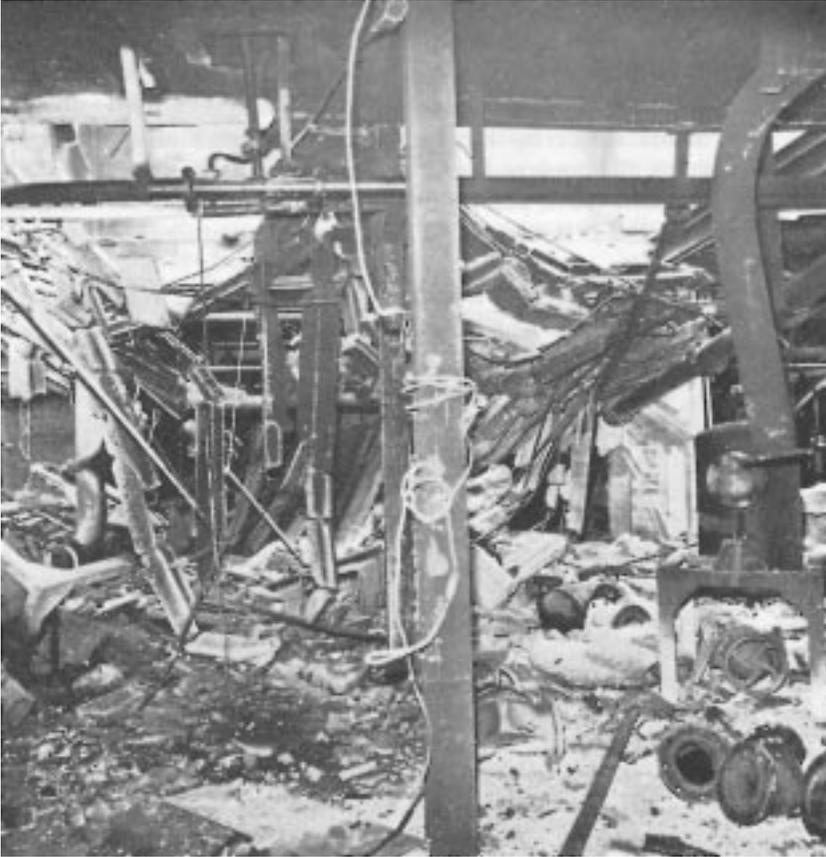
As already stated the leak of ethylene occurred from a badly made joint on a small diameter line, about 1/2 inch (12 mm) internal diameter. The joint was a special type, suitable for use at high pressures and assembling it required more skill than is required for an ordinary flanged joint. Once the joint had been made it was impossible to see whether or not it had been made correctly. It would be easy to say that more care should be

Figure 4.1 Some of the damage caused by the explosion

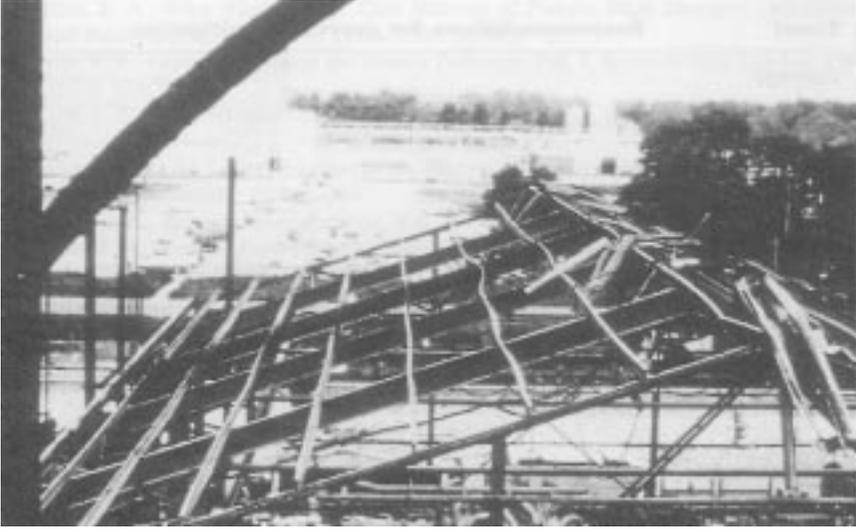
Figure 4.2 The result of an explosion in a hydrogen compressor house

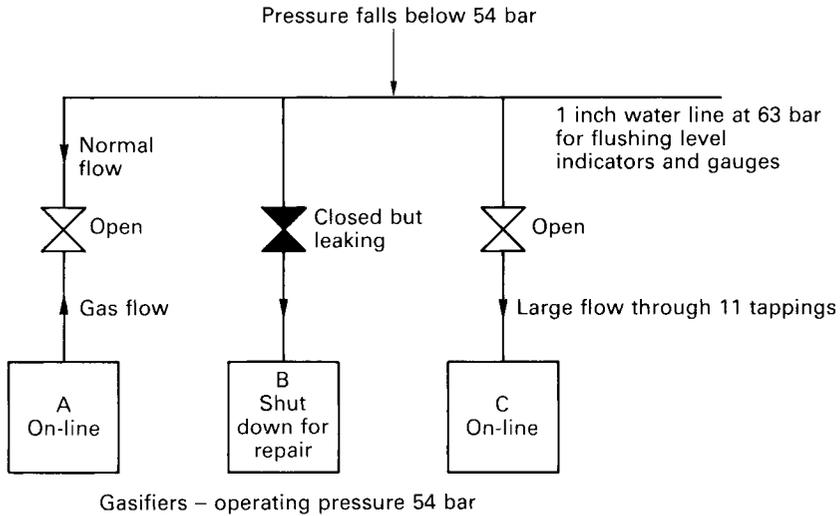
Figure 5.2 Another accident due to a missing slip-plate. When the pressure in the water line fell, gas from gasifier A entered the water line, passed through the leaking valve into gasifier B and exploded

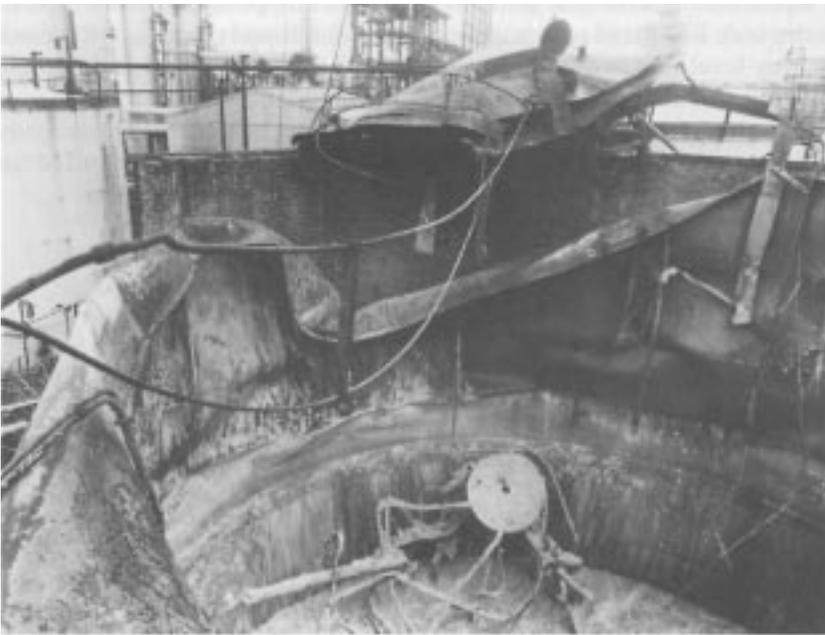
An explosion followed by a fire occurred in a 1000 m³ fixed roof storage tank which was one-third full of a volatile hydrocarbon (Figure 6.1). The roof was blown off the tank but remained attached at one point. Application of the theoretical quantity of foam from hoses failed to extinguish the fire, either because the foam dried out before it reached the

Figure 6.1 The inside of the tank after the fire

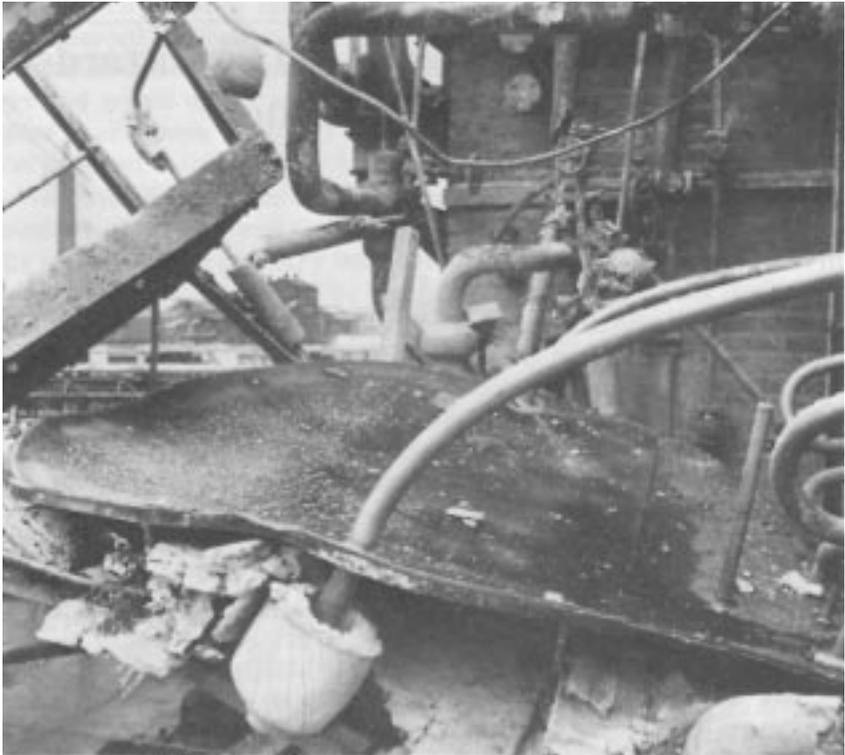
It was later found that the vent was plugged with solidified product. The tank was designed to withstand a gauge pressure of 5 psi (0.3 bar) and would burst at a gauge pressure of about 20 psi (1.3 bar) so in retrospect it is not surprising that the plug of solid was stronger than the tank.

Figure 7.1 The end blown off the tank by gas pressure

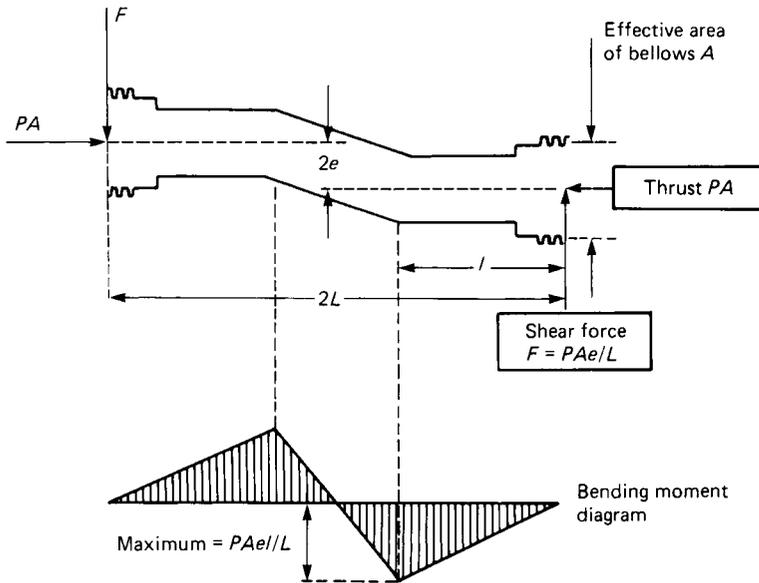
Figure 8.2 Sketch of pipe and bellows assembly showing shear forces on the bellows and bending moments in the pipe (due to internal pressure only). (Reproduced by permission of the Controller of Her Majesty's Stationery Office)

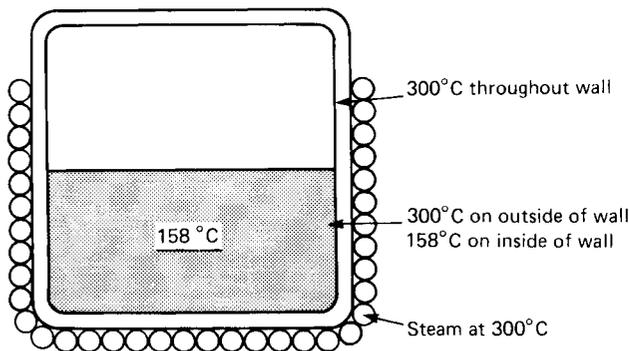
The temperature of the liquid could not get above its boiling point at the operating pressure, about 160°C , and so below the liquid level there was a temperature gradient through the reactor wall, the outside being at 300°C and the inside at 160°C . Above the liquid level the wall was at 300°C right through. When the steam was isolated the wall below the liquid level soon fell to the temperature of the liquid, but above the liquid level it remained hotter. Heat passed from the upper wall to the surface of the liquid. When, 15 minutes later, the stirrer was switched off, the

Figure 9.1 The Seveso reactor. The hot upper portion of the reactor wall heated the surface of the liquid

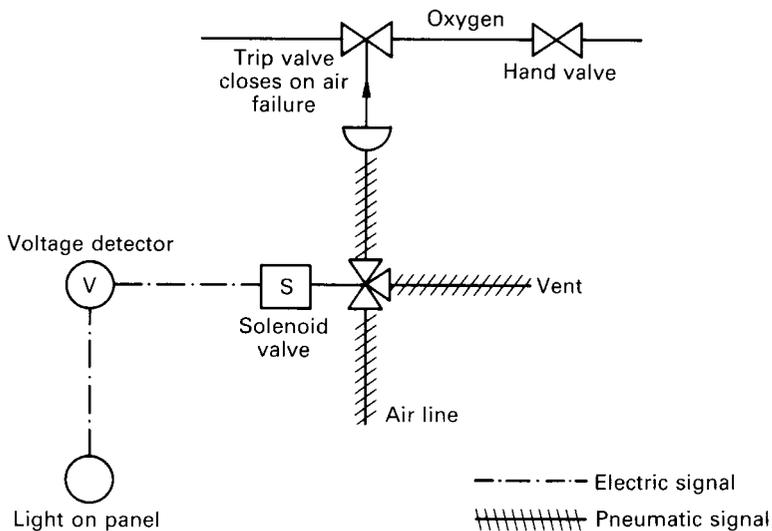
The valve was a pneumatic one and was closed by venting the air supply to the valve diaphragm, via a solenoid valve (Figure 11.3). The light on

Figure 11.3 The light shows that the solenoid is de-energised, not that the oxygen flow has stopped

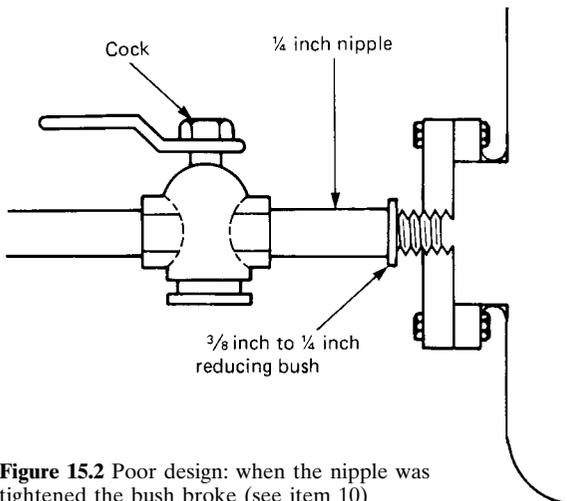
Figure 15.2 Poor design: when the nipple was tightened the bush broke (see item 10)

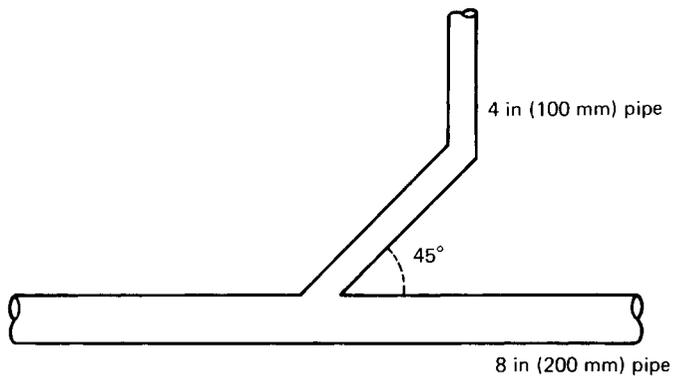
Figure 16.4 A poorly designed joint which failed, causing a major leak

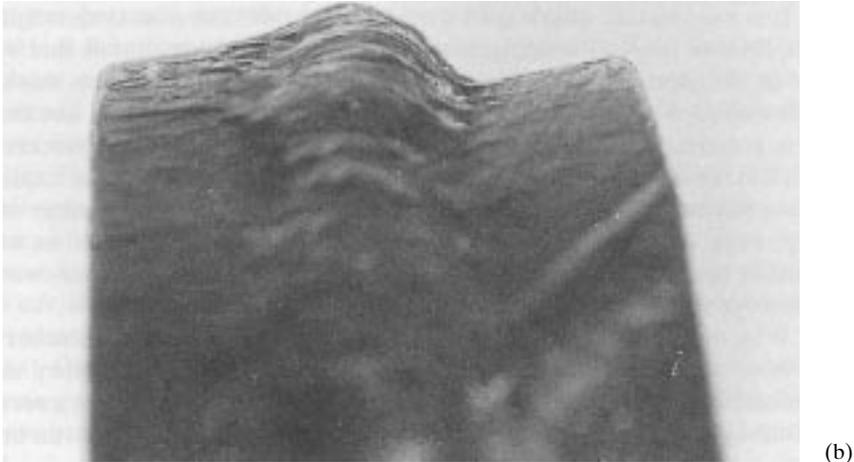
Figure 16.5 (a) and (b) Two pipes of slightly different diameter were welded together

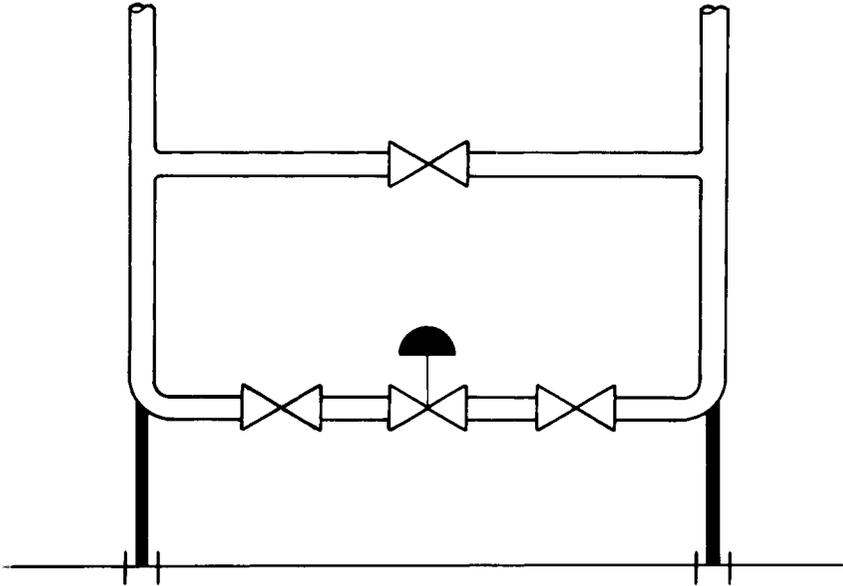
Figure 16.6 The supports were bolted to the concrete bases and welded to the pipes. When the pipe moved, a piece was torn out

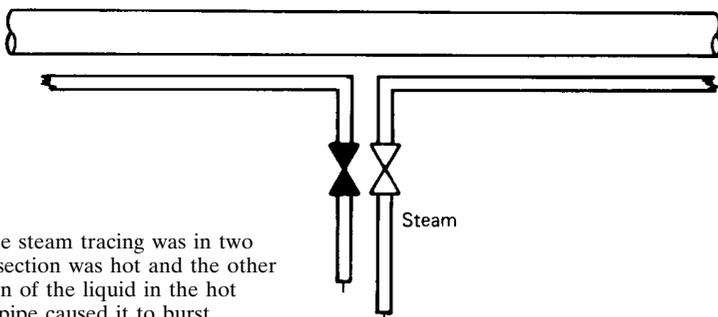
Figure 16.8 The steam tracing was in two sections. One section was hot and the other cold. Expansion of the liquid in the hot section of the pipe caused it to burst

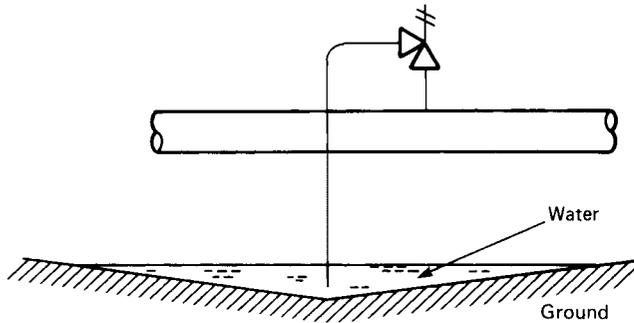
Figure 16.9 The end of the relief valve tail pipe was so close to the ground that it was below the surface of a puddle and was blocked when the puddle froze

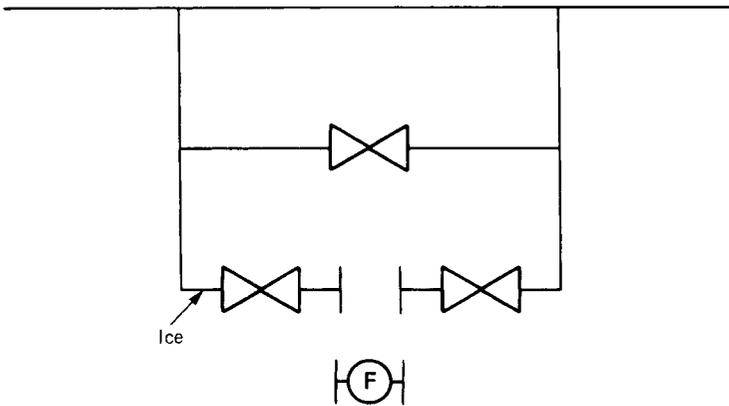
Figure 16.10 When the flowmeter was removed it formed a dead-end in which water collected

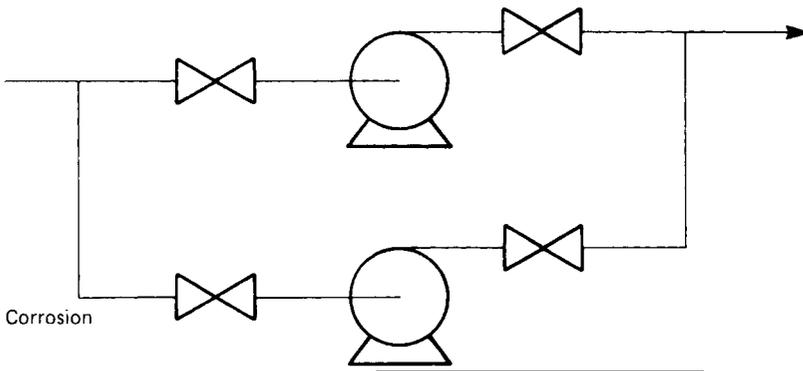
Figure 16.11 The lower pump was rarely used. Water collected and corrosion occurred

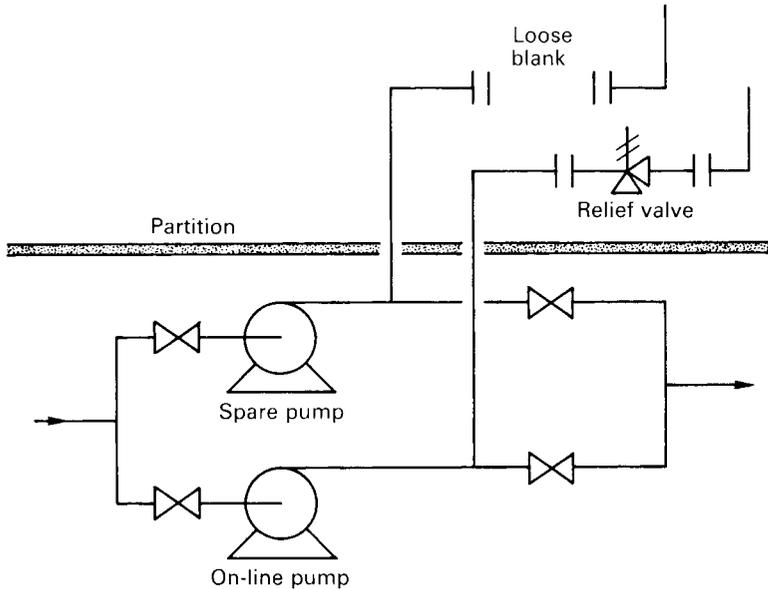
Figure 17.2 Piper Alpha: the on-line pump broke down so the other pump, which was shut down for overhaul and for testing of the relief valve, was brought on line. The operators did not know that the relief valve had already been removed and the open end loosely blanked

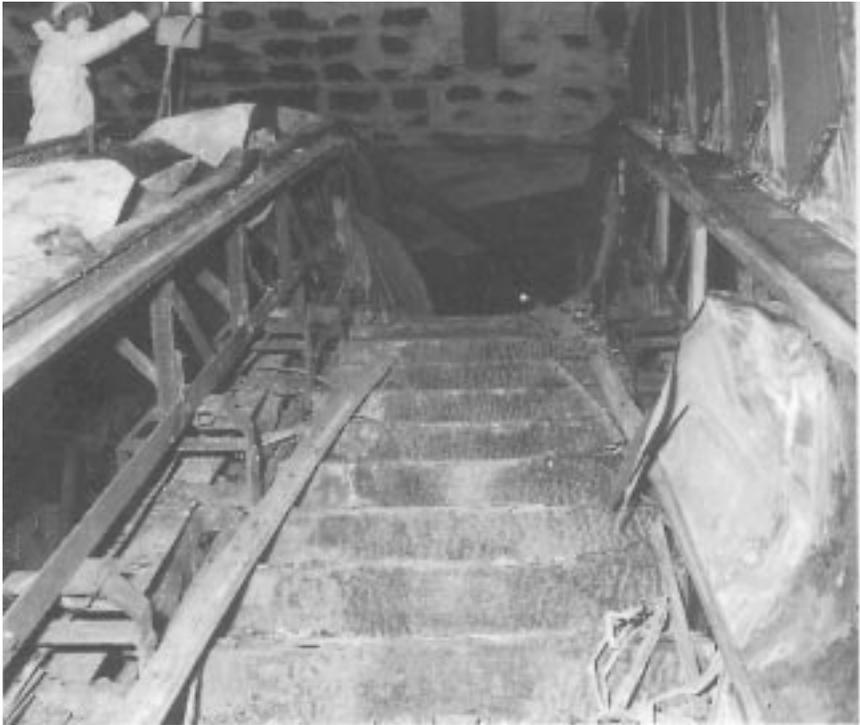
Figure 18.1 The top of the escalator at King's Cross after the fire. (Reproduced by permission of the Health and Safety Executive.)

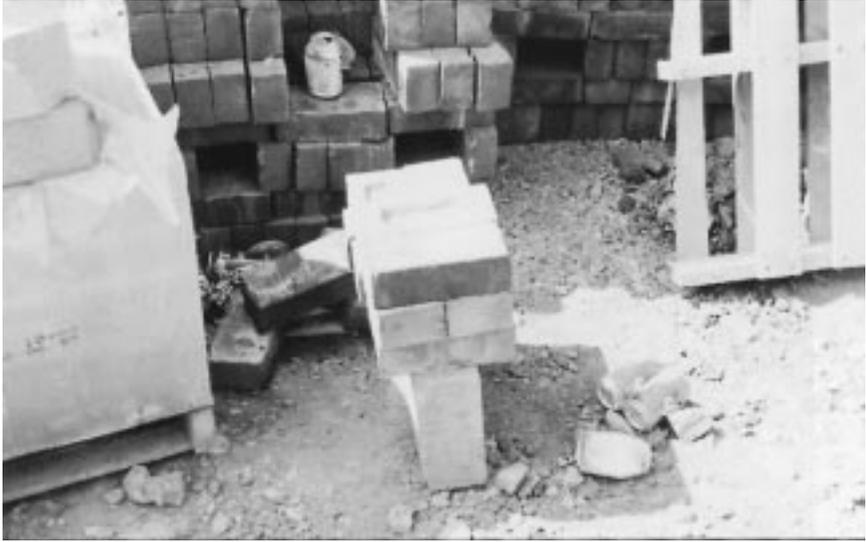
Figure 22.1 Reconstruction showing how the brick columns were supported on lightweight blocks (Reproduced with the permission of The Controller of Her Majesty's Stationery Office)

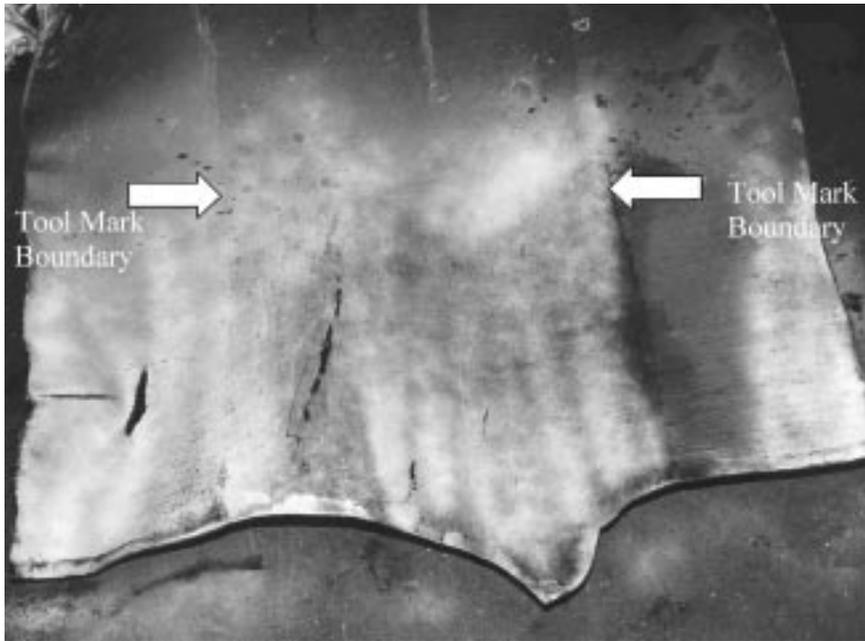
Figure 28.1 Blown-out section of a 40 bar steam main (Photograph reproduced courtesy of Eastman Chemical Company)

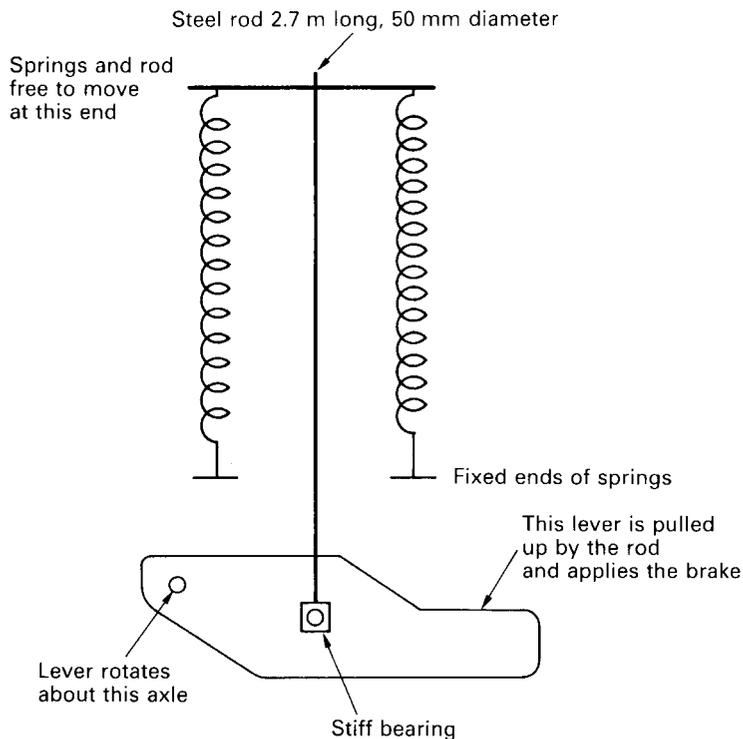
Figure 30.1 The brake system on the cage at Markham Colliery. The rod was 'single-line' and when it failed the cage fell out of control
