# WHAT WENT WRONG?

Case Histories of  
Process Plant Disasters

Trevor Kletz

**FOURTH EDITION**

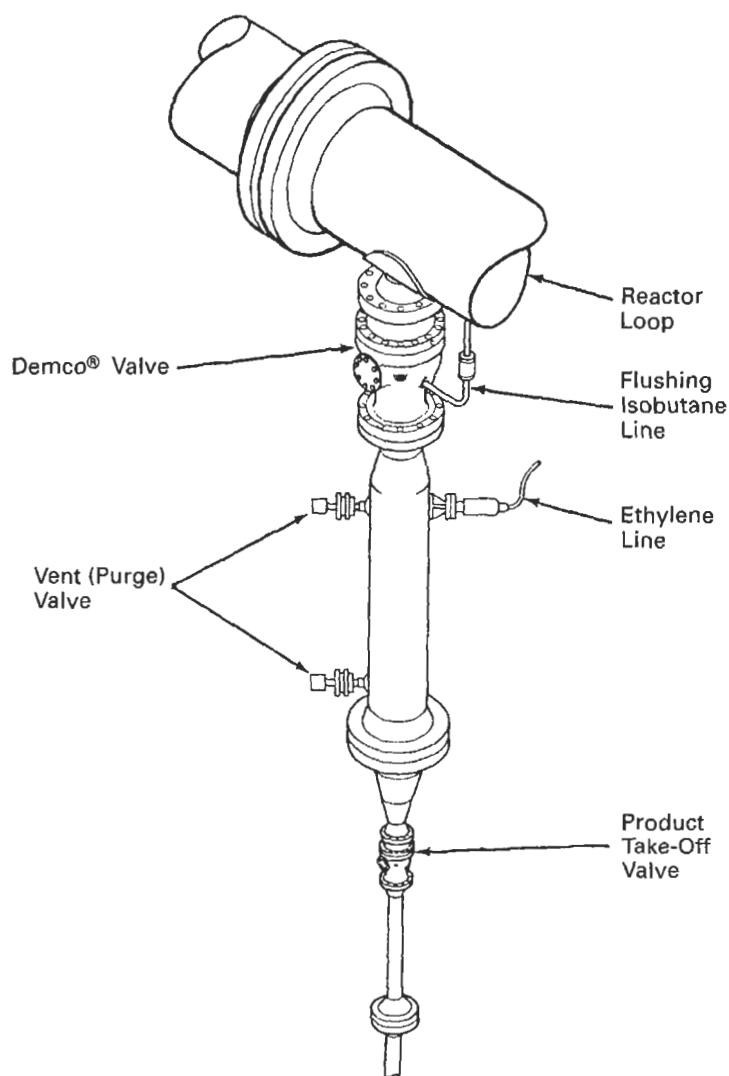
There was another similarity to the first incident. In this case the equipment also had been prepared for repair and then had to wait for a couple of days until the maintenance team was able to work on it. During this period, the air lines were reconnected, the lockout removed, and the isolation valve opened.

**Figure 1-2.** The take-off branch was dismantled with the Demco valve open.  
(Illustration courtesy of the U.S. Department of Labor.)

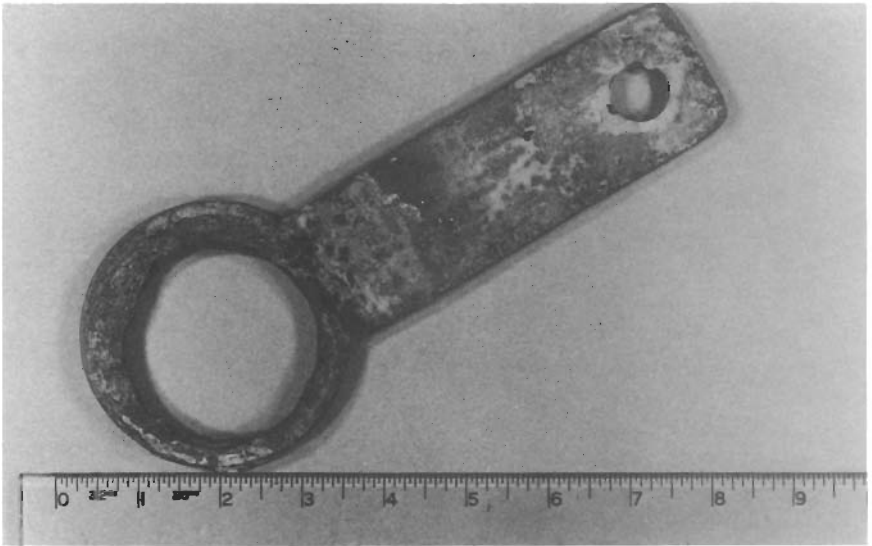
**Figure 1-5.** A slip-plate left in position for many months had corroded right through.

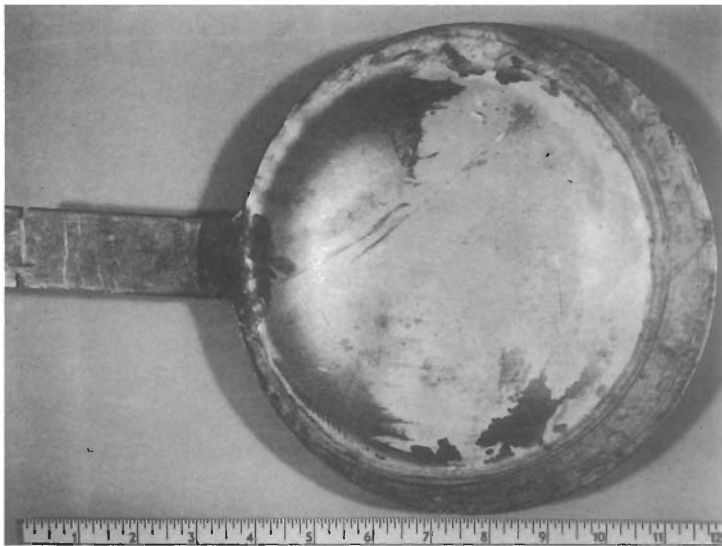
- On several occasions small bore branches have been covered by insulation, overlooked, and not isolated.
- On several occasions thin slip-plates have been used and have become bowed; they are then difficult to remove. Figure 1-6 shows a thin slip-plate that has been subjected to a gauge pressure of 470 psi (32 bar).

**Figure 1-6.** A slip-plate bowed by a gauge pressure of 470 psi (32 bar).

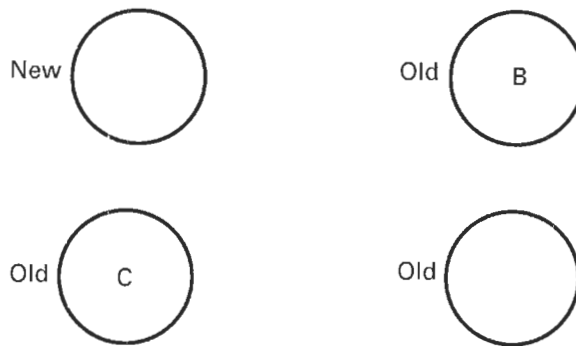
- (b) There were four crystallizers in a plant, three old ones and one just installed. A man was asked to repair A. When he went onto the structure, he saw that two were labeled B and C but the other two were not labeled. He assumed that A was the old unlabeled crystallizer and started work on it. Actually, A was the new crystallizer. The original three were called B, C, and D. Crystallizer A was reserved for a possible future addition for which space was left (Figure 1-8).

**Figure 1-8.** Which is crystallizer A?

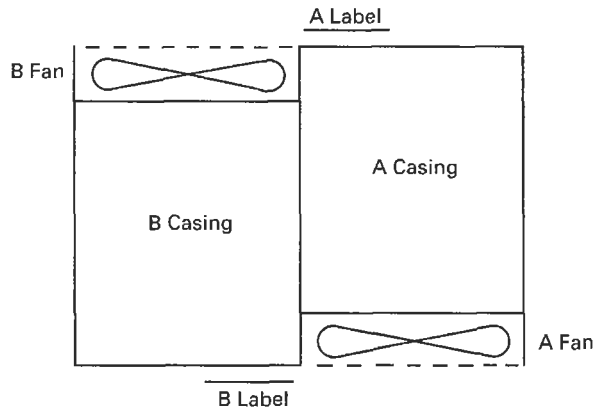
- (c) The labels on two air coolers were arranged as shown in Figure 1-9. The B label was on the side of the B cooler farthest away from the B fan and near the A fan. Not unreasonably, workers who were asked to overhaul the B fan assumed it was the one next to the B label and overhauled it. The power had not been isolated. But fortunately, the overhaul was nearly complete before someone started the fan.
- (d) Some pump numbers were painted on the coupling *guards*. Before long, repairs were carried out on the couplings of two adjacent pumps. You can guess what happened. Now, the pump numbers are painted on the pump bodies. It would be even better to paint the numbers on the plinths.

**Figure 1-9.** Which is the A fan?

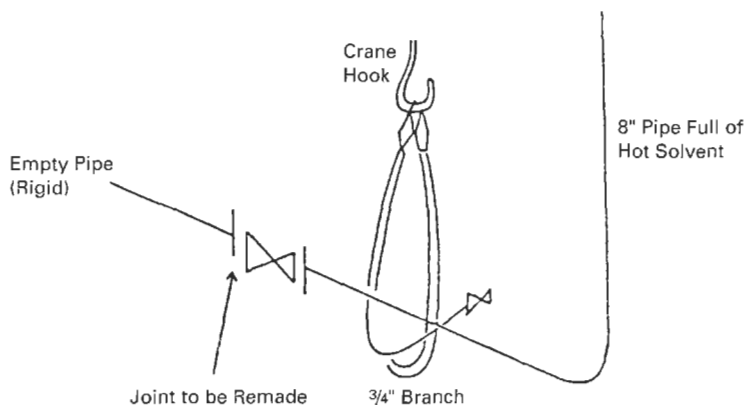
It was not a good idea to use a crane for a job like this on a line full of process material. Fortunately the leaking vapor did not ignite, although

**Figure 1-11.** A branch broke when a crane was used to move a live line.

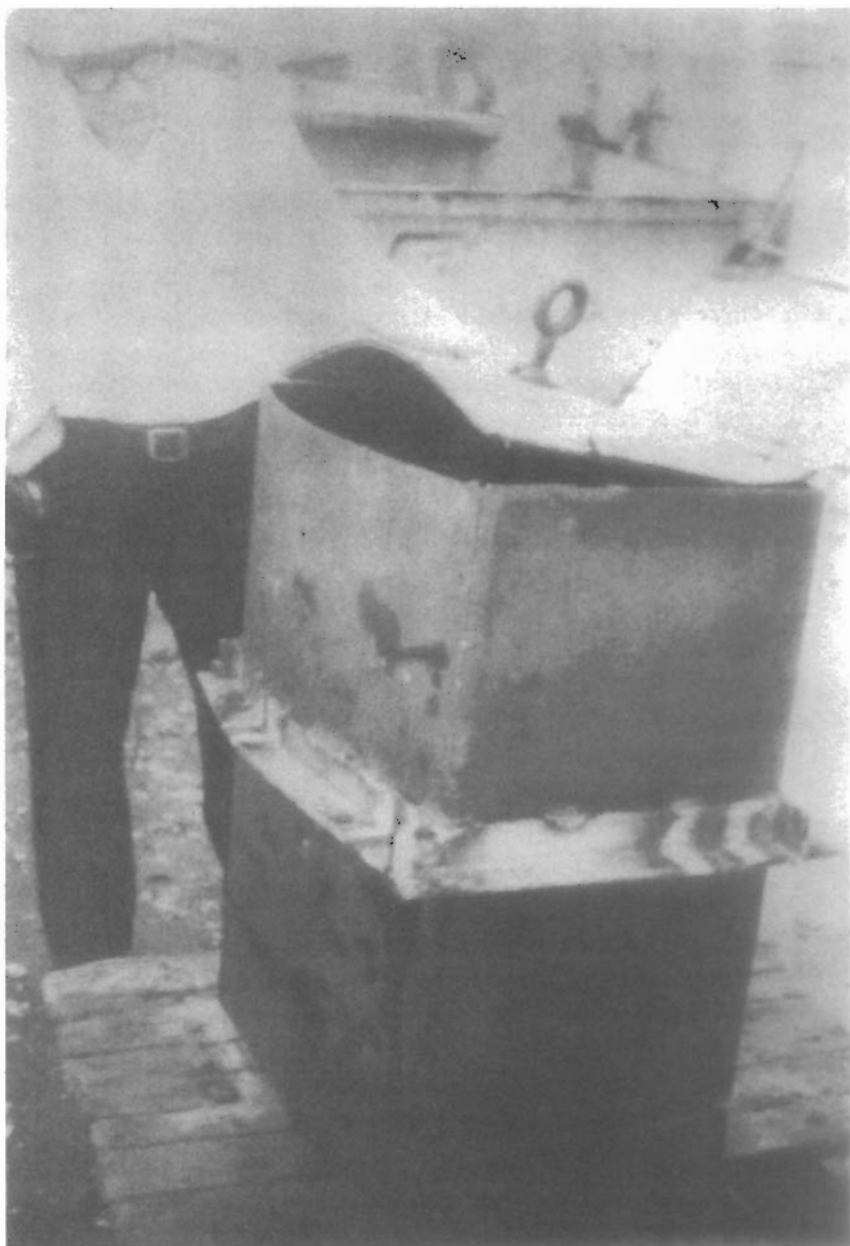
**Figure 1-13.** This steel box was quite incapable of containing a leak of steam at a gauge pressure of 300 psi (20 bar).

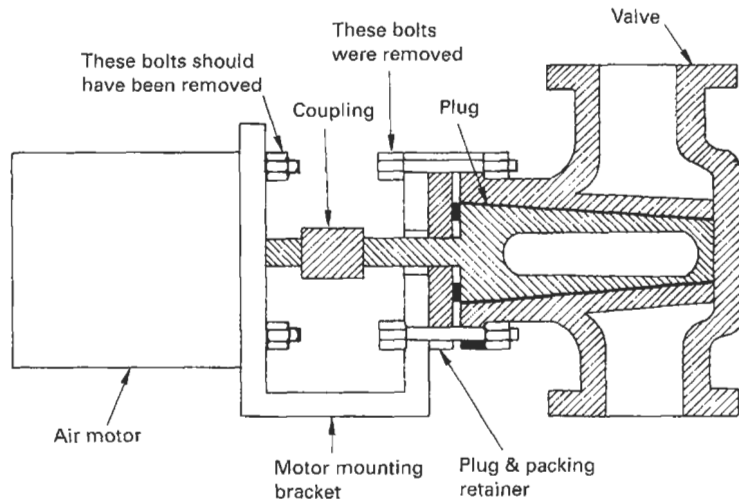
- (a) Several spillages have occurred from power-operated valves while the actuators were being removed because the bolts holding the valve bonnets in position were removed in error. Figures 1-14 and 1-15 show how two such incidents occurred. The second system is particularly vulnerable because in trying to unscrew the nuts that

**Figure 1-14.** Wrong nuts undone to remove valve actuator.

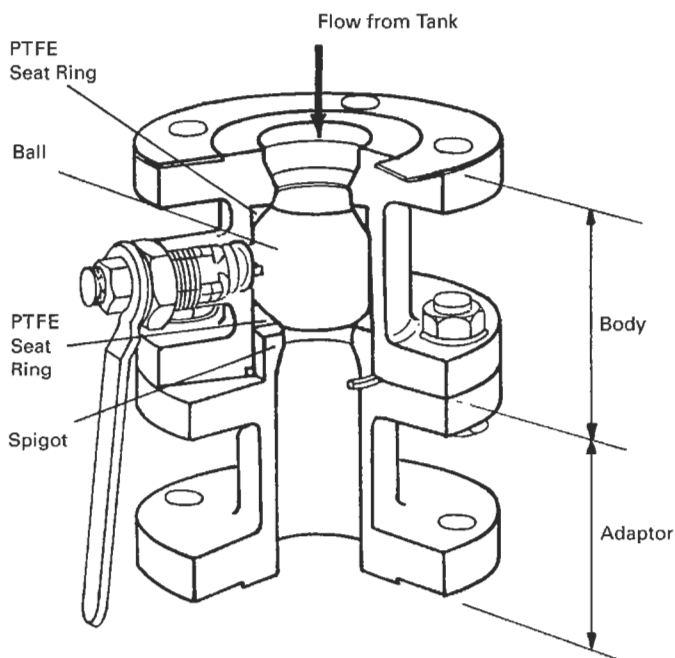
The valve was the drain valve on a small tank containing liquefied petroleum gas (LPG). The 5 tons of LPG that were in the tank escaped over two to three hours but fortunately did not catch fire. However, 2,000 people who lived near the plant were evacuated from their homes [11].

**Figure 1-16.** Valve dismantled in error.

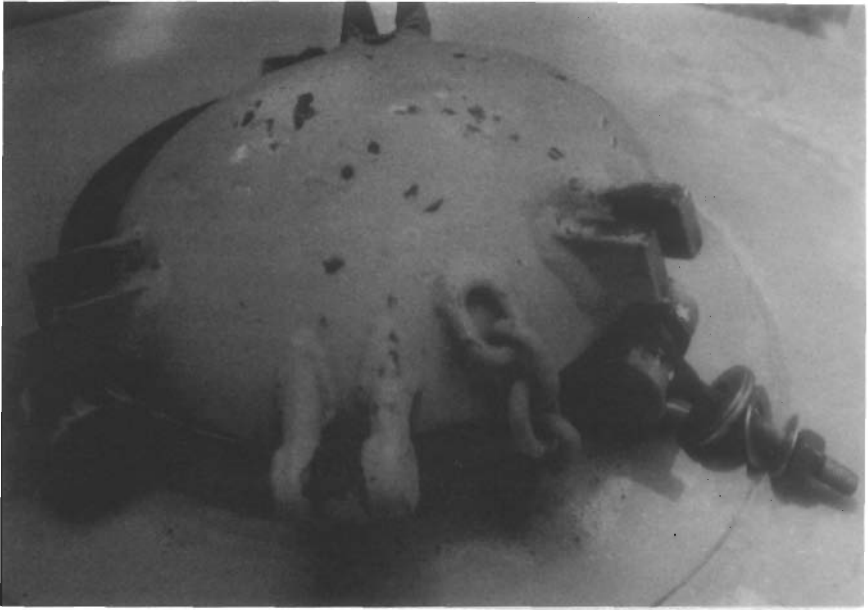
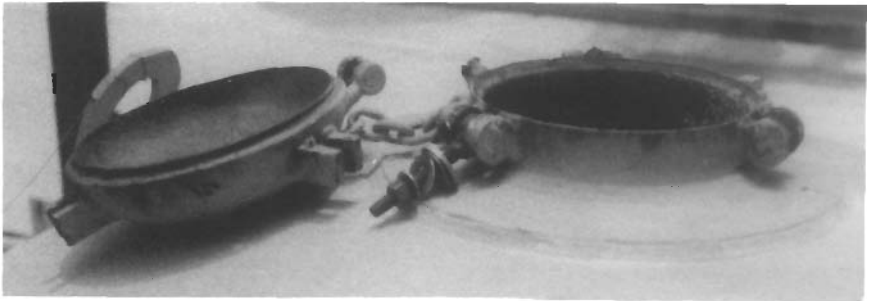
- (a) A pressure vessel was fitted with a quick-opening lid, 10 in. diameter, secured by four eye-bolts (Figure 1-18). They had to be replaced, as the threads were corroded. Instead of replacing the whole eye-bolt, a well-meaning person decided to save time by simply cutting the eyes off the bolts and welding new studs onto them. As soon as the vessel was pressurized (with compressed air) the new studs, which had been made brittle by the welding, failed, and the lid flew off. Fortunately a short length of chain restrained it, and it did not fly very far [38]. (See Sections 13.5 and 17.1 for the hazards of quick-opening lids.)

**Figure 1-18.** Instead of replacing the eye-bolts, new studs were welded in place of the threaded portions. They were made brittle by the heat and failed in use. Fortunately the chain prevented the lid from going into orbit.

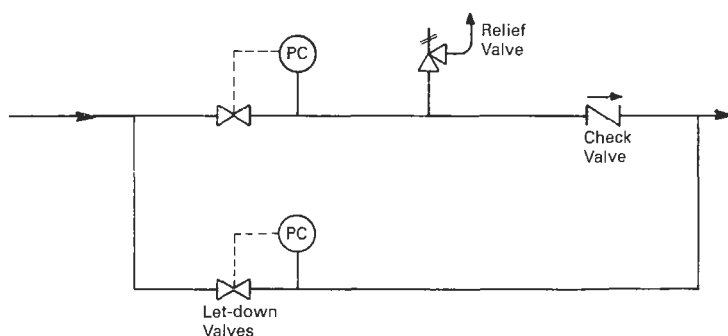
**Figure 2-3.** The second (lower) let-down valve was joined to the original line downstream of the check valve. When this let-down valve leaked, the downstream equipment was overpressured.

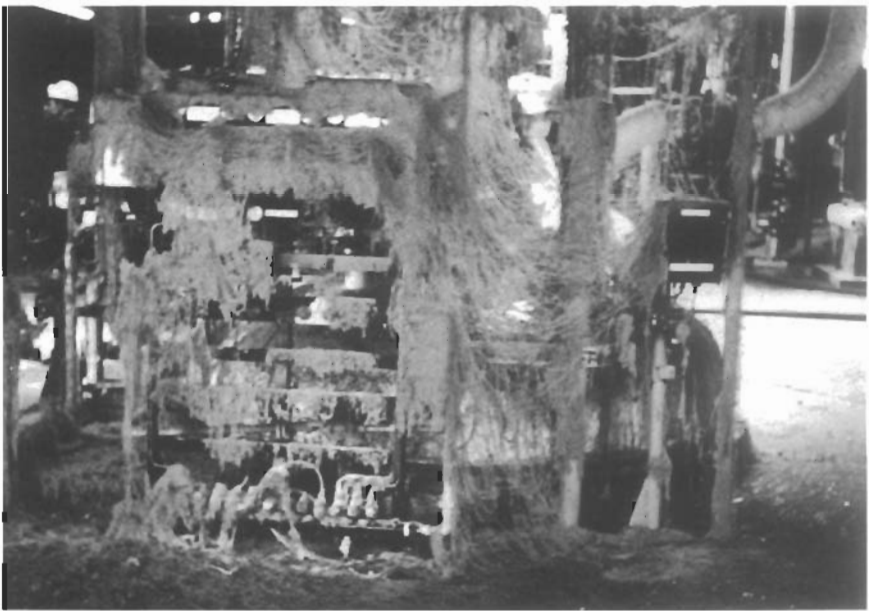
**Figure 3-1b.** Because a rupture disc was fitted to the wrong side of a vacuum support, the flanges leaked, covering the reactor with "candy."

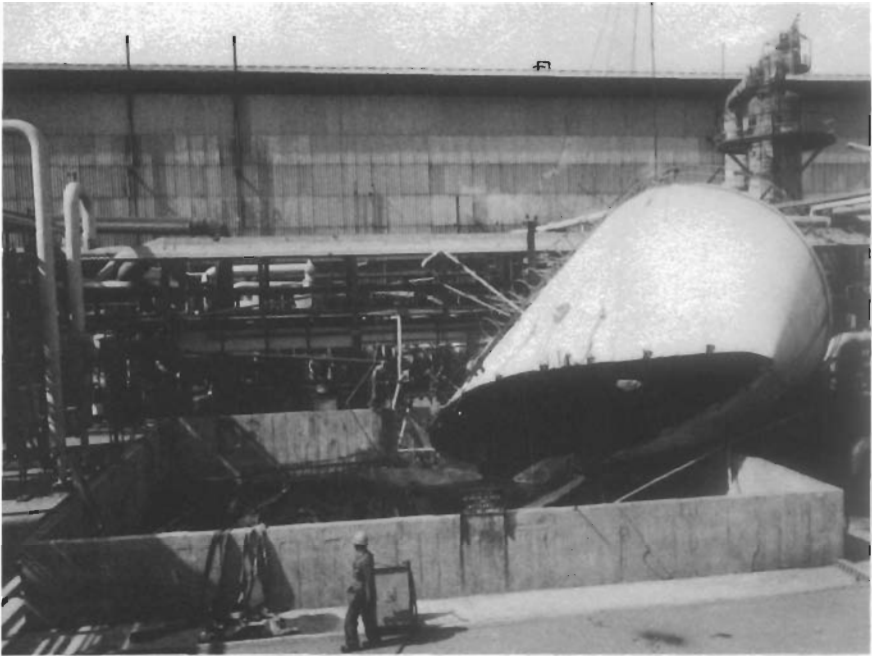
**Figure 5-1.** Corrosion and missing holding-down bolts caused this tank to fail at the base instead of the top.

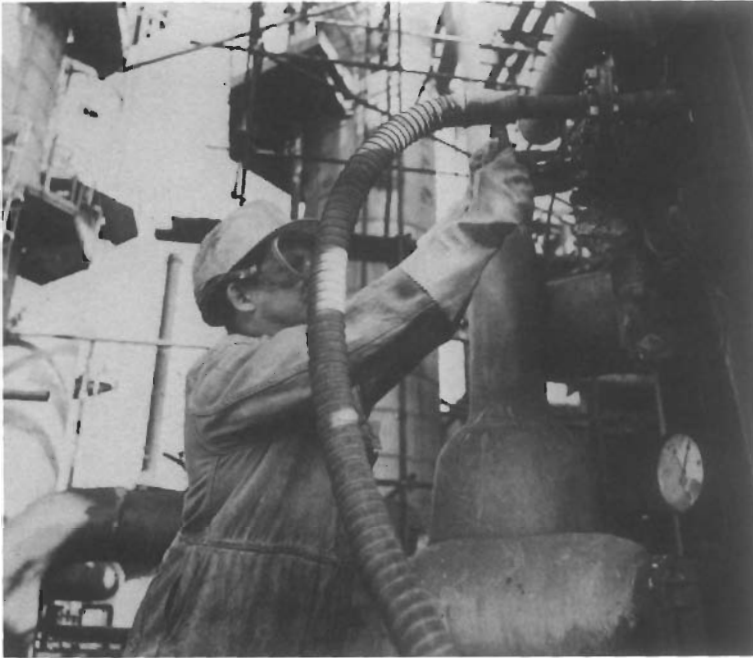
**Figure 7-3.** This hose burst, injuring the operator. It was the wrong type, was damaged, and was badly located.

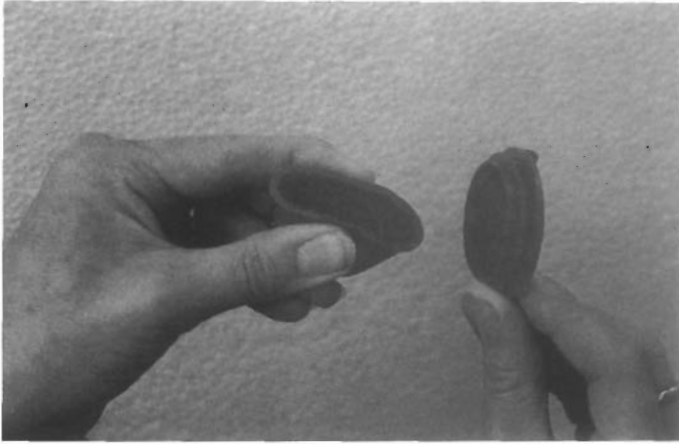
**Figure 7-4.** A soft plastic “top hat” plug (left) was fitted to the end of a railway carriage brake pipe to keep it clean. It was the same color as the end of the pipe and was not noticed and removed before the pipe was installed. The brakes failed, and the train overran. A more rigid plug with a larger lip (right) would have failed the brake test and would have been more visible. (*Photo courtesy of Roger Ford.*)

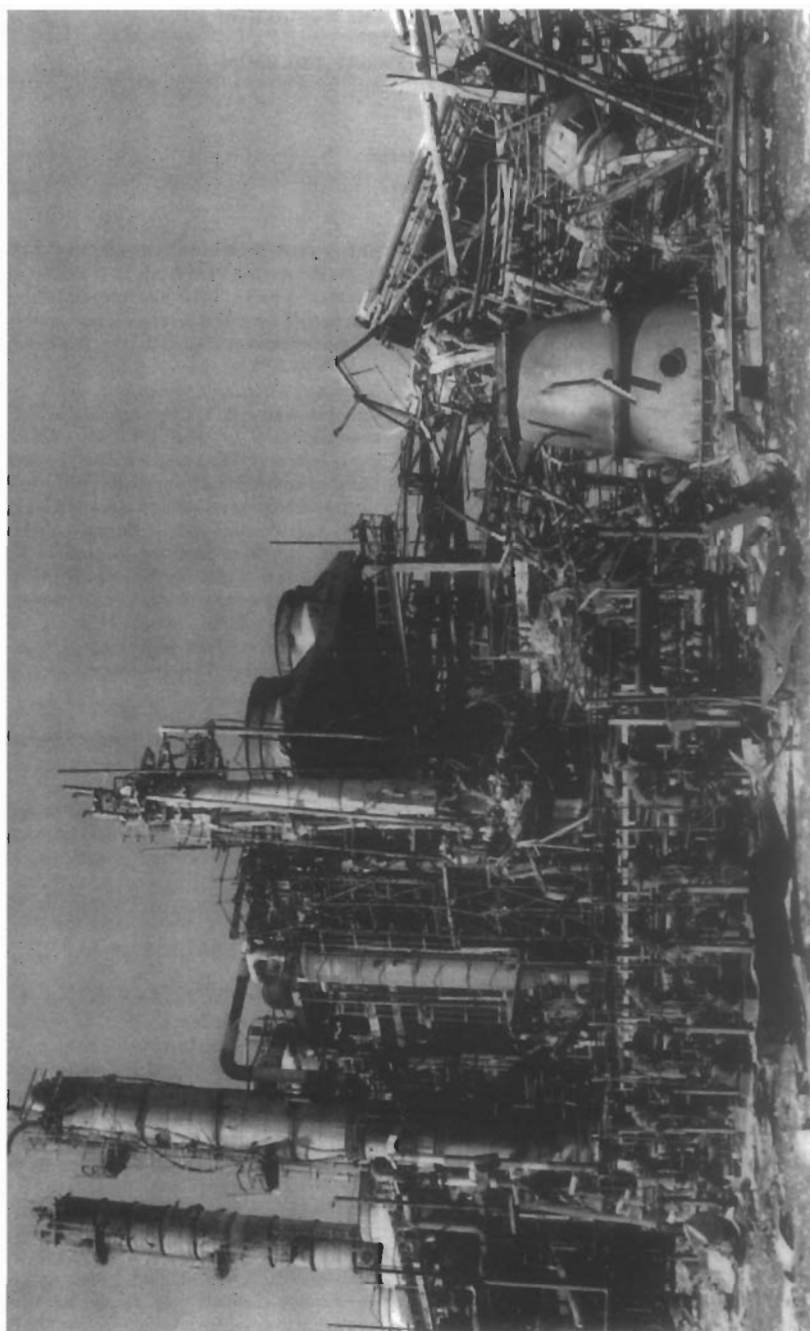
**Figure 7-8.** The ethylene oxide plant after the fire and explosion. (Photo courtesy of BP Chemicals Limited.)

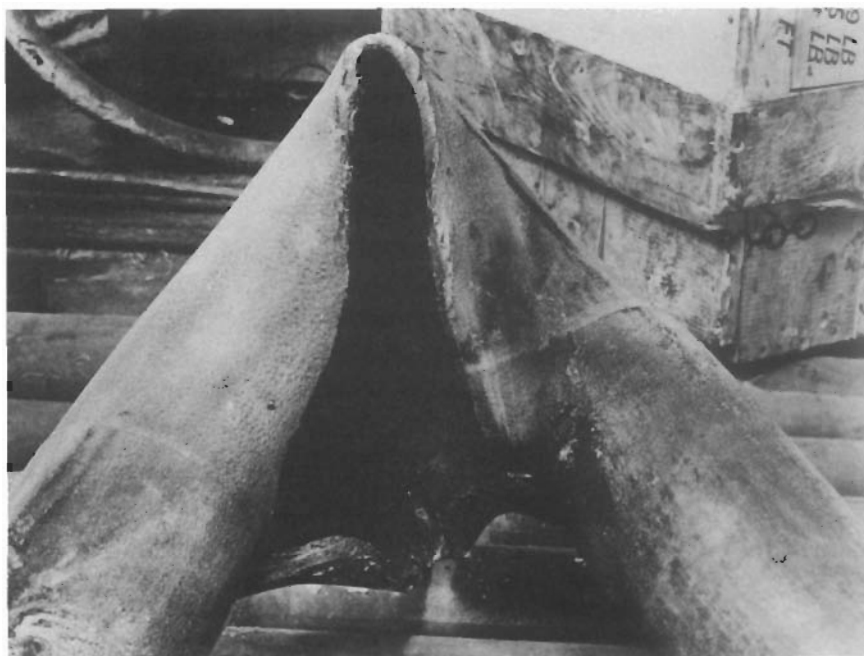
**Figure 9-12.** An old pipe was reused and failed by creep.

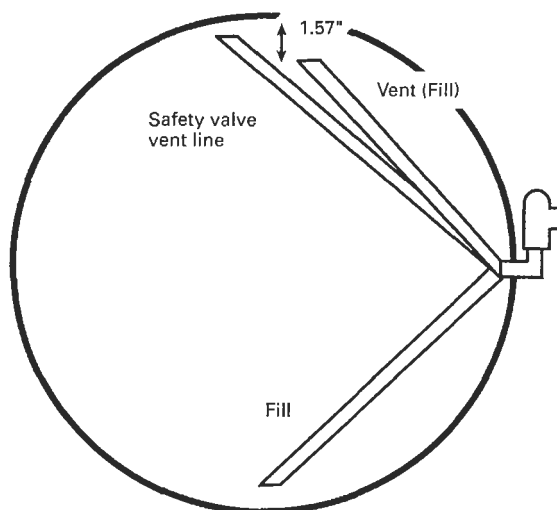
**Figure 9-14.** Unusual arrangement of relief valve and pipework on tank truck used to transport liquid carbon dioxide. The relief valve was cooled by the liquid and became blocked by ice from condensed atmospheric moisture. (*Illustration courtesy of the Institution of Chemical Engineers.*)

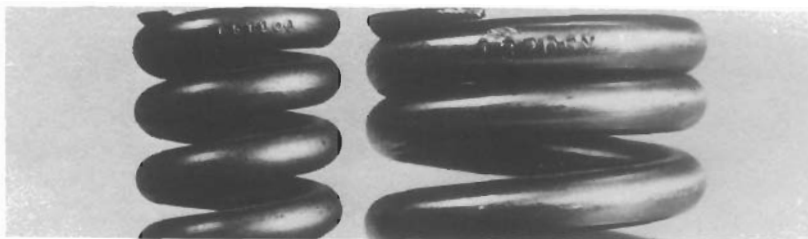
**Figure 10-5.** Identification marks on body coils could lead to spring failure

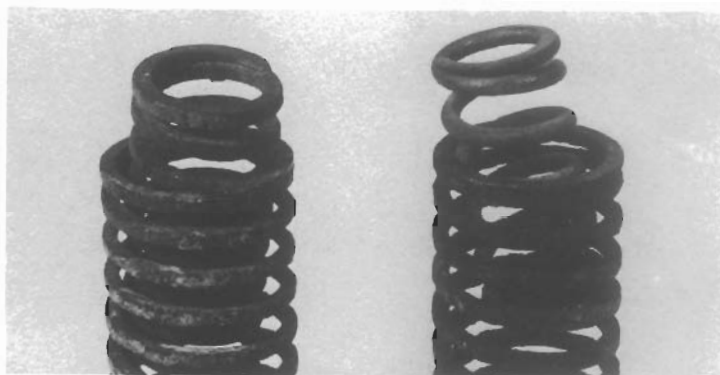
**Figure 10-6.** Use of additional inner springs of unknown quality in an attempt to obtain set pressure.

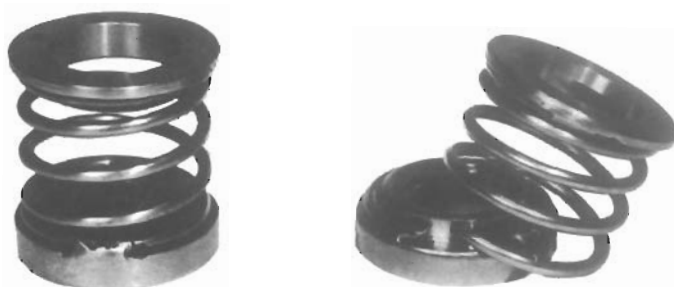
**Figure 10-7.** End caps welded to spring. Failure occurred at weld.

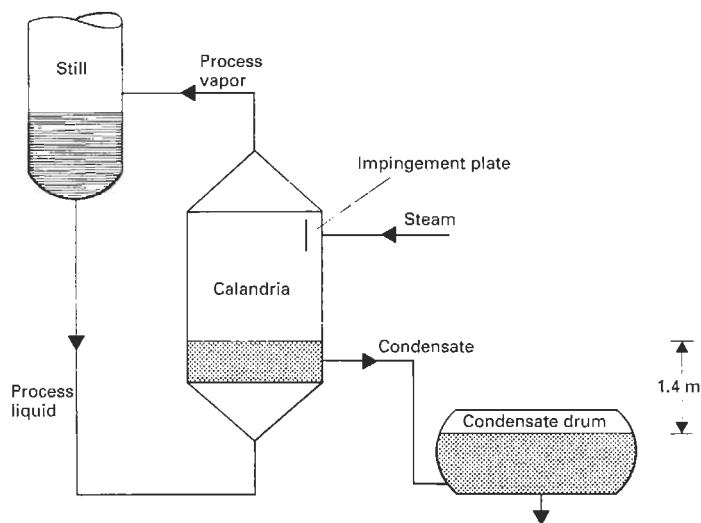
**Figure 10-11.** Condensate in the steam—the result of too few steam traps—knocked off the impingement plate and damaged the calandria tubes.

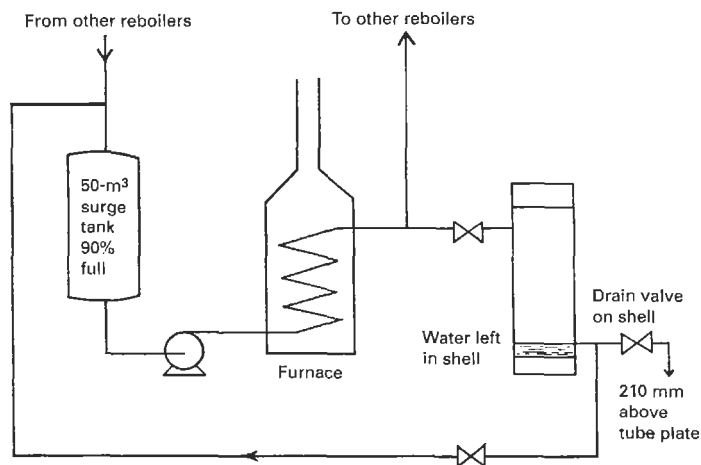
**Figure 12-2.** Water left in the heat exchanger was vaporized by hot oil.

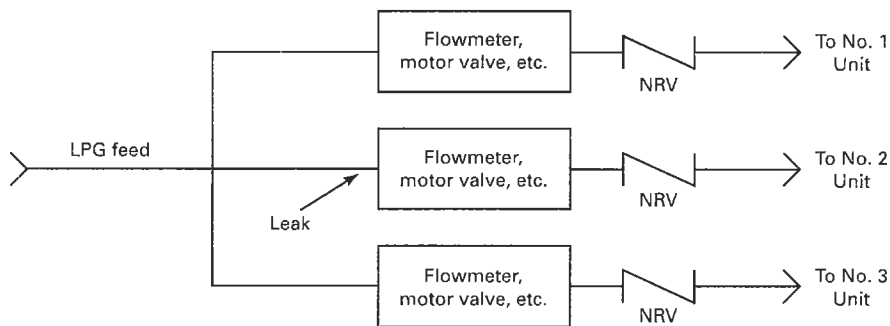
**Figure 14-2.** The check valves (nonreturn valves NRV) prevented a leak test of the equipment to the left of them. During startup a leak occurred at the point indicated.
