Learning from Accidents

Third edition

Trevor Kletz

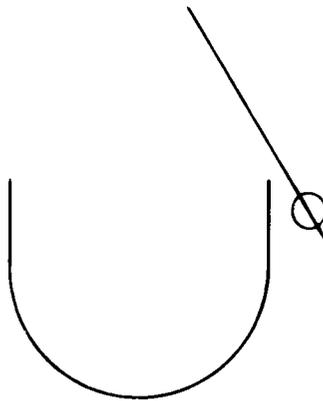
Figure 1.4 The lid is opened

It was then found that the welds between the lid and its hinges had cracked. It was a fatigue failure, caused by the strains set up by repeated opening and closing of the lid. There was nothing wrong with the original design but the lid had been modified about ten years before the incident occurred and, in addition, some repairs carried out a few years before had not been to a high enough standard.

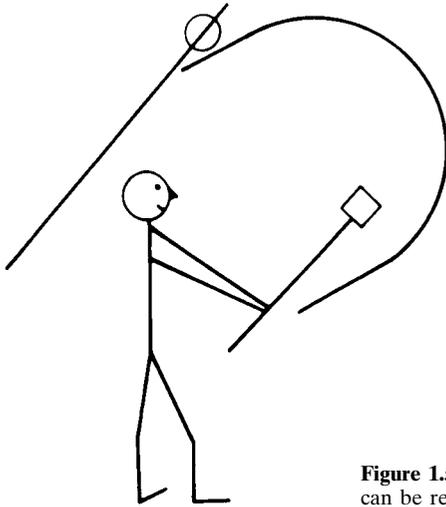
Figure 1.5 The vessel is rotated so that the contents can be removed

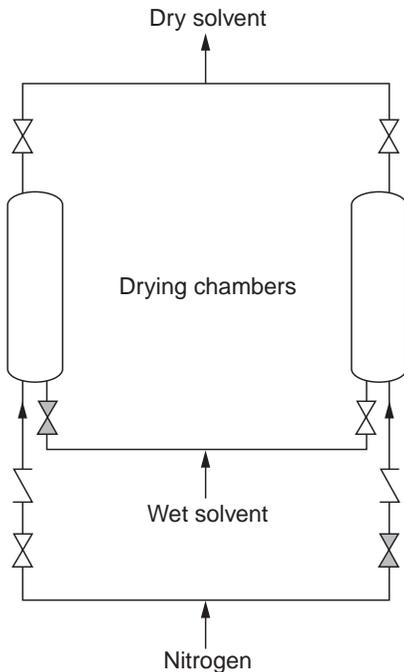
Figure 2.1 Drying unit in which the accident occurred. (Regeneration lines not shown)

There was no leak from the drying unit or the main plant at the time and there was no flammable vapour present in the atmosphere. The fuel did not leak into the metal cabinet from outside, the route which had been foreseen and against which precautions had been taken, but entered with the nitrogen. The nitrogen supply was permanently connected to the driers by single isolation valves and non-return (check) valves as shown in Figure 2.1. The gauge pressure of the nitrogen was nominally 40 psi (almost 3 bar) but fell when the demand was high. The gauge pressure in the driers was about 30 psi (2 bar). Solvent therefore entered the nitrogen lines through

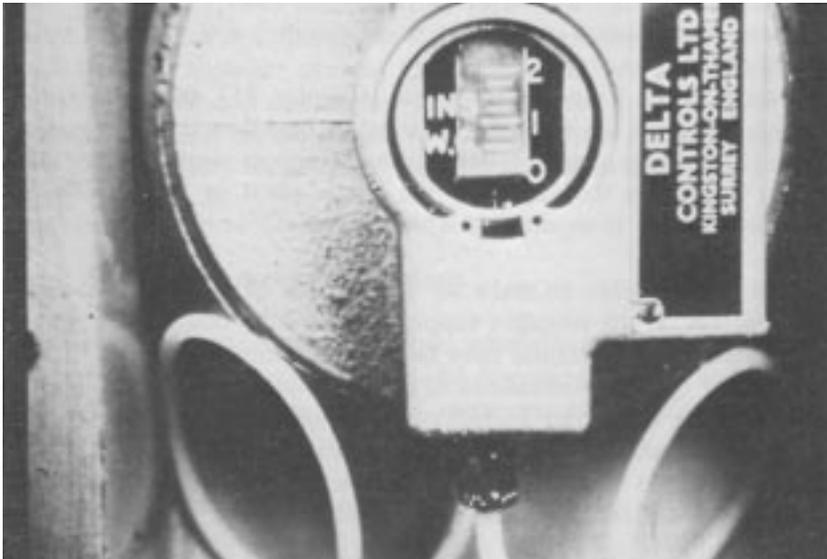
Figure 2.4 Note that on the switch, as shown here with the cover removed, the set-point has been reduced enough to disarm the protective equipment

should have isolated the supply. The reason it did not do so is shown by Figure 2.4, a photograph of the pressure switch with the cover removed. It will be seen that the set-point has been reduced from 1/2 inch water gauge to zero. The switch cannot operate unless the pressure in the cabinet falls below zero, an impossible situation. The protective equipment had been effectively disarmed (that is, made inoperable).

Set-points should be visible to the operators; the pressure switch should therefore have a glass or plastic cover. Unfortunately, carrying out this recommendation is not as easy as it sounds. The switch was a flameproof one and could not be modified without invalidating its certification. Redesign had to be discussed with and agreed by the manufacturer and followed by recertification.

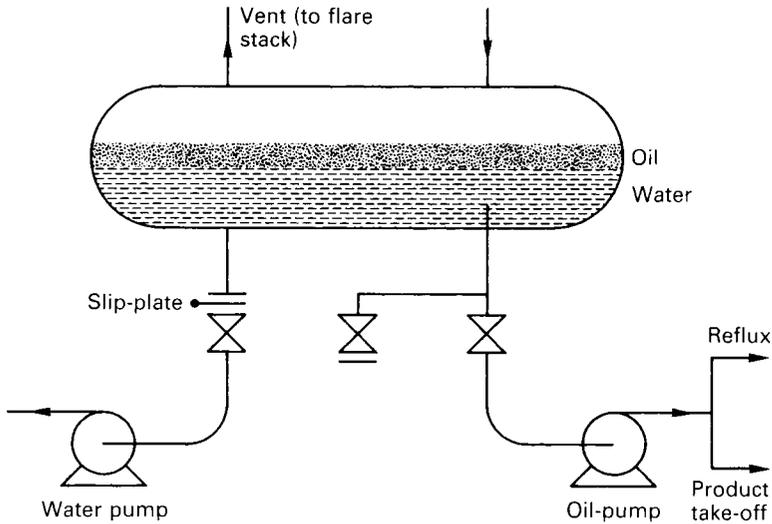
The foreman asked an operator to start up the water pump. He discovered that a slip-plate (spade) had been left in the suction line to the pump on the drum side of the isolation valve (Figure 3.1). All the branches on the drum had been slip-plated during the turnaround to isolate the drum for entry. The other slip-plates had been removed but this one had been overlooked by the fitter who removed them and this was not noticed by the process foreman when he accepted back the permit-to-work.

Figure 3.1 The reflux drum and connections, showing the position of the slip-plate

Removing the slip-plate was more hazardous than it seemed at first sight because the gauge pressure at the slip-plate, due to the head of liquid, was nearly 10 psi (0.7 bar) higher than the pressure in the reflux drum (a gauge pressure of about 15 psi or 1 bar). This was not realised at the time. It might have been realised if those present had given themselves time to talk over the proposed course of action.

A shutdown could have been avoided with less risk by freezing the water above the slip-plate with solid carbon dioxide (dry ice) or by injecting water into the reflux drum via the spare branch shown in Figure 3.1 so as to maintain the level. Another possible way of avoiding the shutdown would be to remove the pump, pass a drill through the valve and drill through the slip-plate. This method could, of course, only be used if the valve was a straight-through type.

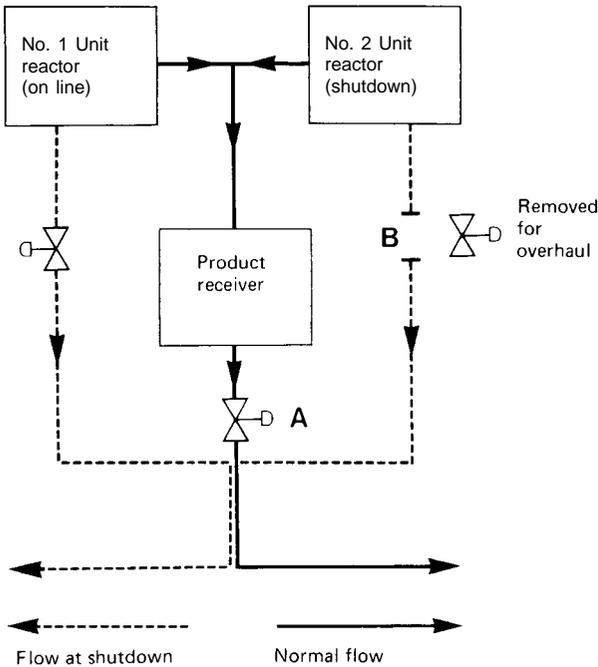
First, however, let us look at Figure 5.1 in more detail. The reaction sections of the two units were quite separate. Reaction product entered a common product receiver and was then further processed in a common unit. The product receiver could be by-passed by the lines shown dotted in Figure 5.1. These lines had been installed to make it easier to empty the reactors when they were being shut down and were used only occasionally. They were therefore overlooked when slip-plates were inserted to isolate the operating unit from the one that was to be maintained.

Valve B, in the by-pass line from the shutdown unit (No 2), had been removed for overhaul. A few hours later valve A was operated.

Figure 5.1 Simplified flow diagram showing a combination of series and parallel equipment

Hot hydrocarbon (boiling point about 85°C, temperature about 150°C and gauge pressure about 7 bar [100 psi]) travelled in the wrong direction along No 2 unit by-pass line and came out of the open end. Someone sounded the evacuation alarm and the eighty maintenance workers who were on the plant at the time, working on No 2 unit, started to leave. Unfortunately, for some of them the direct route to the main gate and assembly point lay close to the leak. As they were passing it, ninety seconds after the leak started, the hydrocarbon ignited. However, most of the maintenance workers escaped without injury.

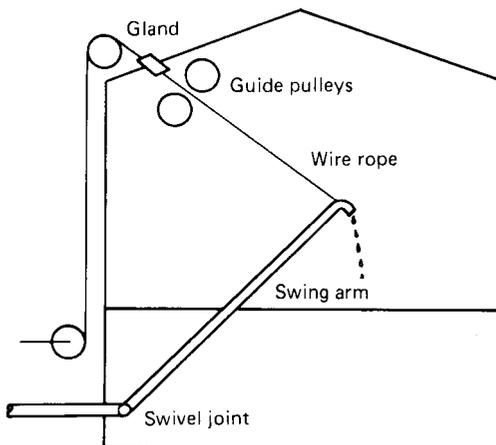
Figure 6.2 The tank was being splash-filled through a swing arm which was stuck in the raised position. (Drawing not to scale)

suction (Figure 6.2). As a result the composition of the vapour space reflected the composition of the incoming, splashing liquid rather than the composition of the bulk of the liquid in the tank and the vapour composition changed as soon as the composition of the incoming liquid changed. This probably explains why the explosion occurred soon after the upset on the distillation column.

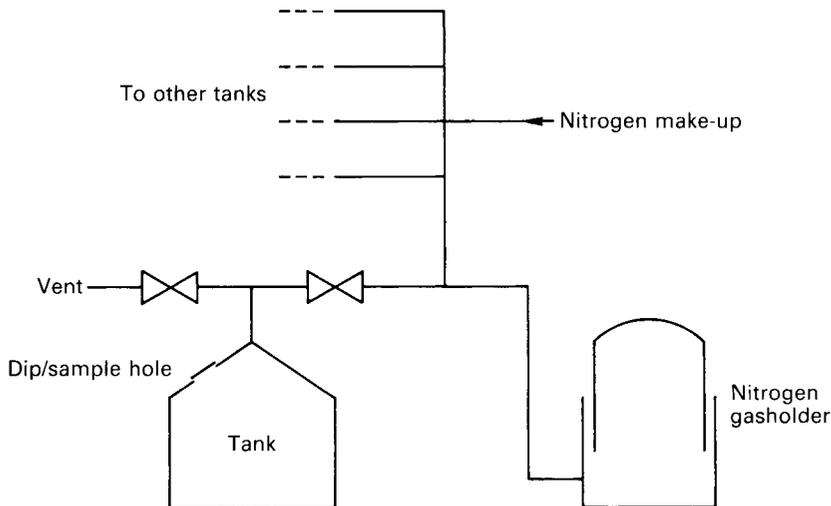
Figure 6.3 The tank was connected to the nitrogen gasholder but could be isolated and vented while it was dipped

and to do this they had to be disconnected from the gasholder and vented to atmosphere for a short time, otherwise nitrogen would be wasted and would also be discharged from the dip hole close to the dipper (Figure 6.3).

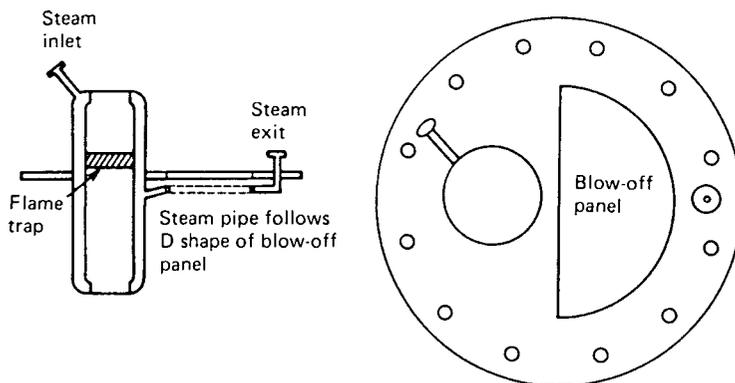
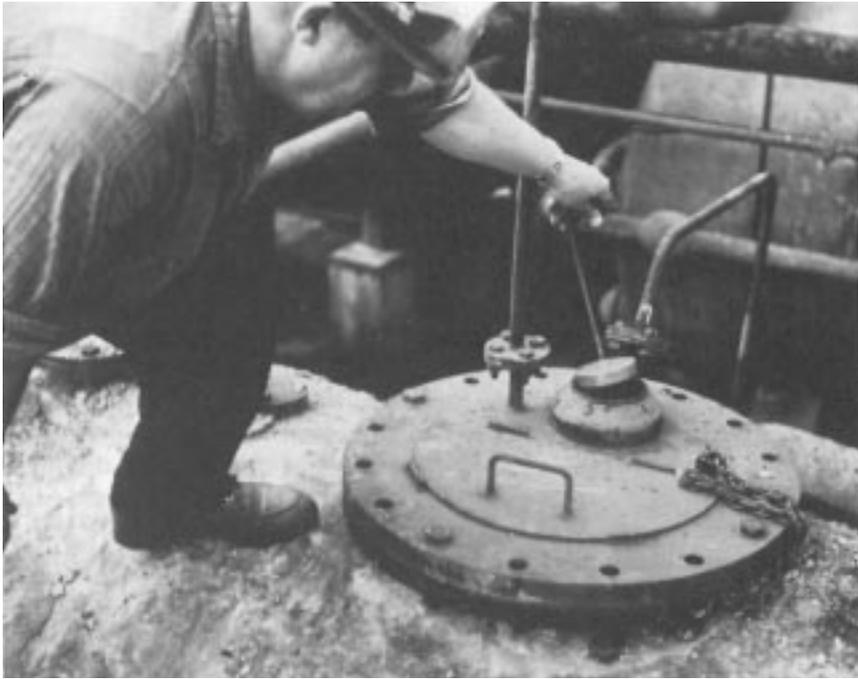
Figures 7.2 and 7.3 illustrate the flame trap assembly that was fitted to 200 tanks, in place of the manhole cover, after the accident¹⁰. The device consisted of a short length of steam-jacketed pipe into which a crimped ribbon flame arrester was fitted. A long handle on the flame arrester enabled it to be removed, without the use of tools, and held up to the light for inspection. The inspector could also look through the vent hole into the tank to see that there was no obstruction. Adequate access was, of course, provided. Should the flame trap have choked, or been unable to pass the required quantity of gas, a loose D-shaped lid lifted and relieved the pressure. A chain prevented the lid going into orbit. Steam tracing prevented the lid from being stuck in position by adhering solid.

The steam jacket extended at least 3 inches (75 mm) into the tank to prevent a bridge of solid forming across the bottom. The flame arrester was about 9 inches (225 mm) from the bottom of the vent and about 3–4 inches (75–100 mm) from the top.

evidence that a chemical explosion had occurred and the tank failed at exactly the time that it was calculated the pressure would have risen to the bursting pressure. Nevertheless it is not good practice to blow compressed air into a tank containing flammable vapour and after the incident nitrogen was used instead. As air might diffuse into the tank a flame arrester was fitted in the vent. Two hundred other tanks in the plant were treated similarly.

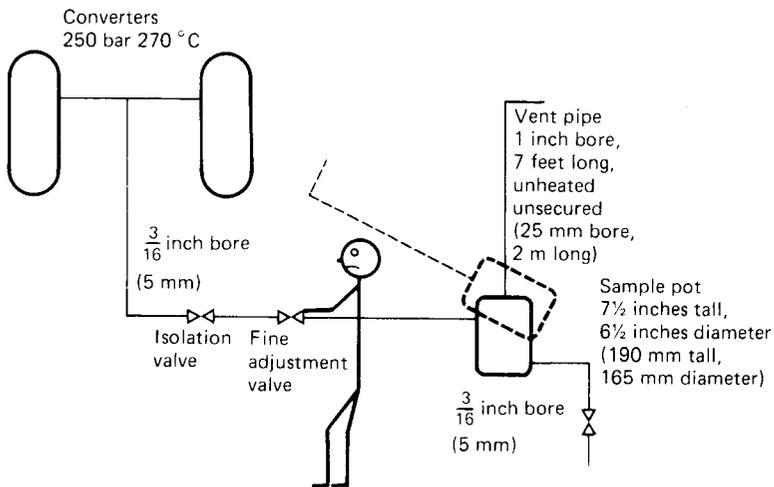
A vegetable oil was being hydrogenated on a pilot plant and samples had to be taken from the line joining two reactors (Figure 7.4). The sample pot was filled by opening the isolation valve and cracking open the fine adjustment valve. Both valves were then closed and the sample drained into a sample can. As the oil and product had a melting point of 20°C, all lines were steam traced, except for the vent line.

The sample pot and vent line had not been clamped and were free to rotate by partially unscrewing the flange on the inlet pipe. It had been intended to clamp them but this had been overlooked. It is believed that there was a choke somewhere in the system, probably in the vent pipe which was not heated, and that when it cleared the back pressure from the sudden rush of gas caused the vent pipe to move backwards.

The main recommendation of the report was that plants handling materials which are solid at atmospheric temperature should be adequately heated. This applied particularly to the vent pipe.

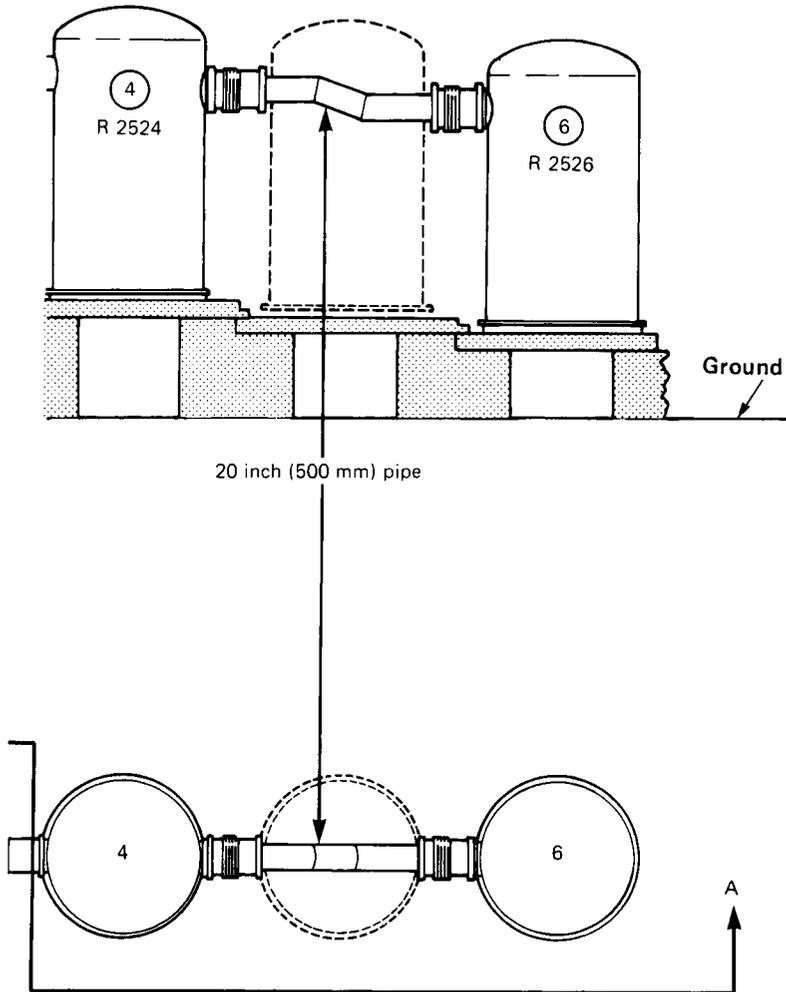
One of the reactors developed a crack and was removed for repair. In order to maintain production a temporary pipe was installed in its place. Because the reactors were mounted on a sort of staircase, so that liquid would overflow from one to another, this temporary pipe was not straight but contained two bends (Figure 8.1). It was 20 inches diameter although the short pipes which normally joined the reactors together were 28 inches diameter. Calculation showed that 20 inches would be adequate for the flow rates required. Bellows, also 28 inches diameter, were installed between each reactor and these were left at each end of the temporary pipe.

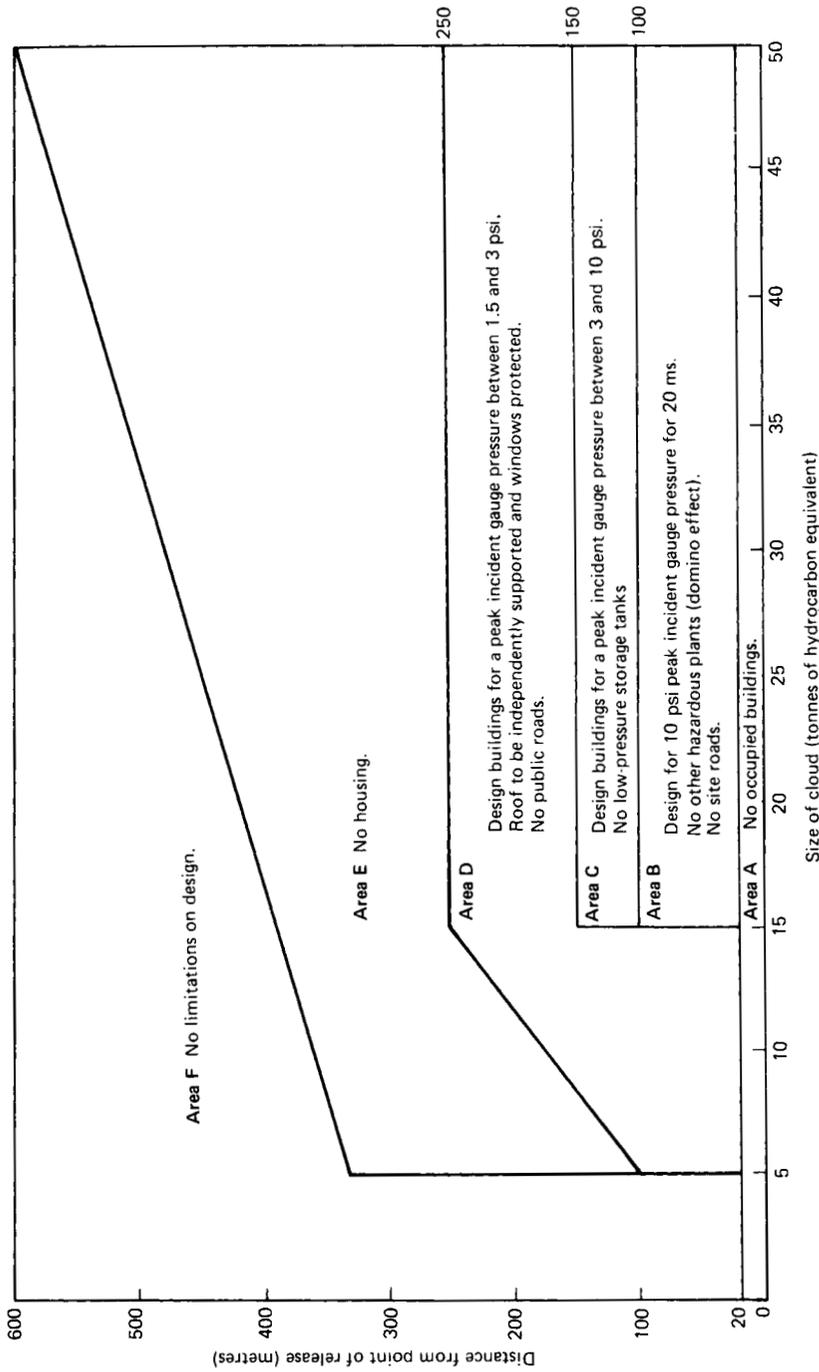
The same procedure can be used to find a satisfactory layout and location for the plant. Thus other plants containing hazardous materials should not be placed at points at which the peak incident pressure will be 0.35 bar (5 psi) or more or they may be so seriously damaged that a further leak and a further explosion occur (the so-called domino effect). For low pressure storage tanks containing hazardous materials the maximum acceptable pressure is 0.2 bar (3 psi). Public roads should not be located where the pressure exceeds 0.07 bar (1 psi) and houses where it exceeds 0.05 bar (0.7 psi), preferably 0.03 bar (0.4 psi). The conclusions are summarised in Figure 8.3 and reference 17 gives more detail.

Figure 8.3 shows that there should be no buildings at all within 20 m of plant containing materials which might explode. This is to provide a fire

Some writers have suggested lower pressures, some higher. However, they have also suggested different methods for the calculation of the pressure, in particular different explosion efficiencies, and their final conclusions are not much different from those shown in Figure 8.3. Each method of estimation should be considered as a whole and we should not pick and choose figures from different methods.

A final point to be considered under layout is the location of the assembly points at which people congregate when a warning sounds and a plant is evacuated. They should be some distance away, at least 150 m, from equipment containing large inventories, in Area D of Figure 8.3. Control rooms should not be used as assembly points.

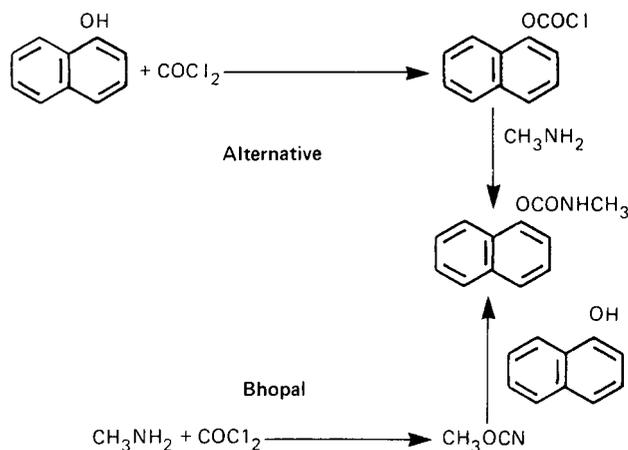
If reducing inventories, or intensification as it is called, is not practicable an alternative is substitution, that is, using a safer material or route. At Bhopal the product (carbaryl) was made from phosgene, methylamine and alpha-naphthol. The first two were reacted together to make MIC which was then reacted with alpha-naphthol. In an alternative process used by the Israeli company Makhteshim, alpha-naphthol and phosgene are reacted together to make a chloroformate ester which is then reacted with methylamine to make carbaryl. The same raw materials are used but MIC is not formed at all (Figure 10.1)¹⁵.

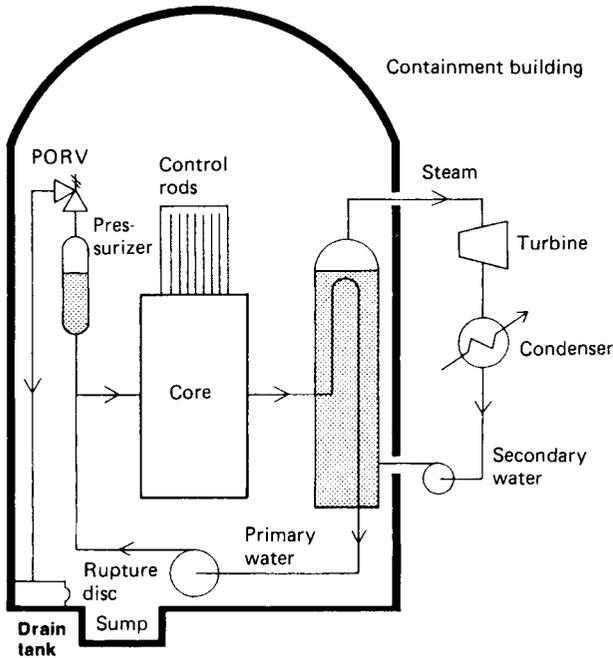
Figure 11.1 is a simplified diagram of a pressurised water reactor (PWR), the type used at Three Mile Island and in most nuclear power stations (except for the PWR at Sizewell, all UK reactors are gas-cooled). Heat is generated in the core by nuclear fission and is removed by pumping primary water round and round. The water is kept under pressure so that it is not boiling. (It is called a pressurised water reactor to distinguish it from a boiling water reactor, the type used at Chernobyl.) The primary water gives up its heat, in a heat exchanger, to the secondary water which does boil. The steam produced drives a turbine and is condensed. The condensate is recycled. All radioactive materials, including the primary water, are enclosed in a containment building so that they will not escape if there is a leak²⁻¹⁰.

The secondary water was passed through a resin polisher unit to remove traces of impurities. There were several parallel paths and one of them choked. Less attention had been paid to the design of this off-the-shelf ancillary unit than to the design of the main radioactive equipment. In particular its reliability had not been studied to the same extent.

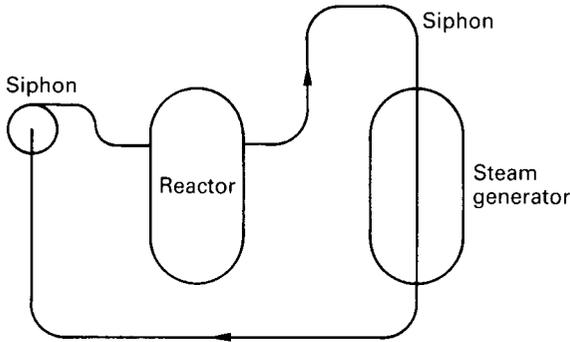
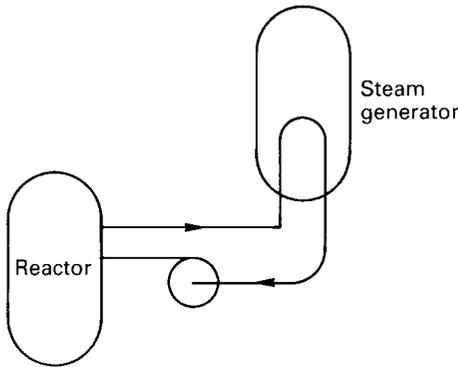
A halfway-house to inherently safer designs are those containing passive safety features. For example, in Three Mile Island and other early PWR designs the heat source, the core, is only a little below the heat sink, the steam generator, and so there is little or no convection cooling if the circulation pumps stop (Figure 11.2a). In addition, at Three Mile Island, siphon loops (high points in the piping) filled with steam and prevented flow and other obstructions increased the pressure drop. These problems are overcome in the modern design shown in Figure 11.2b. The steam generator is well above the core and there are no siphon loops. Convection cooling can supply 25% of the full cooling load²¹.

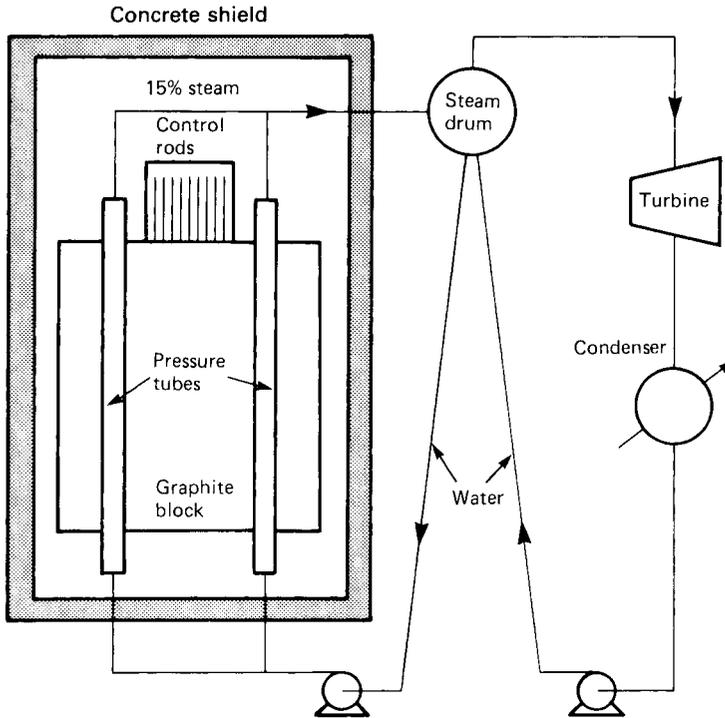
Figure 12.1 is a simplified diagram of the Chernobyl reactor. The uranium fuel is contained in 1661 pressure tubes, made of zirconium alloy, through which the water is passed. About 15% of the water is turned into

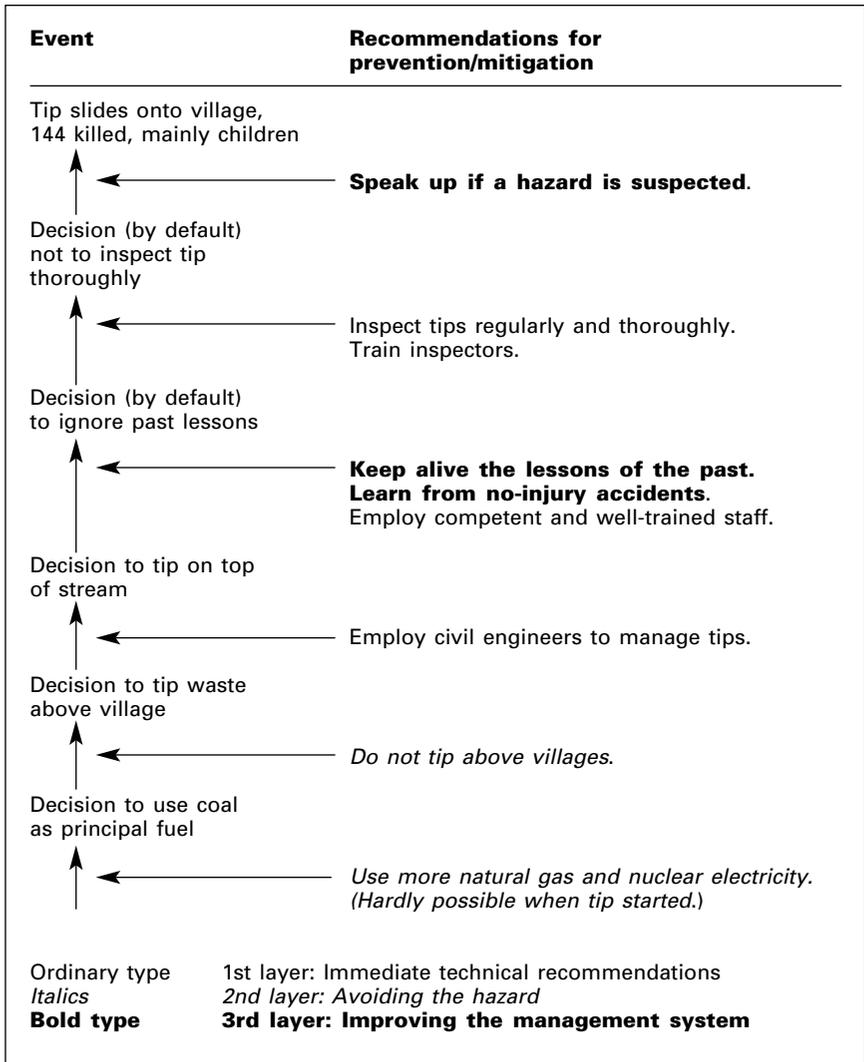
Figure 13.1 Summary of Chapter 13 – Aberfan

The simple truth is that there was no regular inspection of the tips. On the contrary, their inspection (such as it was) was wholly haphazard in point of time and had no reference to their stability at all, but simply related to such matters as the condition of the mechanical equipment for tipping (§64).

The inspection of the Aberfan tips was carried out by the Area Mechanical Engineer. . . . it was remarkably inadequate. It was purely visual; (he) had no plans or surveys with him and he made no notes . . . and he never climbed to the top of Tip 7 to see conditions for himself or to seek information from the tipping gang . . . There was in truth much for him to note – the extent of the 1944 slip, the results of the incident of 1963,

and the deep bowl-like depression, to mention just some of the unusual features . . . Had these obvious features been noted and properly enquired into, it seems inconceivable that there would have been a disaster (§170).

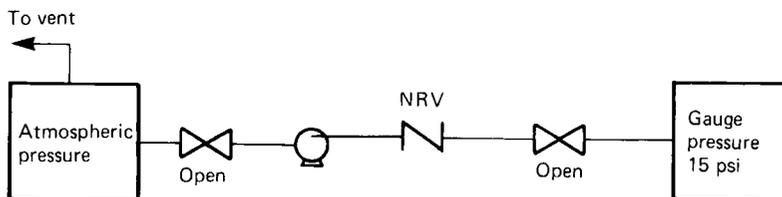
Figure 15.1 When the NRV failed, a leak was inevitable (see item 4)

The first dangerous occurrence: liquid was pumped intermittently from an atmospheric pressure storage tank to one which was kept at a gauge pressure of 1 bar. The pump suction and delivery valves were kept open and a non-return valve was relied on to prevent backflow (Figure 15.1).

A piece of wire, about 3 inches long, became stuck in the non-return valve and the atmospheric pressure storage tank overflowed. Two tonnes of liquid were spilt.

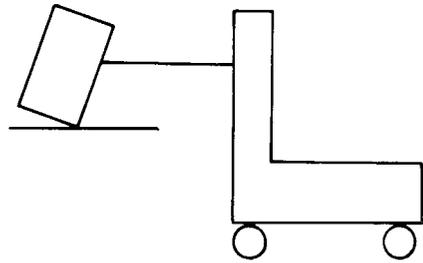
Figure 15.5 ... and then tipped up like this (see Accident 29)

Full 40-gallon drums were being loaded onto a flat wagon with a fork lift truck. The drums were stored on their sides in tiers, as in Figure 15.3. Two drums were lifted onto the wagon at a time (Figure 15.4) and then tipped into a vertical position with the ends of the forks (Figure 15.5). One tipped too far and fell onto the foot of the driver who was standing on the wagon to adjust the position of the drums.

One possible solution would have been to store the drums on their ends and lift them onto the wagons with a suitable attachment fitted to the fork lift truck. However, this would need extra storage space and would not be the complete answer as a layer of horizontal drums was put on top of the vertical layer (Figure 15.6).

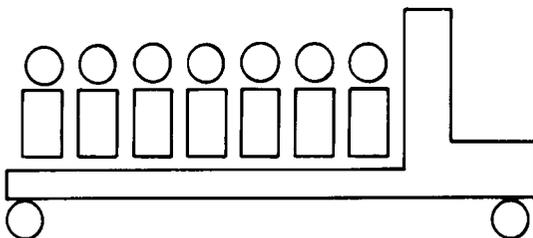
Figure 15.6 Method of carrying drums on a flat wagon (see Accident 29)

One customer would not accept wagons with the upper horizontal layer of drums as a man had been killed when one of these drums fell off. This illustrates one of the problems of industrial safety. There may be a case for forbidding the top layer of drums at all times; there may be a case for allowing it to continue. There is no logic in stopping it at the site where the accident occurred but allowing it to continue elsewhere.

We felt that this problem called for more expertise than we, or any of the local management, possessed and we recommended that it was referred to consultants.

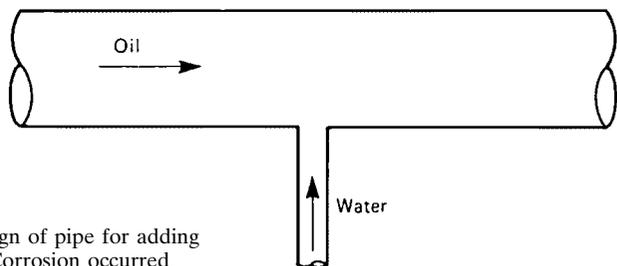
(A1) Water was added to an oil stream using a simple T-junction (Figure 16.1). The water did not mix with the oil and extensive corrosion occurred downstream of the junction. There was a major fire.

Figure 16.1 Original design of pipe for adding water to an oil stream. Corrosion occurred

The corrosion would not have occurred if the water pressure had been higher, so that the water hit the opposite wall of the pipe, or if the water had been added to the centre of the oil line as shown in Figure 16.2.

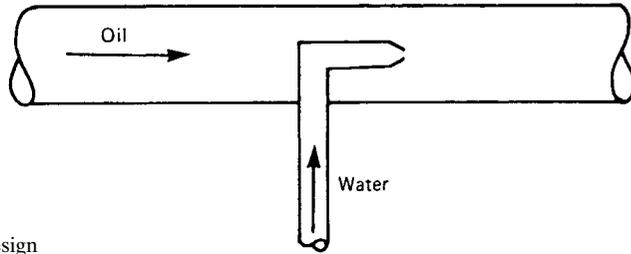
Figure 16.2 A better design

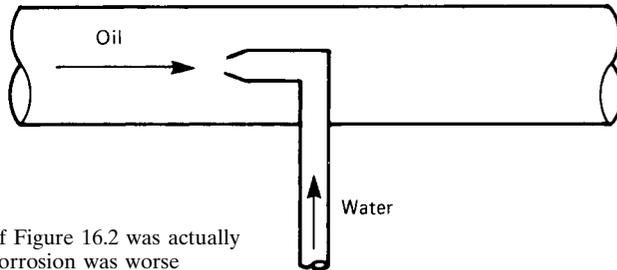
Figure 16.3 The design of Figure 16.2 was actually assembled in this way. Corrosion was worse

(A2) A device to achieve this was designed for another plant. It was assembled as shown in Figure 16.3. Corrosion was worse! Once the device was assembled it was impossible to tell if it had been assembled correctly. It should have been designed so that there was a tell-tale sign on it or, better still, so that it could not be assembled incorrectly.

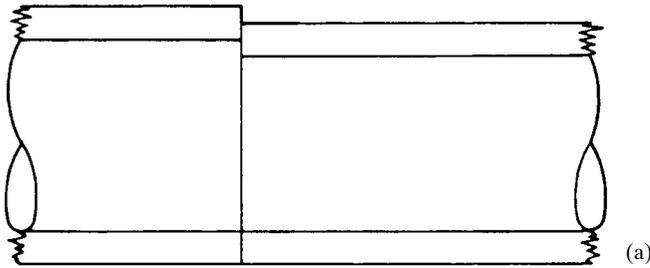
Figure 16.5 (a) and (b) Two pipes of slightly different diameter were welded together

(B7) Two lengths of 8-inch (200 mm) pipe which had to be welded together were not exactly the same diameter so the welder joined them with a step between them over part of the circumference (Figure 16.5(a) and (b)). The pipe was then insulated. The botched job was not discovered until ten years later when the insulation was removed for inspection of the welds.

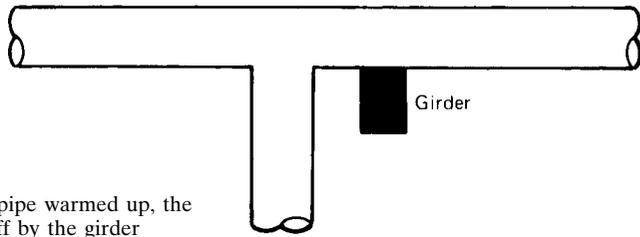
(B10) A 10-inch (250 mm) pipe was fitted with a $\frac{3}{4}$ inch (20 mm) branch. The main pipe rested on a girder and there was a gap of 5 inches (125 mm) between the branch and the girder (Figure 16.7). When the pipe was brought into use its temperature rose to 300°C. The branch came into contact with the girder and was knocked off. Calculation showed that the pipe, which was 120 feet (36 m) long, had moved 6 inches (150 mm).

Again, it is unlikely that the designer specified precisely how the branch was to be positioned in relation to the girder and that he left this detail to be decided on site. The construction workers would not have known the operating temperature of the pipe or how much it would expand.

Figure 16.7 When the pipe warmed up, the branch was knocked off by the girder

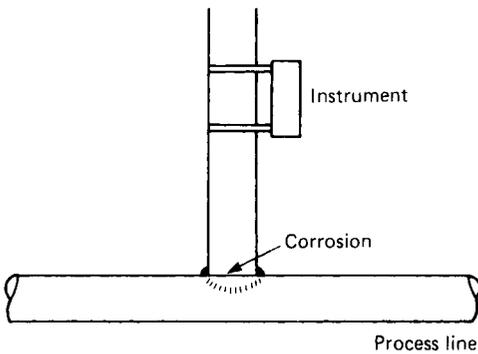
Figure 16.12 Water collected in a piece of pipe, used as an instrument support, and corrosion occurred

A piece of pipe was welded onto a liquefied petroleum gas line to support an instrument (Figure 16.12). Water collected in the support and corroded the LPG line. Gas was seen blowing out of the support!

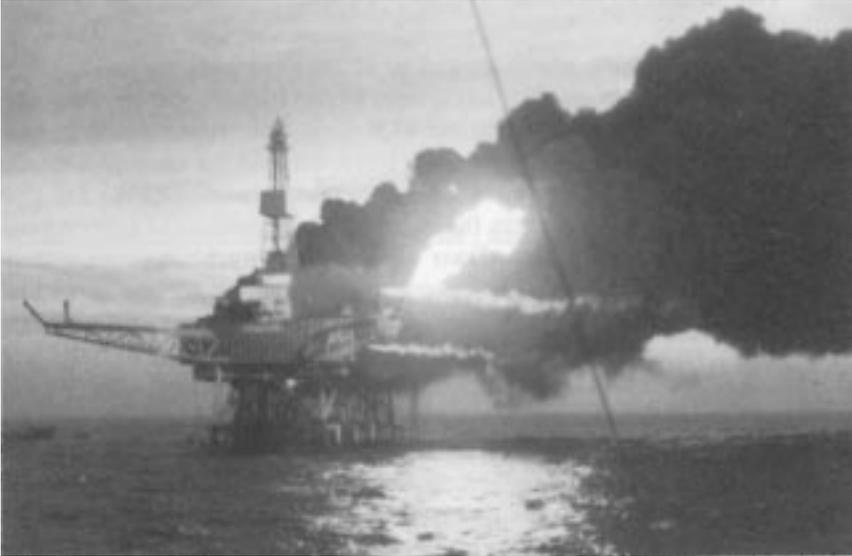
The disaster originated at 20.00 hours on 6 July 1988 with the explosion of a low lying cloud of condensate. That caused extensive damage and led to an immediate large crude oil fire, the smoke from which made access to any of the platform's lifeboats impossible from the outset. About 20 minutes later there was a second explosion which caused a massive intensification of the fire. It was due to the rupture of the riser on the gas pipeline from the Tartan platform. The fire was further intensified by

Figure 17.1 The fire on Piper Alpha during its early stages, before the rupture of the risers. (Copyright: Robert Gibson)

successive ruptures some 30 minutes and 60 minutes later of risers on the other two gas pipelines, to the gas gathering and the Claymore platforms. Apart from the drilling rig end structure, the Piper platform was totally destroyed within a few hours, its equipment and accommodation falling into the sea which was about 150 m deep (Figure 17.1).

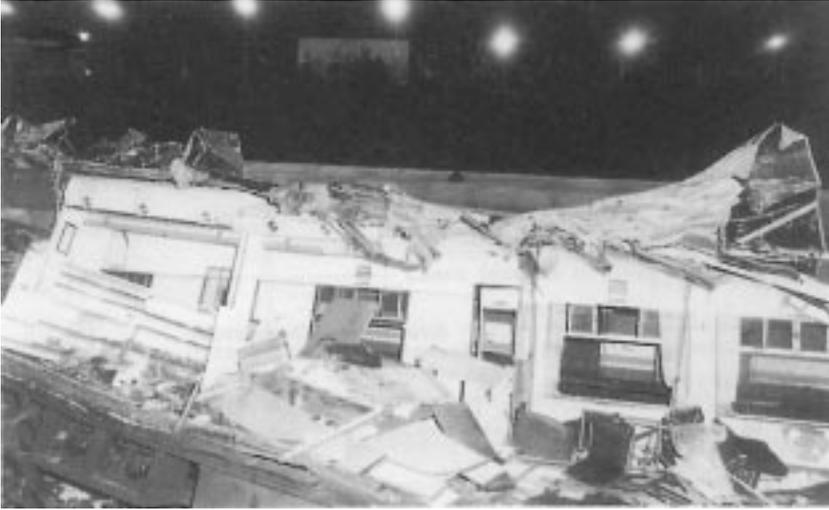
Just after 8.00 am on 12 December 1988 a crowded commuter train (B) ran head on into the rear of another train (A) which was stationary in a cutting near Clapham Junction railway station in South London. The moving train (B) veered to the right and struck a train (C) coming in the opposite direction. Thirty-five people were killed and nearly 500 injured, sixty-nine seriously. All those killed were travelling in the front two coaches of train B (see Figure 19.1).

Figure 19.1 The second coach (buffet car with loose seats) of the second (moving) train involved in the railway accident at Clapham Junction. (Reproduced by permission of London Fire Brigade.)

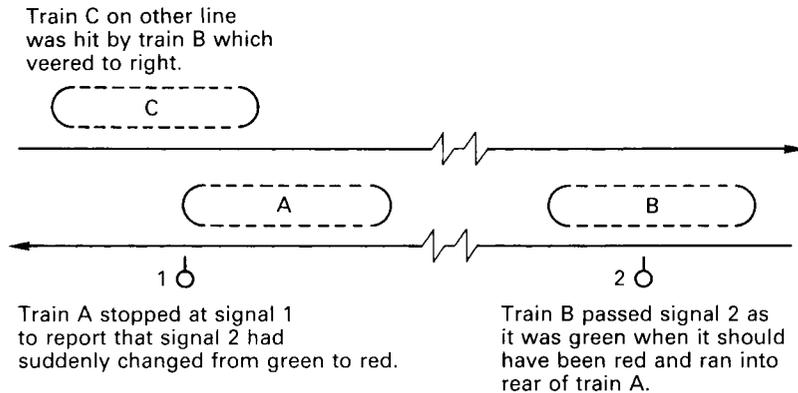
Figure 19.2 The Clapham Junction railway accident

The stationary train (A) had stopped because a signal suddenly changed from green to red when the train was almost on top of it. In accordance with instructions the driver stopped at the next signal to report the fault by telephone to the signalman. He assumed, as he had every right to do, that the track-circuiting would detect the presence of his train on the tracks and would keep the previous signal at red. Unfortunately there was a fault in this signal, a wrong side failure; it was green when it should have been red; it was inviting the next train (B) to pass it and enter the section already occupied by the stationary train (A) (Figure 19.2).

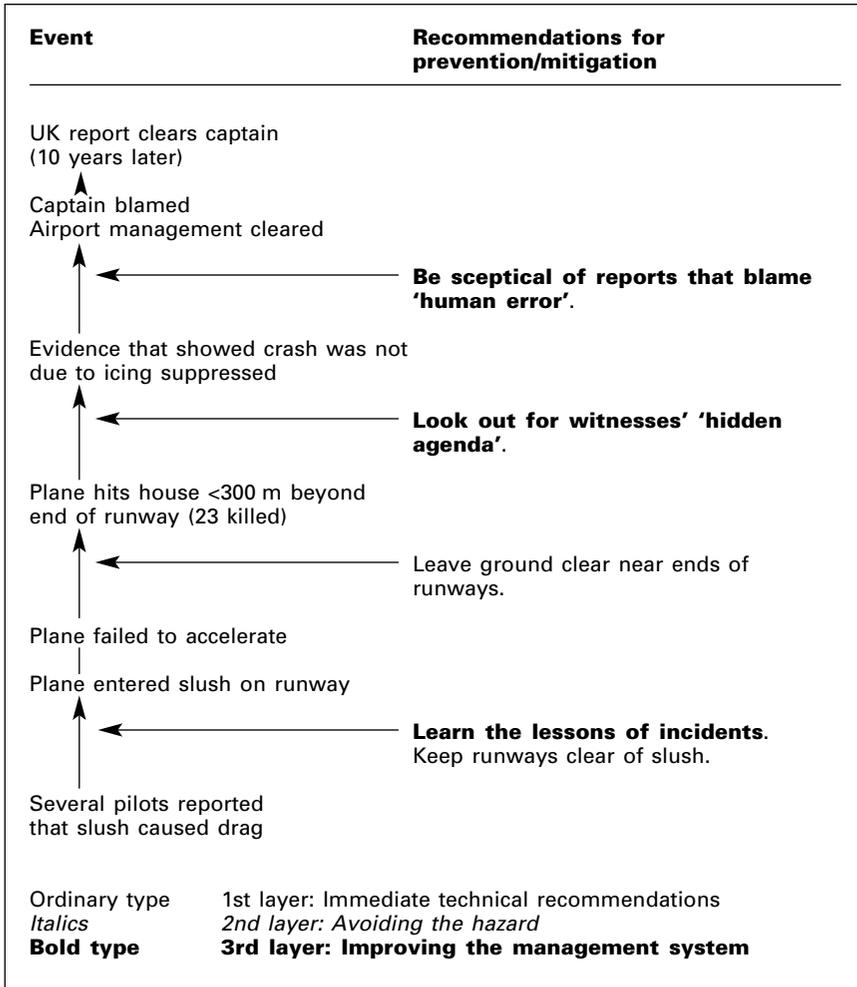
The weather was bad. There were several centimetres of slush on the runway and some of the other planes taking off at about the same time had been de-iced. The captain of the British plane decided that this was not necessary and the German inquiry blamed the accident on his error of judgement.

At the time the effect of slush on acceleration was not fully understood or the runway might have been cleared. As evidence accumulated, from experiments and from reports by other pilots, that slush might have been responsible, there were calls for the inquiry to be re-opened but the German authorities refused. Finally, ten years after the accident a British Commission cleared the captain, who had survived. One of their witnesses was the first man on the scene after the crash; he had examined

Figure 21.3 The Munich crash 1958

the wings and found no ice on them. He had not been called to the German inquiry, only someone who detected a patch of ice six hours later.

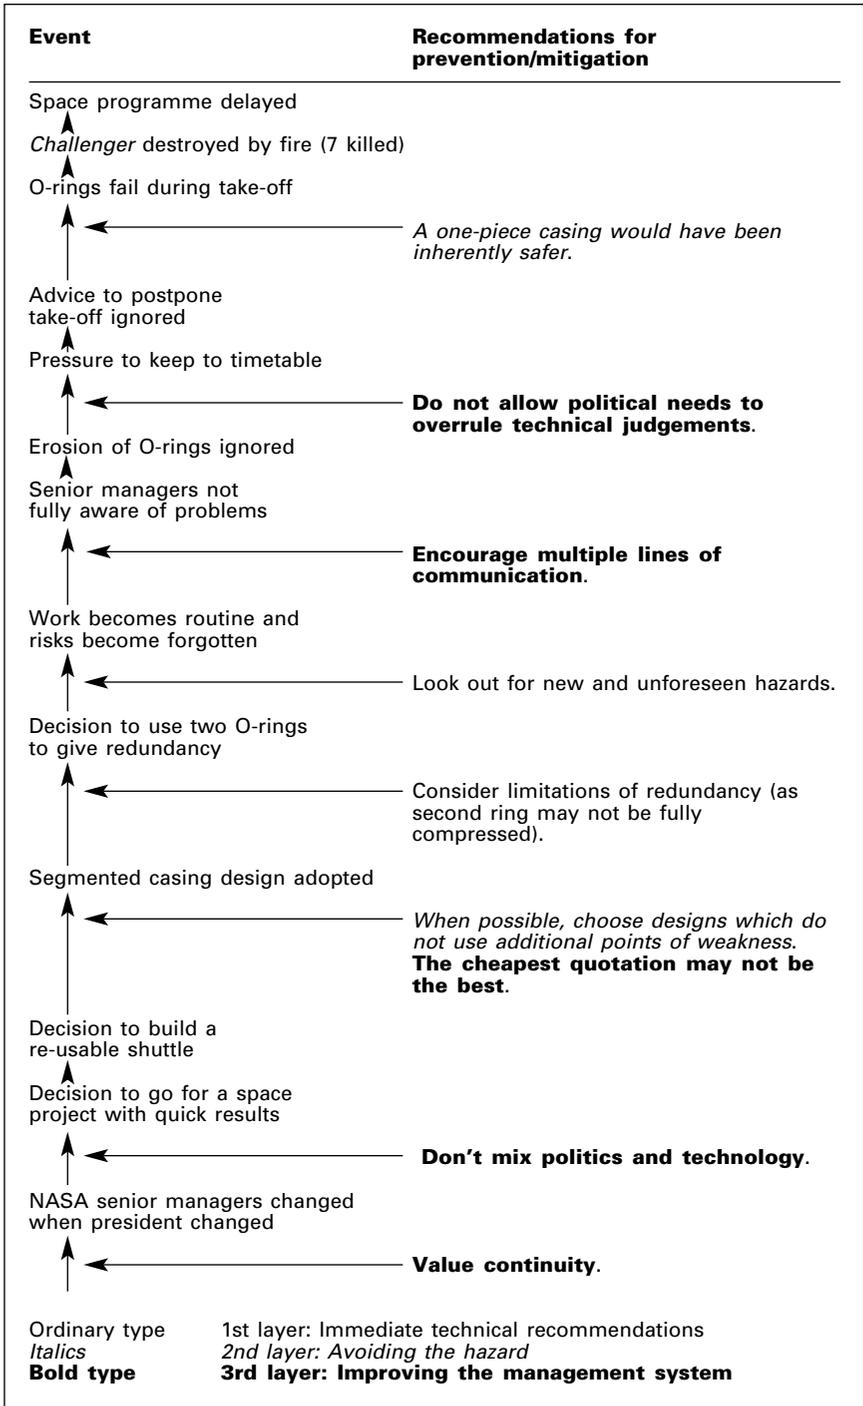
The story is summarised in Figure 21.10, though some of the events occurred simultaneously rather than in the order indicated. It started about 1970 when President Nixon decided to go ahead with the construction of a re-usable space shuttle. Unlike President Kennedy he was not a space enthusiast and decided to back a project that, he hoped, would bring him credit during his term of office, rather than a long-term project such as an expedition to Mars. About the same time many of the senior staff

NASA accepted the cheapest quotation for the design of the shuttle even though the casing would be made in parts. One of the four quotations was for a one-piece design, an inherently safer one as its integrity does not depend on additional pieces of equipment, seals, which are

Figure 21.10 *Challenger*

inevitably weaker in nature than the parts they join. The failure of one of these O-ring seals led to the loss of *Challenger*.

The first flights showed that the O-rings became eroded but this caused little concern among the senior management. Development of a new design, a 27-month programme, was started but meanwhile the old design continued in use, for several reasons⁷:

Finally, on the day before the fatal launch several engineers urged that it should be postponed as the temperature was below freezing and the O-rings would be brittle and more likely to fail. They were overruled, for the same three reasons. Several writers have suggested that the pressure to keep to programme came from President Reagan, as he was due to make a State of the Union Message later that day and would have liked to report a successful start to the flight. However, it is equally or more likely that the senior staff at NASA *thought* they were being pressured.

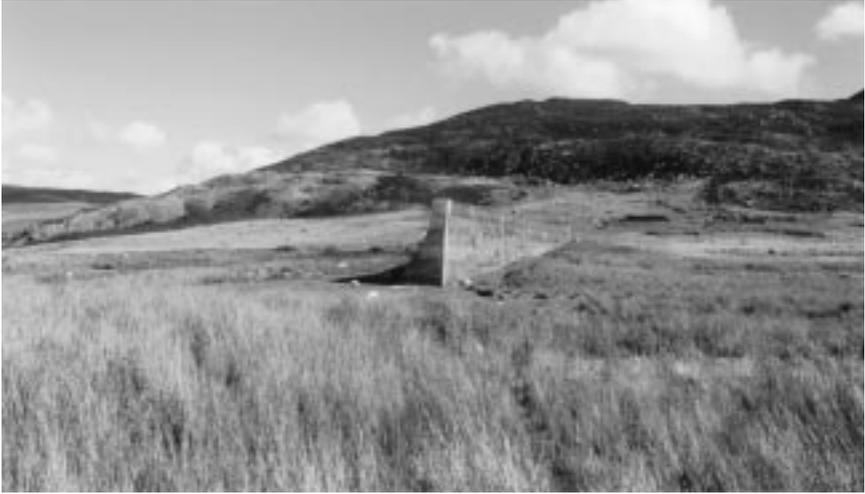
- In 1909 a concrete wall 1.4 km long was built to raise the water level in Llyn Eigiau in North Wales by 6 m. According to the design, the wall should have extended 1.8 m into the clay on which it was built but the contractor for part of the work sank the wall only 0.5 m into

Figure 22.2 Part of the Llyn Eigiau concrete dam today. The broken end has been straightened

the clay. Those who examined the wall afterwards could not, of course, see this. In 1925 the reservoir was full and overflowing. The clay underneath a section of wall was washed out leaving the wall hanging as a bridge over a gap 18 m wide and 3.5 m deep. A flood of water caused the Coety dam, 90 m below, to fail and the combined waters destroyed a hamlet about 300 m below^{8,9} (see Figure 22.2).

The immediate triggering event was probably the drying out of the clay during a hot summer but the underlying causes were the failure of the contractor to follow the design and the failure of the designers and owners to inspect the work during construction. Sections 13.6, 13.7 and 14.4 describe other dam failures.

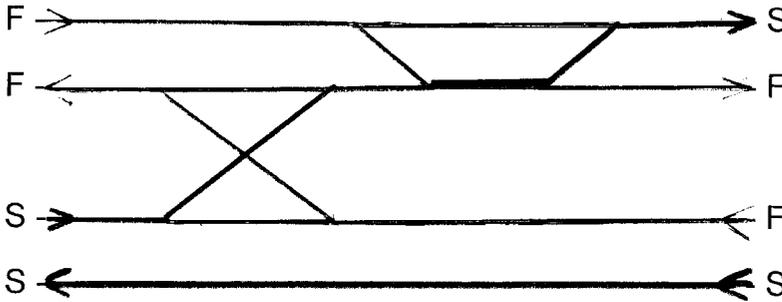
Most SPADS, over 99%, do not result in accidents⁹. When one train is following another down a line the first train is usually well ahead. SPADS are most likely to result in an accident when there is a conflicting movement, that is, one train has to cross the path of another¹⁰. Such movements are inevitable at junctions, unless one line is bridged over

Figure 23.1 An example of railway track which requires conflicting train movements. The layout has now been changed. F = fast, S = slow

another, an expensive solution, and at terminal stations, but there are also many unnecessary conflicts. Figure 23.1 shows an example.

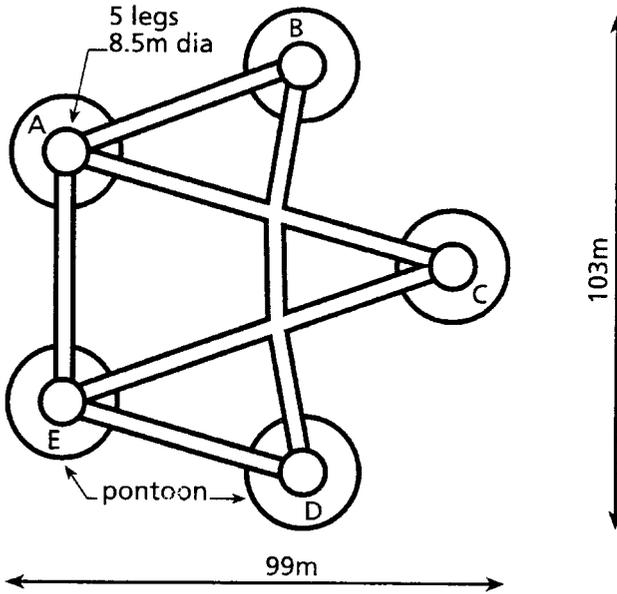
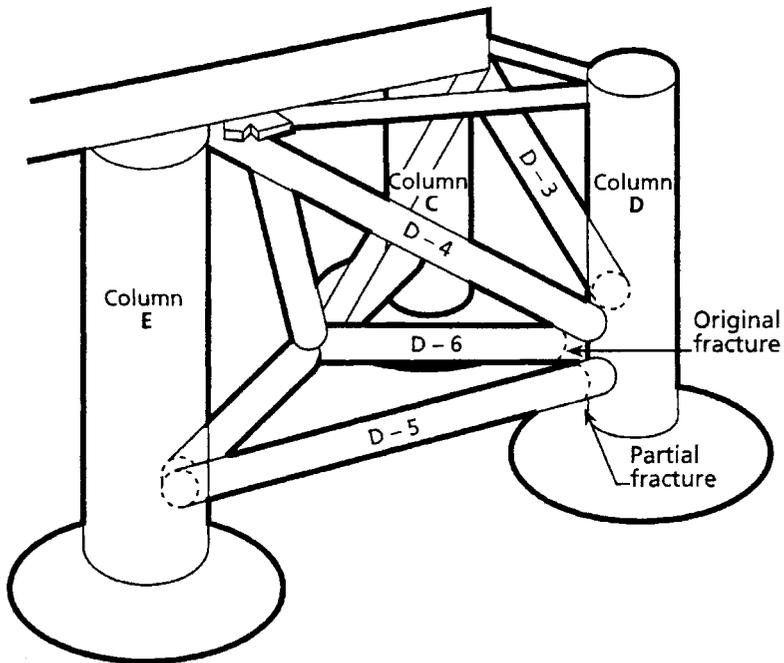
The rig was semi-submersible. In use the pontoons (Figure 28.2) were full of water and the rig was partly submersed in the water for maximum stability. When being moved the pontoons were pumped out and the rig rose 21 m higher. Though designed as a drilling rig it was being used only for accommodation. During a heavy storm in March 1980 column D, like the others 8.5 m diameter, broke and the rig turned upside down. There were 212 men on the rig at the time; 123 of them died.

Figure 28.2 (a) The pentagon design of the Alexander Kielland offshore rig (Reproduced with permission from Macmillan³)

Figure 28.2 (b) Close-up of columns C, D and E showing bracing (Reproduced with permission from Macmillan³)

The immediate cause was a fatigue crack at the position shown in Figure 28.2 which spread right round the circumference. This so weakened the structure that the other bracings cracked, the rig listed 30–35°, water entered the superstructure and 20 minutes later the rig tipped right over.

- The pentagon design was known to be prone to failure when waves came in the BD direction, the direction at the time of failure. Such rigs were normally anchored in another direction. However the Alexander Kielland was connected by gangway to a platform and was not free to change its position.
- Other rigs of the same design had been given extra bracing.
- The change in use to accommodation had increased the weight of the rig, especially above column D, making the rig less stable. (Many other rigs were said to have increased their weight since construction.)
- Pumping water into D pontoon when the rig started to list would have stabilised it.
