Learning from Accidents

Third edition

Trevor Kletz

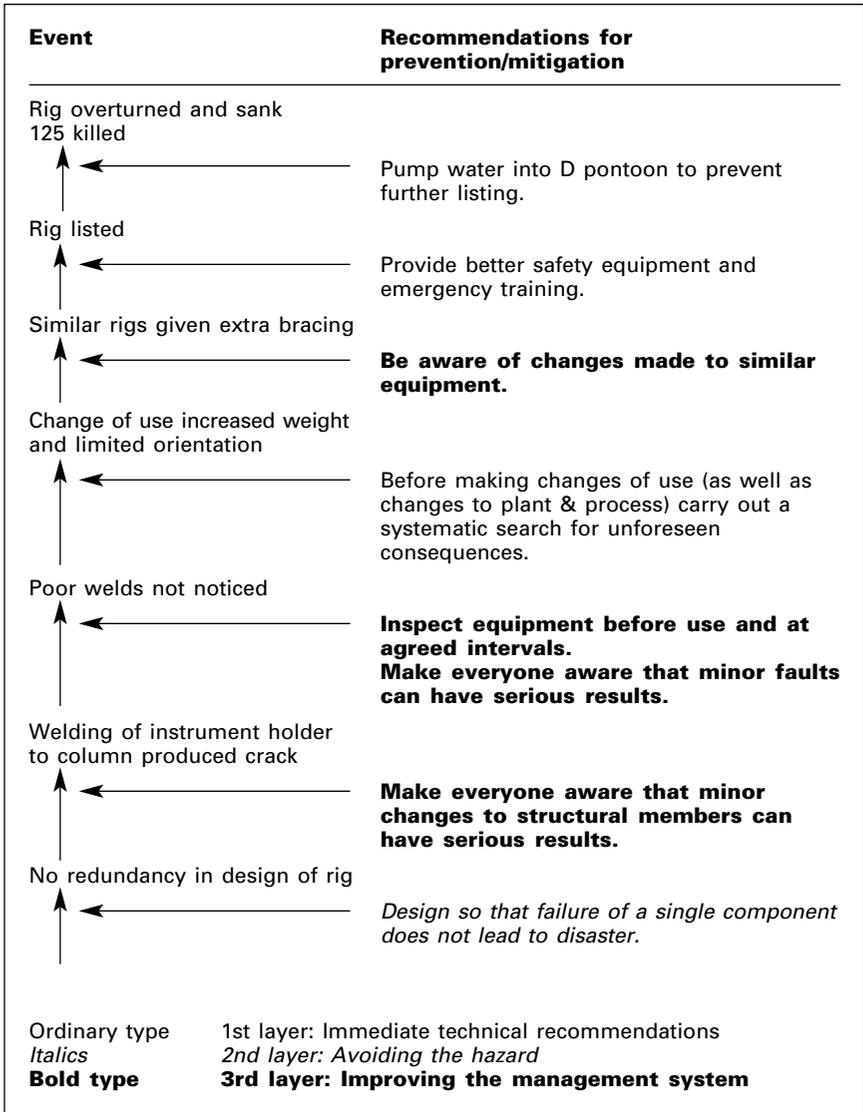
Figure 28.3 summaries the various opportunities that were missed for preventing the collapse or minimising the consequences. Foremost among these were the failure to look thoroughly and systematically for the consequences of the change in use and failure to realise that changes that look trivial can sink a ship.

Figure 28.3 Summary of Section 28.4 Sinking of a North Sea floating rig

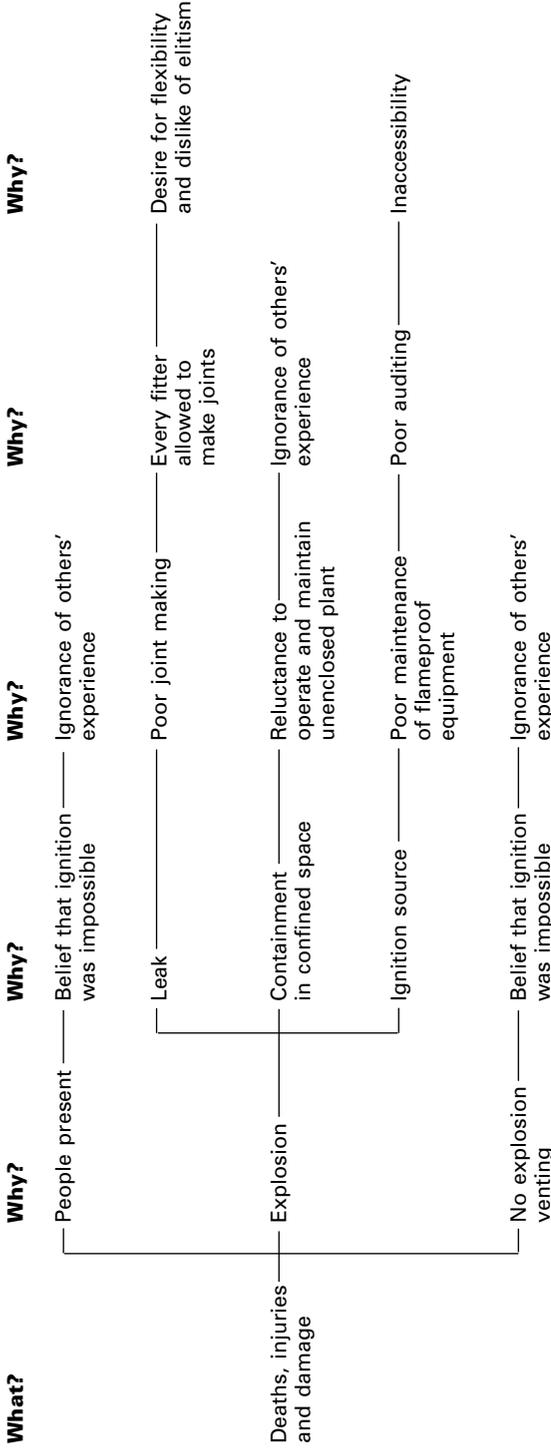
Figure 30.2 shows another way of representing the events leading up to this accident.

One method of encouraging people to look for the underlying or root causes of accidents as well as the immediate causes and triggering events, suggested by Majora²¹, is to complete a 'why-why' diagram, systematically asking the questions, 'Why did this happen?'. Figure 30.2 shows this technique applied to the accident described in Chapter 4.

Figure 30.2 A Why-Why diagram for the accident described in Chapter 4. 'Ignorance of others experience' (called insularity in Chapter 4) includes a failure to recognise or accept that such experience may be relevant. The two places where lines join are AND gates, that is, a leak, containment and a source of ignition were needed before an explosion could occur. Removal of either could have prevented the explosion (or made it less likely). A leak could have been made less likely by removing the conditions shown to the right of it, and so on
