# WHAT WENT WRONG?

Case Histories of  
Process Plant Disasters

Trevor Kletz

**FOURTH EDITION**

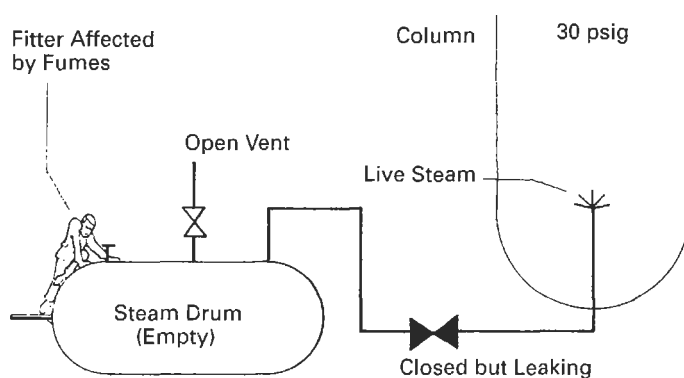
The company concerned normally used slip-plates to isolate equipment under repair. On this occasion, no slip-plate was fitted because it was “only” a steam line. However, steam and other service lines in plant areas are easily contaminated by process materials, especially when there is a direct connection to process equipment. In these cases, the equipment under repair should be positively isolated by slip-plate or disconnection before maintenance.

**Figure 1-3.** Contamination of a steam drum by process materials.

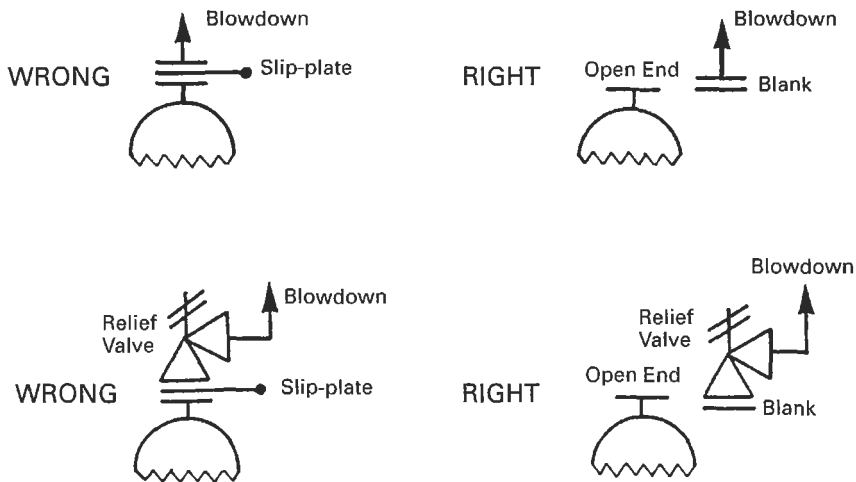
If a vessel has to be isolated from the vent or blowdown line, do not slip-plate it off, but whenever possible, disconnect it and leave the vessel vented to atmosphere (as shown in Figure 1-4).

If the vent line forms part of a blowdown system, it will have to be blanked to prevent air being sucked in. Make sure the blank is put on the flare side of the disconnection, not on the tank side (Figure 1-4). Note that if the tank is to be entered, the joint nearest the tank should be broken.

**Figure 1-4.** The right and wrong ways to isolate a vent line.

If a vent line has to be slip-plated because the line is too rigid to be moved, then the vents should be slip-plated last and de-slip-plated first. If all slip-plates inserted are listed on a register, they are less likely to be overlooked.

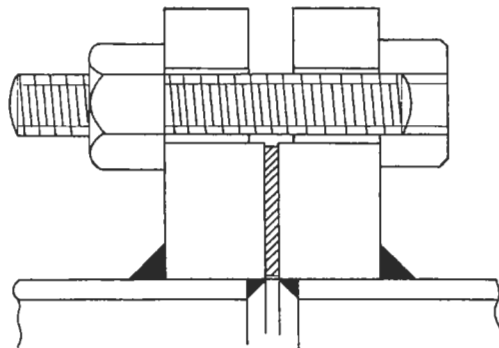
- (a) When a plant came back on line after a long shutdown, some of the flanges had been secured with stud bolts and nuts instead of ordinary bolts and nuts. And some of the stud bolts were located so that more protruded on one side than on the other. On some flanges, one of the nuts was secured by only two or three threads (Figure 1-12).

In addition, stud bolts should not be indiscriminately mixed with ordinary bolts or used in their place. They are often made of different grades of steel and produce a different tension.

**Figure 1-12.** Nuts fitted incorrectly to studs.

In the plant concerned, for the eight-bolt joints the bolts were changed one bolt at a time. Four-bolt joints were secured with clamps until the next shutdown.

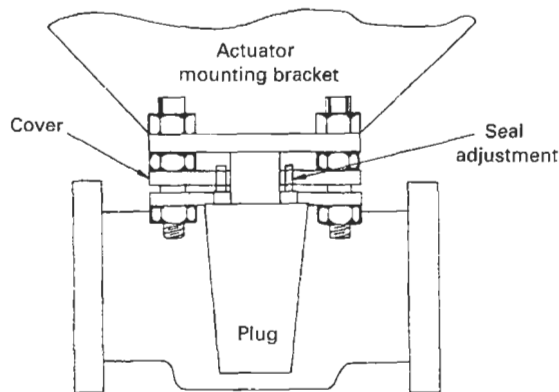
- (a) Several spillages have occurred from power-operated valves while the actuators were being removed because the bolts holding the valve bonnets in position were removed in error. Figures 1-14 and 1-15 show how two such incidents occurred. The second system is particularly vulnerable because in trying to unscrew the nuts that

**Figure 1-15.** Wrong nuts undone to remove valve actuator.

hold the actuator mounting bracket in place, the stud may unscrew out of the lower nuts. This incident could be classified as due to poor design [10].

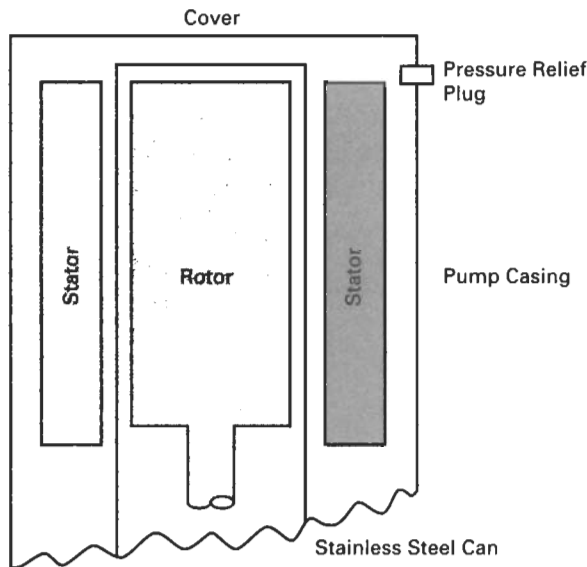
The fixed part of the electric motor—the stator—is not immersed in the process liquid and is separated from the rotor by a stainless steel can (Figure 1-17).

If there is a hole in the can, process liquid can get into the stator compartment. A pressure relief plug is therefore fitted to the compartment and should be used before the compartment is opened for work on the stator. Warning plates, reminding us to do this, are often fitted to the pumps.

The stator compartment of a pump was opened up without the pressure relief plug being used. There was a hole in the can. This had caused a pressure buildup in the stator compartment. When the cover was unbolted, it was blown off and hit a scaffold pole 2 m above. On the way up, it hit a man on the knee, and the escaping process vapor caused eye irritation. Persons working on the pump did not know the purpose of the plug, and the warning notice was missing.

**Figure 1-17.** Canned pumps.

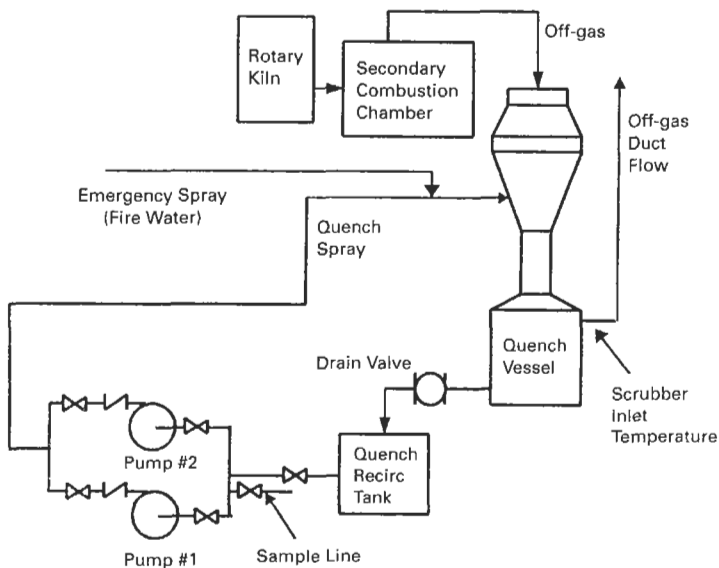
A sample point on the suction line of two water pumps became choked, and a maintenance worker was asked to clear it. He was not told how to do so—craftsmen dislike people from other departments telling them how to do their jobs—but the operators assumed he would use water under pressure or a rod. Instead he used compressed air at a gauge pressure of 115 psi (8 bar), and a pocket of air caused the pumps to lose suction (Figure 1-19).

The results were not serious. The pumps supplied water to cool the hot gases leaving an incinerator; when the water flow stopped, a high-temperature trip shut down the burner. The incinerator was new, was still undergoing tests, and the job had not been done before. The water was recycled, and ash in it probably caused the choke [40].

**Figure 1-19.** Simplified drawing of incinerator quench recirculation system. (Illustration courtesy of the U.S. Department of Energy.)

According to the report, the maintenance worker should have been given more detailed instructions. But, as it also points out, some skills are skills of the craft; we should be able to assume that craftsmen are aware of them and should not need to give them detailed instructions on each and every occasion. We should not need to tell them, for example, how to break a joint every time they are asked to do so (but see Section 1.5.1). Where do we draw the line?

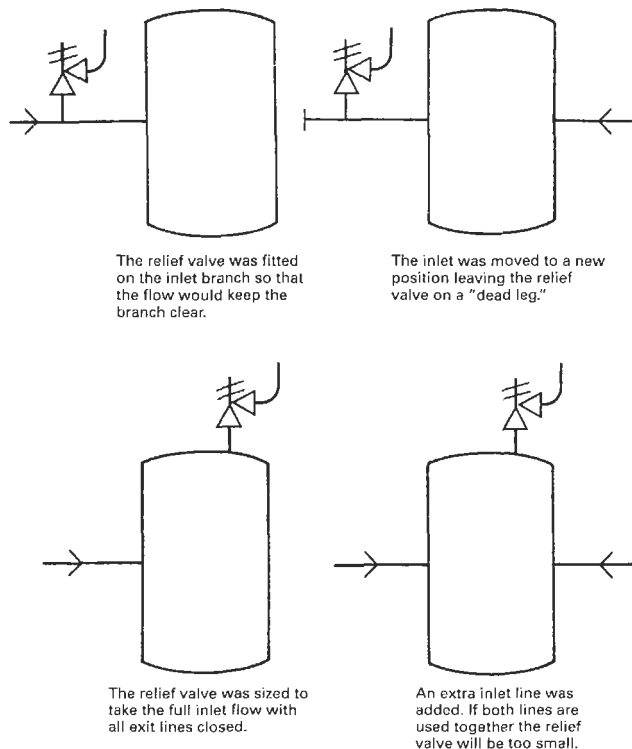
**Figure 2-1.** Some of the modifications made to the relief system in a plant during its first year on line.

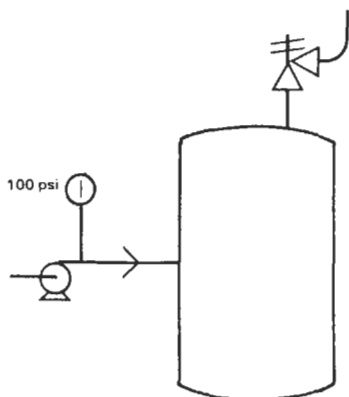
The vessel was designed to withstand the maximum pressure the pump could deliver. The relief valve was not designed to take the maximum flow from the pump.

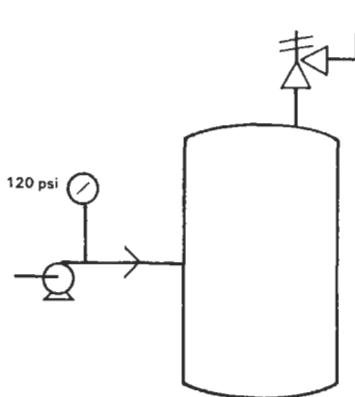
The pump actually proved capable of producing 20 psi more than design. If the exit from the vessel is isolated when the pump is running the vessel will be overpressured.

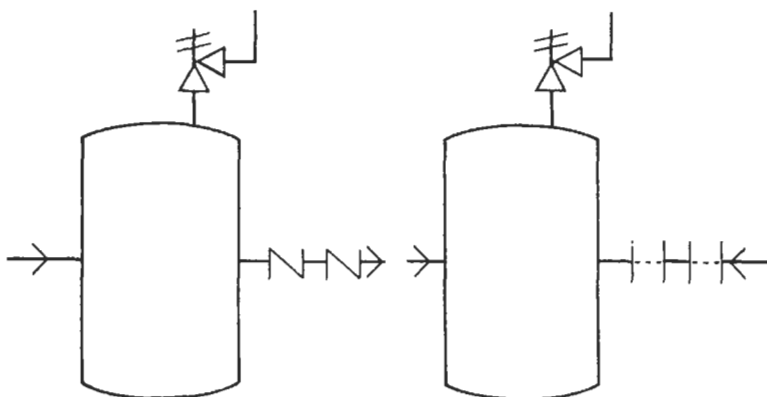
The relief valve was sized on the assumption that two nonreturn valves in series would prevent backflow into the vessel.

Both nonreturn valves corroded, allowing backflow to take place.

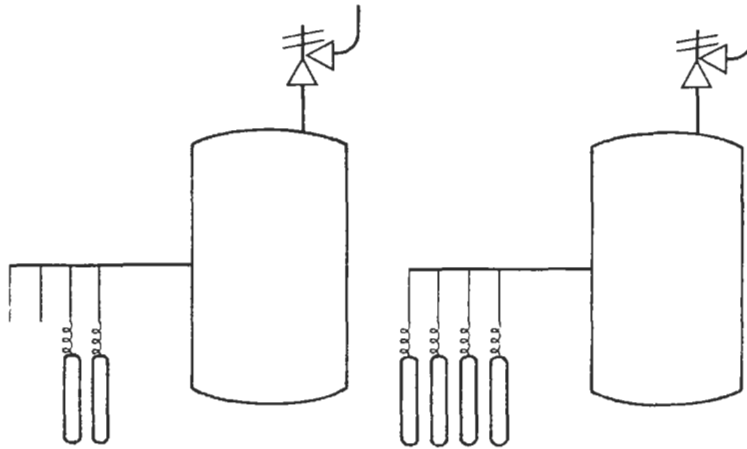
The relief valve was sized on the assumption that only two gas cylinders would be used at a time, though connections were provided for four cylinders.

Inevitably, four cylinders were connected up and sometimes used.

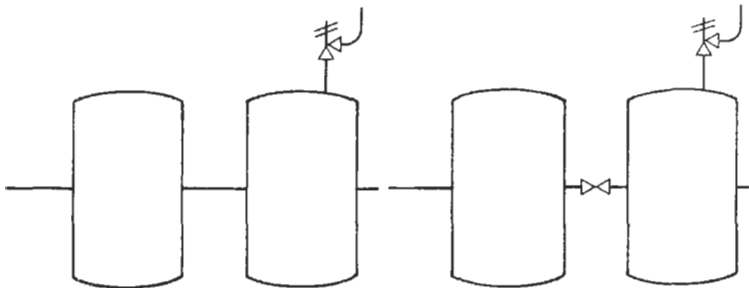
A single relief valve was designed to protect two vessels, which were connected together by a line without any valve or other restriction between them.

An extra isolation valve was fitted between the two vessels, thus making it possible to isolate the first vessel from its relief valve.

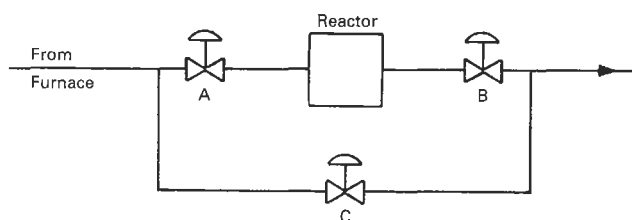
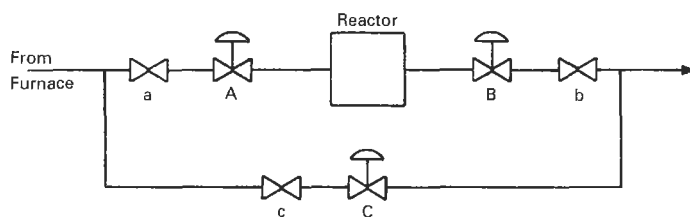
- (b) A reactor was fitted with a bypass (Figure 2-2a). The remotely operated valves A, B, and C were interlocked so that C had to be open before A or B could be closed. It was found that the valves leaked, so hand-operated isolation valves (a, b and c) were installed in series with them (Figure 2-2b).

A blockage occurred downstream. The new let-down valve was leaking, and the downstream equipment was overpressured and burst.

When the modification was designed, the designers assumed that the new line would join the original line immediately after the relief valve. If they realized the importance of this, they did not

**Figure 2-2a.** Original reactor bypass.

**Figure 2-2b.** Modified reactor bypass.

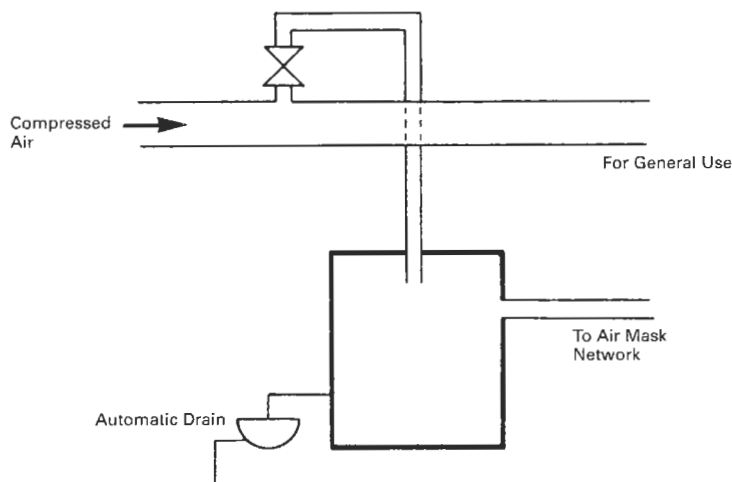
Many years ago a special network of air lines was installed for use with air masks only. A special branch was taken off the top of the compressed air main as it entered the works (Figure 2-4).

Investigation found that the compressed air main had been renewed and that the branch to the breathing apparatus network had been moved to the *bottom* of the main. When a slug of water got into the main, it all went into the catchpot, which filled up more quickly than it could empty. Unfortunately, everyone had forgotten why the branch came off the top of the main, and nobody realized that this was important.

**Figure 2-4.** Original arrangement of air lines.

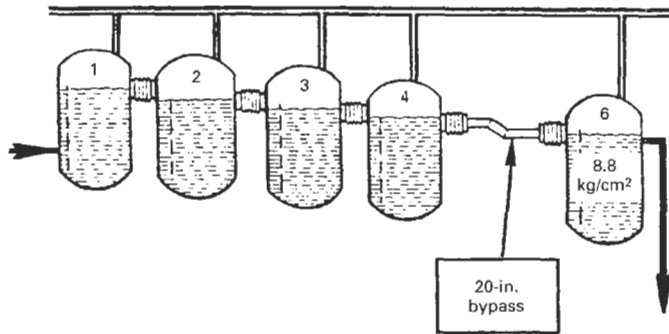
At the Flixborough plant there were six reactors in series. Each reactor was slightly lower than the one before so that the liquid in them flowed by gravity from No. 1 down to No. 6 through short 28-in.-diameter connecting pipes (Figure 2-5). To allow for expansion, each 28-in. pipe contained a bellows (expansion joint).

One of the reactors developed a crack and had to be removed. (The crack was the result of a process modification; see Section 2.6 b.) It was replaced by a temporary 20-in. pipe, which had two bends in it, to allow for the difference in height. The existing bellows were left in position at both ends of the temporary pipe (Figure 2-5).

**Figure 2-5.** Arrangement of reactors and temporary pipe at Flixborough.

The design of the pipe and support left much to be desired. The pipe was not properly supported: it merely rested on scaffolding. Because there was a bellows at each end, it was free to rotate or “squirm” and did so when the pressure rose a little above the normal level. This caused the bellows to fail.

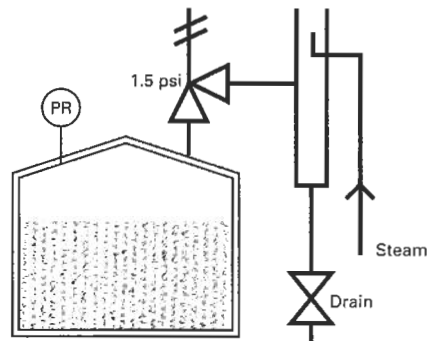
Someone suggested putting steam up the stack to disperse the cold vapor. This seemed a good idea and the suggestion was adopted (Figure 2-6).

**Figure 2-6.** Liquid ethylene tank venting arrangements.

After the tank was repaired, the vent stack was replaced by a flarestack.

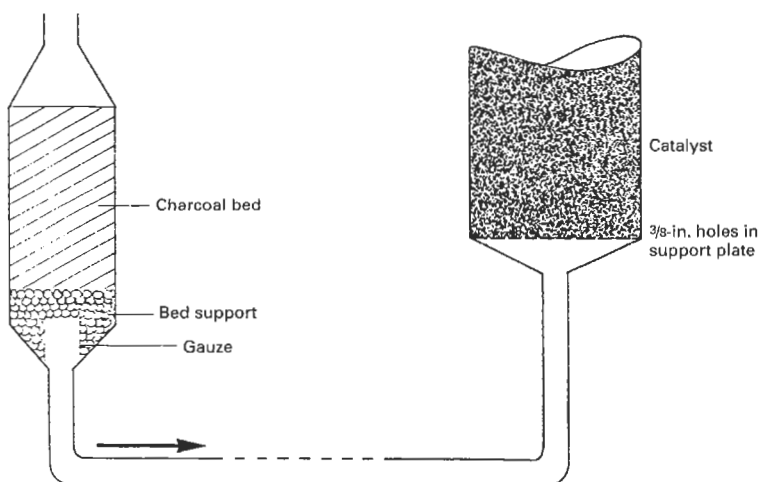
The hydrogen came from another plant and was passed through a charcoal filter to remove traces of oil before it left the supplying plant. Changes of charcoal were infrequent, and the initial stock lasted several years. Reordering resulted in a finer charcoal being supplied and charged without the significance of the change being recognized. Over a long period, the new charcoal passed through its support into the line to the other plant. Small amounts of the charcoal partially clogged the  $\frac{3}{8}$ -in. distribution holes in the catalyst retaining plate (Figure 2-7). There was a big loss of production.

The cause of the pressure drop was difficult to find because it was due to a change in another plant.

**Figure 2-7.** Hydrogen purification system.

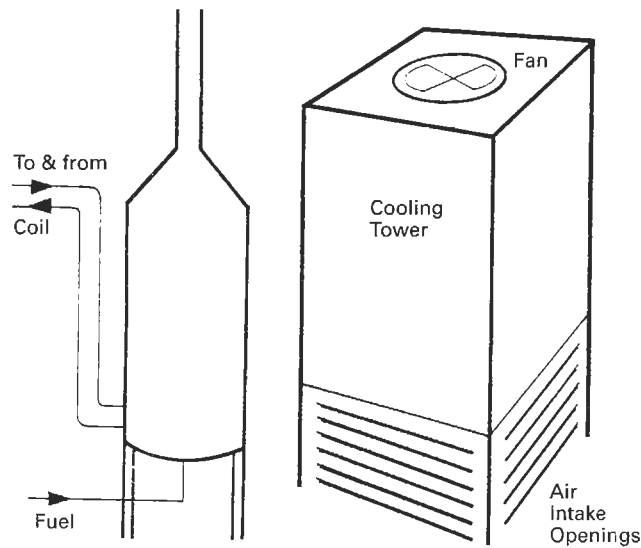
No one realized, when a site for the furnace was decided, that flammable vapors could come out of the cooling tower. Direct contact condensers are not common, but flammable vapors can appear in many cooling towers if there are leaks on water-cooled heat exchangers. After the incident, a combustible gas detector was mounted permanently between the furnace and the tower (Figure 2-8).

**Figure 2-8.** Gas entered the furnace when the cooling tower fan was switched off.

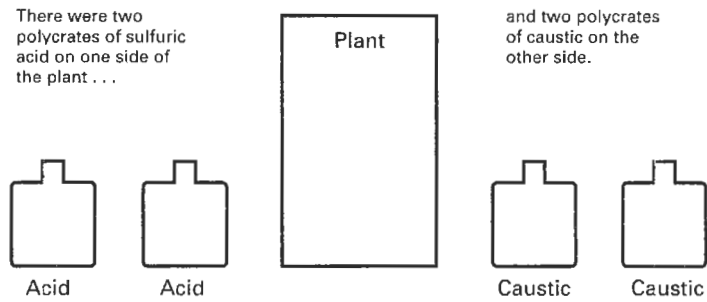
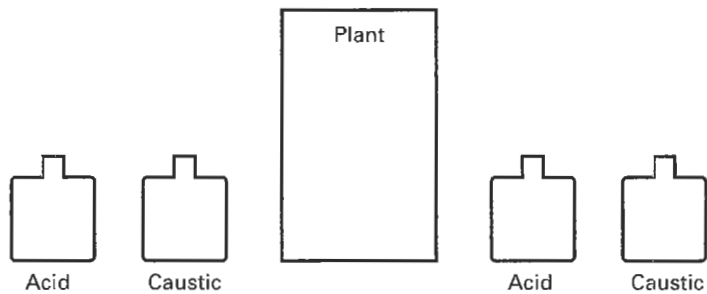
- (a) A plant used sulfuric acid and caustic soda in small quantities, so the two substances were supplied in similar plastic containers called polycrates (Figure 2-9). While an operator was on his day off, someone decided it would be more convenient to have a polycrate of acid and a polycrate of alkali on each side (Figure 2-10). When the operator came back, no one told him about the change. Without checking the labels, he poured some excess acid into a caustic crate. There was a violent reaction, and the operator was sprayed in the face. Fortunately he was wearing goggles.

**Figure 2-9.** Original layout of acid and caustic containers.

**Figure 2-10.** Modified layout of acid and caustic containers.

We should tell people about changes made while they were away. In addition, if incompatible chemicals are handled at the same plant, then, whenever possible, the containers should differ in size, shape, and/or color, and the labels should be large and easily seen from eye level.

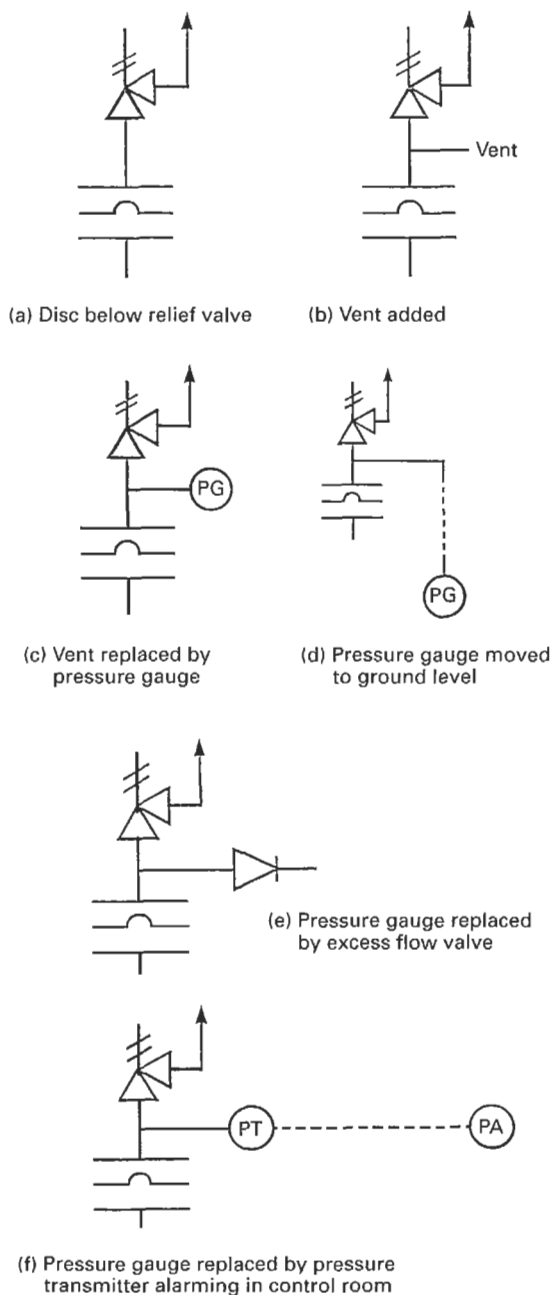
For example, small leaks through relief valves may cause pollution, so rupture discs were fitted below the relief valves (Figure 2-11 a). (On other occasions they have been fitted to prevent corrosion of the relief valves.) It was soon realized that if there is a pinhole in a rupture disc, the pressure in the space between the disc and the relief valve will rise until it is the same as the pressure below the disc. The disc will then not rupture until the pressure below it rises to about twice the design rupture pressure. Therefore, to prevent the interspace pressure rising, small vents to atmosphere were fitted between the discs and the relief valves (Figure 2-11 b).

This is okay if the disc is there to prevent corrosion, but if the disc is intended to prevent pollution, it defeats the object of the disc. Pressure gauges were therefore fitted to the vents and the operators asked to read them every few hours (Figure 2-11 c).

Many of the relief valves were on the tops of distillation columns and other high points, so the operators were reluctant to read the pressure gauges. They were therefore brought down to ground level and connected to the vents by long lengths of narrow pipe (Figure 2-11 d).

These long lengths of pipe got broken or kinked or liquid collected in them. Sometimes operators disconnected them so the pressure always read zero. The gauges and long lengths of pipe were therefore replaced by excess flow valves, which vent small leaks from pinholes but close if the rupture disc ruptures (Figure 2-11 e).

**Figure 2-11.** A modification chain—rupture discs below relief valves.

Pressure transmitters, alarming in the control room, were therefore fitted in place of the excess flow valves (Figure 2-11 f). This was an expensive solution. Perhaps it would be better to remove the rupture discs and prevent leaks to the atmosphere by taking more care over the machining and lapping of the relief valves.

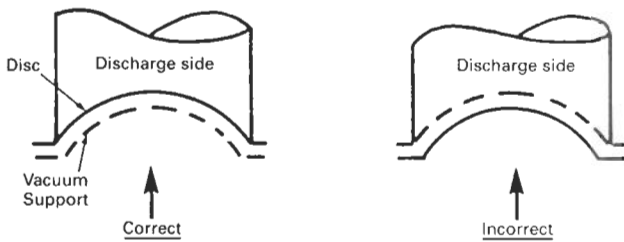
- (e) A runaway reaction occurred in a polymerization reactor. A rupture disc failed to burst. It had been fitted on the wrong side of the vacuum support, thus raising its bursting pressure from a gauge pressure of 150 psi (10 bar) to about 400 psi (27 bar) (Figures 3-1a and 3-1b).

**Figure 3-1a.** Arrangements of rupture disc and vacuum support.

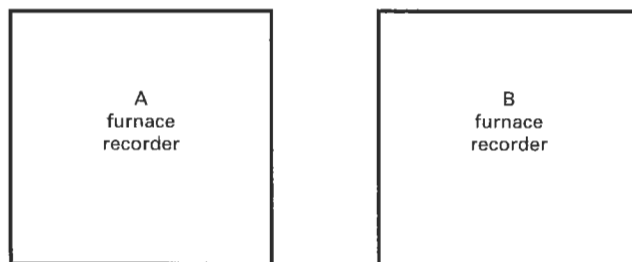
Two furnaces were each fitted with a temperature recorder controller and high-temperature trip. The two recorders were side by side on the instrument panel in the control room, with the recorder for A furnace on the left (Figure 3-2).

**Figure 3-2.** Layout of recorders on panel.

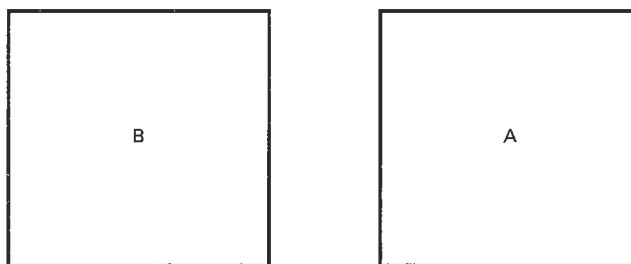
The mechanic, who had done the job many times before, took the cover off the back of B recorder, the one on the left behind the panel (Figure 3-3), and disconnected one of the leads. The effect was the same as if the recorder had registered a high temperature. The controller closed the fuel gas valve, shutting down the furnace and the rest of the plant.

**Figure 3-3.** Layout of recorders behind panel.

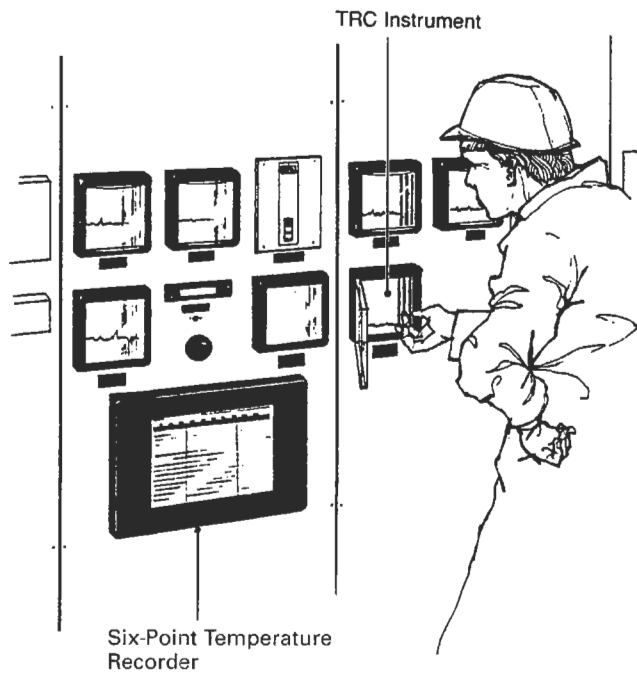
The rise in temperature was, however, indicated on a six-point temperature recorder at a lower level on the panel, but the operator did not notice this (Figure 3-4).

**Figure 3-4.** Instruments below eye level may not be noticed.

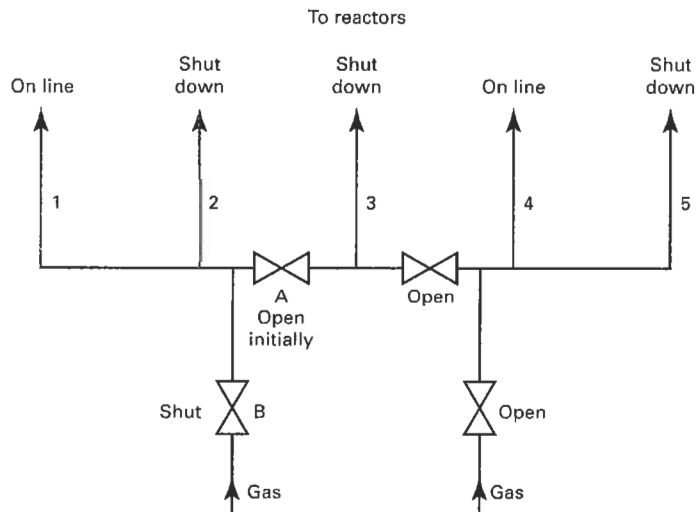
- (a) Figure 3-5 shows part of a plant in which five reactors were in parallel. There were two gas-feed lines with cross connections

**Figure 3-5.** Accidental closing of a valve can cause an explosion.

between them. Oxygen was also fed to the reactors, but the oxygen lines are not shown. At the time of the incident only two reactors, Nos. 1 and 4, were on line.

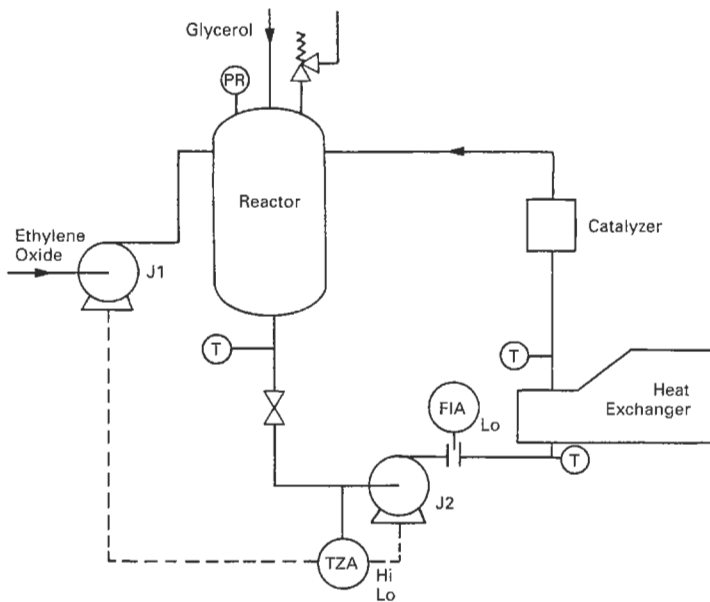
Figure 3-6 shows a batch reaction system. A batch of glycerol was placed in the reactor and circulated through a heat exchanger, which

Figure 3-6. Arrangements of reactor circulating system.

could act as both a heater and a cooler. Initially it was used as a heater, and when the temperature reached  $115^{\circ}\text{C}$ , addition of ethylene oxide was started. The reaction was exothermic, and the exchanger was now used as a cooler.

He then suspected that his theory might be wrong. Could he have forgotten to open the valve at the base of the reactor? He found it shut and opened it. Three tons of unreacted ethylene oxide; together with the glycerol, passed through the heater and catalyzer, and a violent, uncontrolled reaction occurred. The reactor burst, and the escaping gases exploded. Two men were injured. One, 160 m away, was hit by flying debris, and the other was blown off the top of a tank truck.

4. The explosion was due to a failure to directly measure the property that we wish to know. The temperature point was not measuring the temperature in the reactor but the temperature near the pump. This got hot because the pump was running with a closed suction valve. Similarly, the trip initiator on J2 showed that its motor was energized. It did not prove that there was a flow.

5. The explosion occurred because key instruments were not kept in working order. The flow indicator and low flow alarm (FIA) were out of order. They often were, and the operators had found that the plant could be operated without them. If there is no flow, they thought, J2 will have stopped, and this will stop J1.
6. The operator should not have raised the interlock setting, though doing so did not in itself cause the explosion. (However, he did try to use his intelligence and think why the reaction was not occurring. Unfortunately, he was wrong.)

5. Operators should be trained to “look before they leap” when they find valves wrongly set. See also Section 3.3.5 (a). Other accidents that occurred because operators failed to carry out simple tasks are described in Sections 13.5 and 17.1.

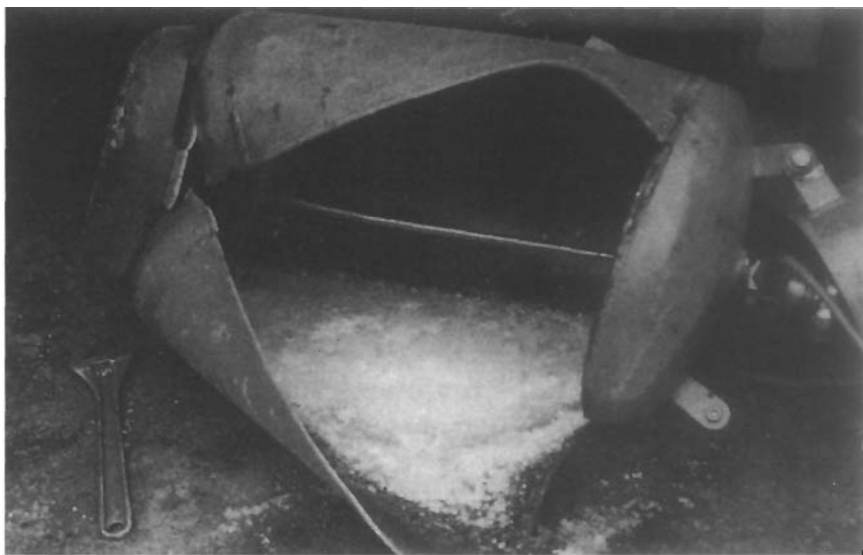
- (g) A catalyst arrived in cylinders and was egged into the plant with nitrogen at a gauge pressure of 30 psi (2 bar). The gauge on the pressure regulator had two scales. The inner one, which was normally used, indicated 0–200 psig in divisions of 10 psi, so it was normally set at three divisions.

The regulator developed a fault and had to be changed. The gauge on the new one also had two scales. The inner one indicated 0–280 kg/cm<sup>2</sup> gauge (a kg/cm<sup>2</sup> is almost the same as a bar) in intervals of 10 kg/cm<sup>2</sup>; the outer one indicated psig. The inner one thus looked like the inner scale on the old gauge, so the operators set the pointer at three divisions on it. Long before the pressure reached two divisions, corresponding to a gauge pressure of 20 kg/cm<sup>2</sup> or 300 psi, the cylinder burst. Figure 4-3 shows the results. The estimated bursting pressure was 215 psig (15 kg/cm<sup>2</sup> gauge) [11].

**Figure 4-3.** The result of pressurizing a cylinder to “two divisions” on a scale graduated in kg/cm<sup>2</sup> instead of psi. (*Photo courtesy of the Institution of Chemical Engineers.*)

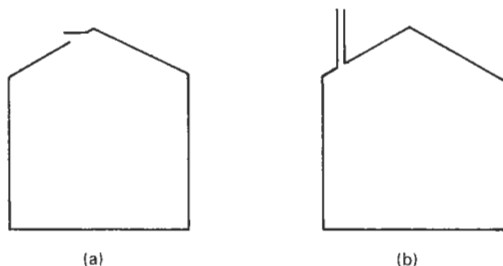
This overflow device should be fitted to the roof near the wall. If it is fitted near the center of the roof, the height of liquid above the top of the walls may exceed 8 in., and the tank may be overpressured (see Figure 5-2a).

Similarly, if the vent is designed to pass liquid, it should be fitted near the edge of the roof, and its top should not be more than 8 in. above the tops of the walls. Vessels have been overpressured because their vent pipes were too long (see Figure 5-2b). Tanks in which hydrogen may be evolved should be fitted with a vent at the highest point as well as an overflow (see Section 16.2).

**Figure 5-2.** A tank may be overpressured if the vent or overflow is more than 8 in. above the tops of the walls.

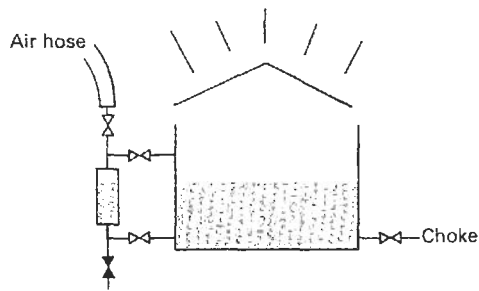
- (a) There was a choke on the exit line from a small tank. To try to clear the choke, the operator held a compressed air hose against the open end at the top of the level glass. The gauge pressure of the compressed air was 100 psi (7 bar), and the top of the tank was blown off (Figure 5-3).
- (b) An old vessel, intended for use as a low-pressure storage tank, had been installed in a new position by a contractor who decided to pressure-test it. He could not find a water hose to match the hose connection on the vessel, and so he decided to use compressed air. The vessel ruptured.

**Figure 5-3.** Tank top blown off by compressed air.

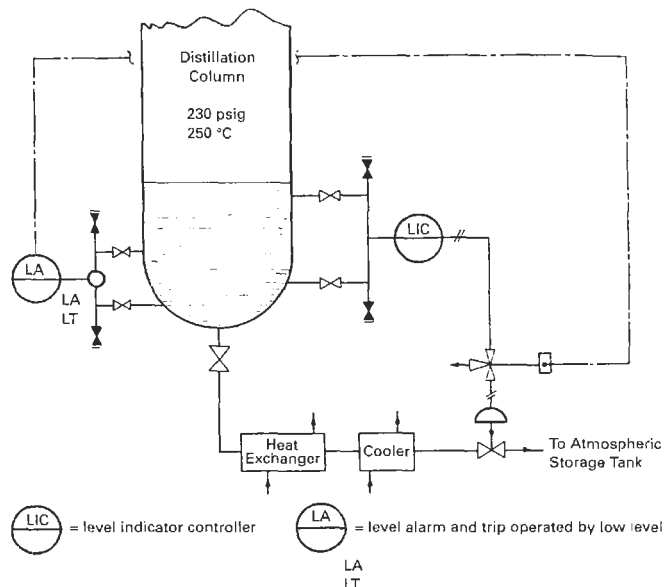
- (c) On other occasions, tanks have been ruptured because the failure of a level controller allowed a gas stream to enter the tank (Figure 5-4). Pressure vessels have also been ruptured in this way (see Section 9.2.2 d).

**Figure 5-4.** How failure of a level controller can overpressure a tank.

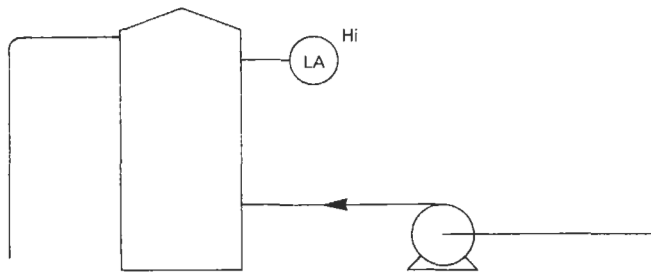
- (f) Cold liquid was added to a tank containing hot liquid.
- (g) A pressure/vacuum valve (conservation vent) was assembled incorrectly—the pressure and vacuum pallets were interchanged. Valves should be designed so that this cannot occur (see Section 3.2.1).
- (h) A pressure/vacuum valve was corroded by the contents of the tank.
- (i) A larger pump was connected to the tank, and it was emptied more quickly than the air could get in through the vent.
- (j) Before emptying a tank truck, the driver propped the manhole lid open. It fell shut.
- (k) A tank was fitted with an overflow, which came down to ground level. There was no other vent. When the tank was overfilled, the contents siphoned out (Figure 5-5).

**Figure 5-5.** Overflow to ground level can cause a tank to collapse if there is no other vent.

The tank should have been fitted with a vent on its roof, as well as the liquid overflow.

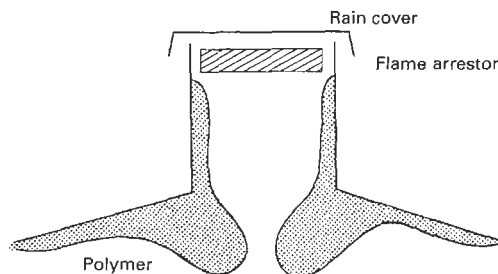
- (l) A vent was almost blocked by polymer (Figure 5-6). The liquid in the tank was inhibited to prevent polymerization, but the vapor that condensed on the roof was not inhibited. The vent was inspected regularly, but the polymer was not noticed.

**Figure 5-6.** Vent almost blocked by polymer.

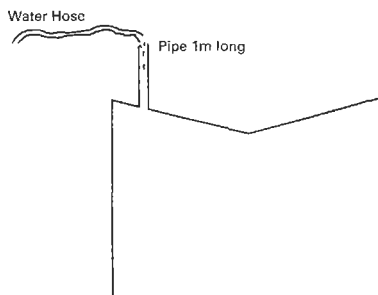
**Figure 5-7.** Method of restoring a tank with a concave roof to its original shape.

hydraulic pump, normally used for pressure-testing pipework, was being connected to the tank. He had it removed, and he replaced the vent with a vertical pipe, 1 m long. He dribbled water into the pipe from a hose, and as he did so the tank was restored to its original shape (Figure 5-7) to the amazement of onlookers. The static pressure of the water in the pipe was sufficient.

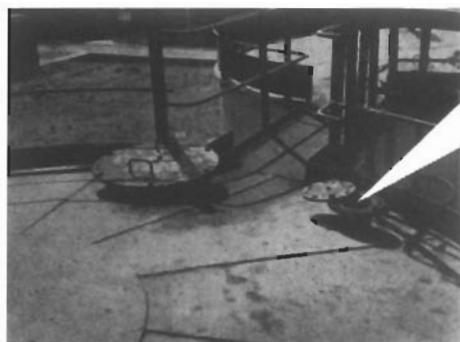
Figure 5-8.

External sources of ignition, such as lightning (Figure 5-8) or welding near an open vent, can also trigger a tank explosion. Sample and dip holes and other openings should be kept closed or protected by flame arrestors. These are liable to choke and need regular inspection (see Sections 5.3 a, 6.2 g, and 14.2.4).

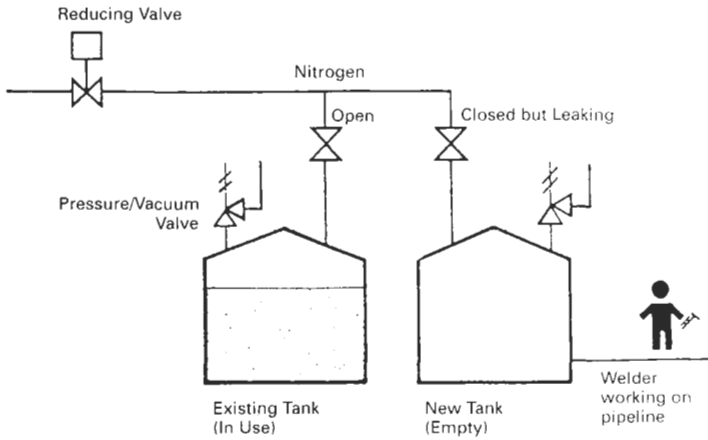
The new tank and an existing one were designed to be on balance with each other to save nitrogen (Figure 5-9), but the contractors did not understand this. The valve to the new tank was closed but leaking. Nitrogen and methanol vapor entered the tank, and the vapor was ignited by a welder who was completing the inlet line to the tank. The roof was blown right off. By great good fortune, it landed on a patch of empty ground just big enough to contain it (Figure 5-10).

**Figure 5-9.** If tanks are on balance, the nitrogen entering one tank is inevitably mixed with vapor.

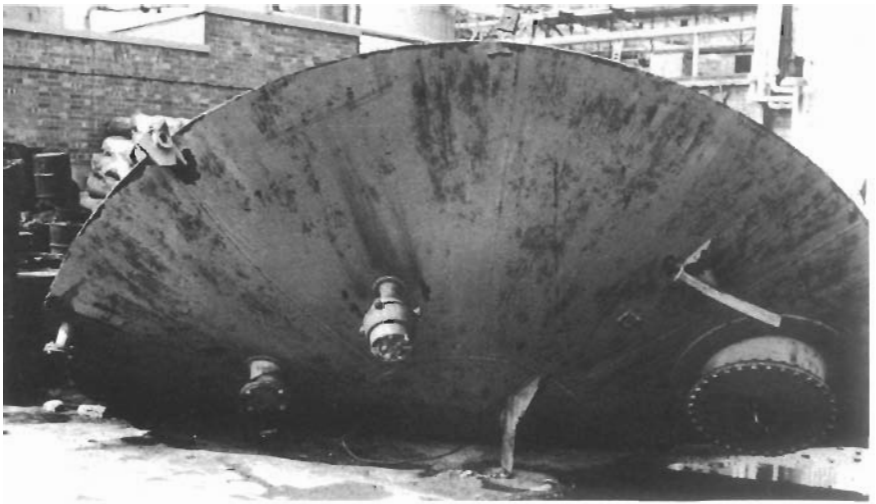
It is believed that a hot speck, loosened by the welding, fell off the inside of the roof and ignited a flammable mixture that was present near the surface of the liquid [18]. Tests have shown that the atmosphere in a tank can take a long time to reach equilibrium when the liquid level is low.

**Figure 5-10.** When an explosion occurred in a tank, the roof landed on an area just big enough to contain it.

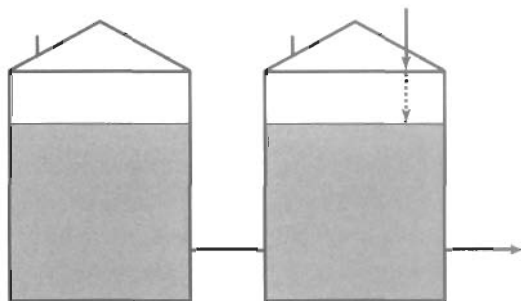
- (f) Paper mills use large quantities of water, and the water is usually recycled. Buffer storage is needed, and at one paper mill, it took the form of a 740-m<sup>3</sup> tank. Experience showed that this was insufficient, and another tank of the same size was installed alongside. To simplify installation it was not connected in parallel with the original tank but on balance with it, as shown in Figure 5-13. A week after the new tank was brought into use, welders were completing the handrails on the roof when an explosion occurred in the tank. Two welders were killed, and the tank was blown 20 m into the air, landing on a nearby building.

**Figure 5-13.** Extra buffer storage for water was provided by installing a second tank on balance with the first one. Lack of aeration allowed hydrogen-forming bacteria to grow, and an explosion occurred. (*Reproduced with permission of the American Institute of Chemical Engineers. Copyright © 1995 AIChE. All rights reserved.*)

Investigation showed that the explosion was due to hydrogen formed by anaerobic bacteria. In the original tank the splashing of the inlet liquor aerated the water and prevented anaerobic conditions. This did not apply in the new tank [20].

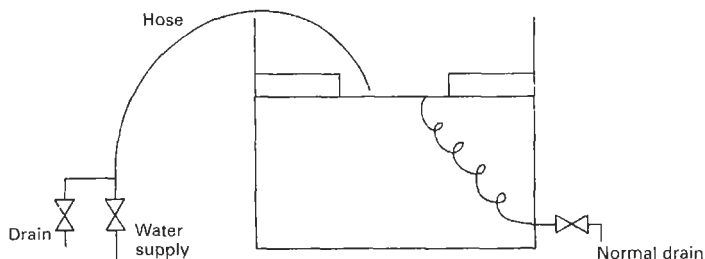
A choke occurred in the flexible pipe that drained the roof of a floating-roof tank. It was decided to drain rainwater off the roof with a hose. To prime the hose and establish a siphon, the hose was connected to the water supply. It was intended to open the valve on the water supply for just long enough to fill the hose. This valve would then be closed and the drain valve opened (Figure 5-14). However, the water valve was opened in error and left open, with the drain valve shut. Water flowed onto the floating roof and it sank in 30 minutes (see also Section 18.8).

**Figure 5-14.** How to sink the roof of a floating-roof tank.

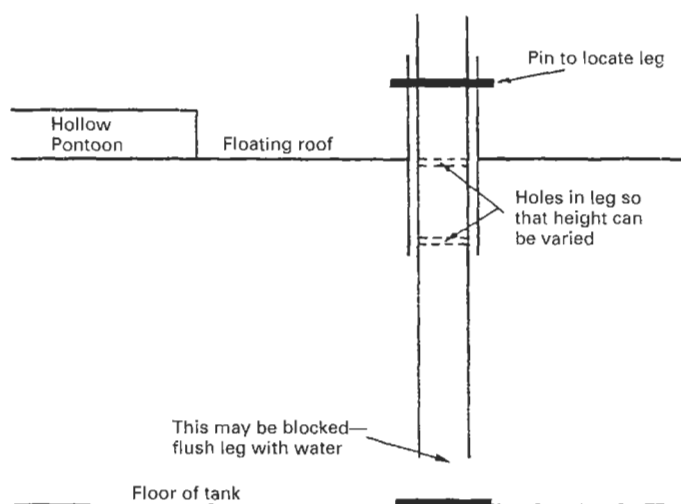
It is believed that the bottom of the hollow leg was blocked with sludge and that, as cutting took place near the leg, the leg moved and disturbed the sludge (Figure 5-15).

**Figure 5-15.** Oil trapped in the leg of a floating-roof tank caught fire during demolition.

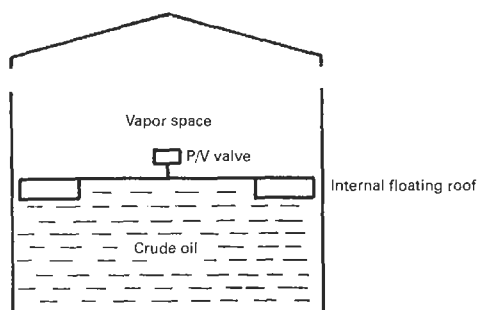
When the tank was refilled with warm crude oil at 37°C, vapor was pushed out into the space above the floating roof and then out into the atmosphere through vents on the fixed-roof tank (Figure 5-16). This vapor was ignited at a boiler house some distance away.

The fire flashed back to the storage tank, and the vapor burned as it came out of the vents. Pumping was therefore stopped. Vapor no longer came out of the vents, air got in, and a mild explosion occurred inside the fixed-roof tank. This forced the floating roof down like a piston, and some of the crude oil came up through the seal past the side of the floating roof and out of the vents on the fixed-roof tank. This oil caught fire, causing a number of pipeline joints to fail, and this caused further oil leakages. One small tank burst; fortunately, it had a weak seam roof. More than 50 fire appliances and 200 firemen attended, and the fire was under control in a few hours.

**Figure 5-16.** Tank with internal floating roof.

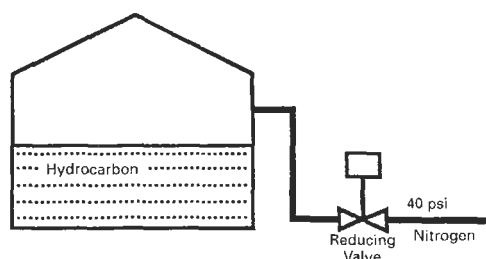
On one group of tanks the reducing valve on the nitrogen supply was installed at ground level (Figure 5-17). Hydrocarbon vapor condensed in the vertical section of the line and effectively isolated the tank from the nitrogen blanketing.

**Figure 5-17.** Incorrect installation of nitrogen blanketing.

The reducing valve should have been installed at roof height. Check your tanks—there may be more like this one.

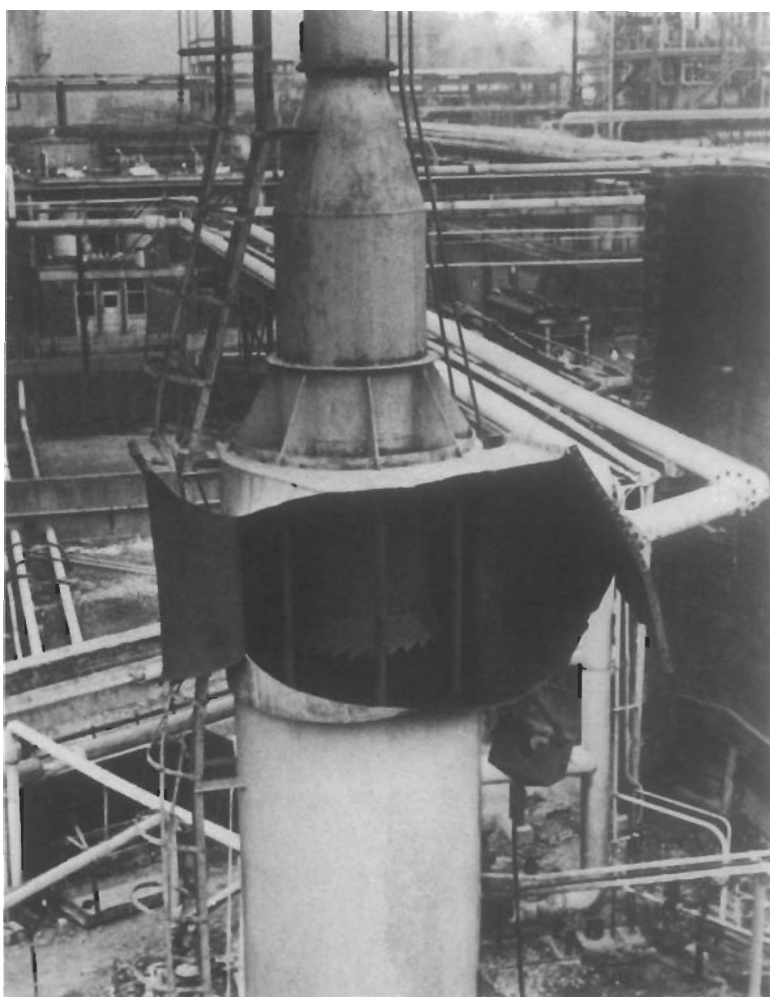
(a) Figure 6-1 shows the results of an explosion in a large flarestack. The stack was supposed to be purged with inert gas. However, the flow was not measured and had been cut back almost to zero to save nitrogen. Air leaked in through the large bolted joint between unmachined surfaces. The flare had not been lit for some time. Shortly after it was relit, the explosion occurred—the next time some gas was put to stack. The mixture of gas and air moved up the stack until it was ignited by the pilot flame.

**Figure 6-1.** Base of flarestack.

1. Stacks should be welded. They should not contain bolted joints between unmachined surfaces.
2. There should be a continuous flow of gas up every stack to prevent air diffusing down and to sweep away small leaks of air into the stack. The continuous flow of gas does not have to be nitrogen—a waste-gas stream is effective. But if gas is not being flared continuously, it is usual to keep nitrogen flowing at a linear velocity of 0.03–0.06 m/s. The flow of gas should be measured. A higher rate is required if hydrogen or hot condensable gases are being flared. If possible, hydrogen should be discharged through a separate vent stack and not mixed with other gases in a flarestack.

3. The atmosphere inside every stack should be monitored regularly, say daily, for oxygen content. Large stacks should be fitted with oxygen analyzers that alarm at 5% (2% if hydrogen is present). Small stacks should be checked with a portable analyzer.

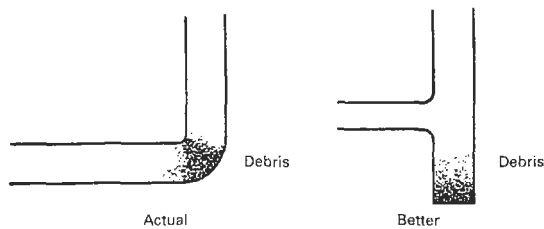
- (b) The vent stack was replaced by a 14-in.-diameter flarestack with a supply of steam to a ring around the top of the stack. A few years later this stack choked again, this time due to a deposit of refractory debris from the tip, cemented together by ice (as some condensate from the steam had found its way down the stack). Fortunately, in this case the high pressure in the tank was noticed before any damage occurred. There was no boot at the bottom of the stack to collect debris (Figure 6-2). A boot was fitted [2].

**Figure 6-2.** Flarestack after fall of debris.

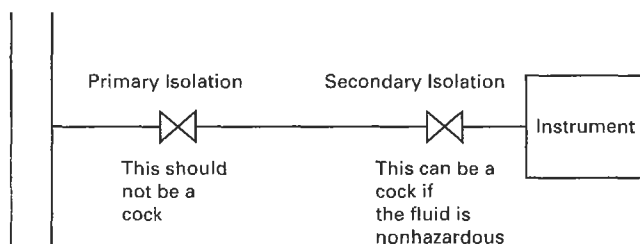
**Figure 7-1.** Small cocks should not be used as primary isolation valves.

It is good practice to use other types of valves for the first isolation valve, as shown in Figure 7-1.

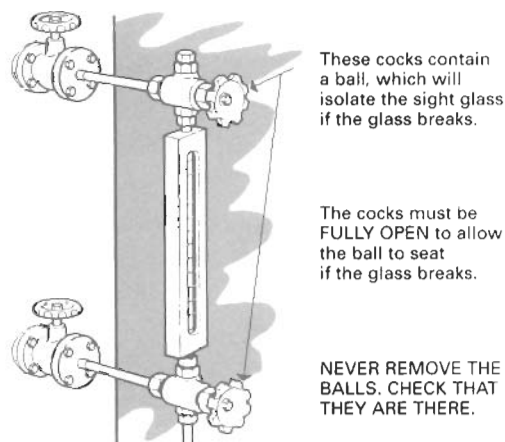
**Figure 7-2.** Ball check cocks.

Level glasses and sight glasses (except magnetic types) should not be used on vessels containing flashing flammable or toxic liquids—that is, liquids under pressure above their normal boiling points. When level glasses are used, they should be fitted with ball check cocks, which prevent a massive leak if the glass breaks. Unfortunately, the balls have sometimes been removed by people who did not understand their purpose. The hand valves must be fully opened or the balls cannot operate (Figure 7-2).

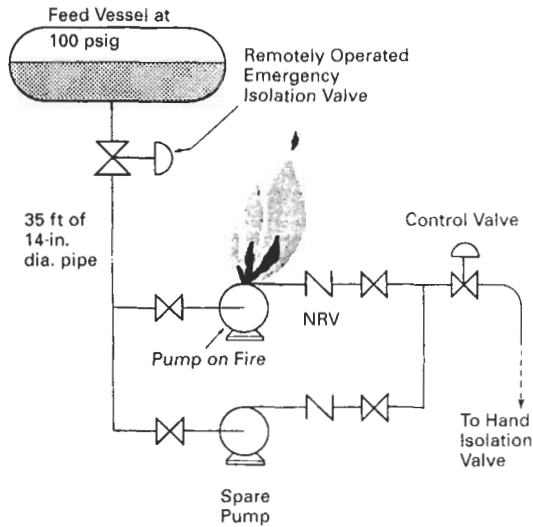
Backflow from the delivery side of the pump was prevented by a check (nonreturn) valve. In addition, a control valve and a hand valve well away from the fire were closed (Figure 7-5).

**Figure 7-5.** An emergency isolation valve stopped a fire.

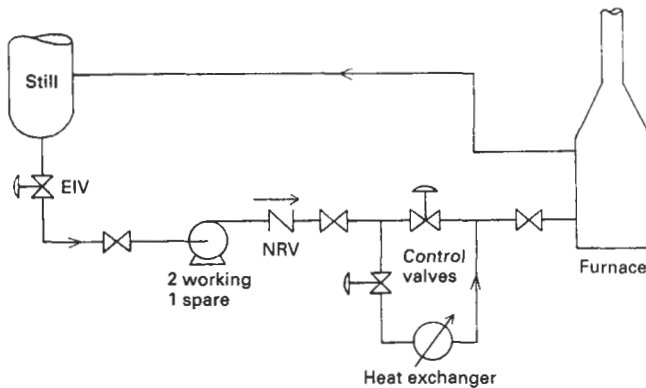
- (b) The bearing on the feed pump to a furnace failed, causing a gland failure and a leak of hot oil. The oil caught fire, but an emergency isolation valve in the pump suction line was immediately closed, and the fire soon died out (Figure 7-6).

**Figure 7-6.** Another emergency isolation valve stopped a fire.

The control valve in the delivery line to the furnace was also closed. Unfortunately, this valve was bypassed by the line through the heat exchanger. In the heat of the moment, no one remembered to close the valve in the bypass line. In addition, the check (nonreturn) valve did not hold. The return flow of oil from the furnace was stopped by closing a hand valve next to the furnace, which was about 30 m from the fire. Afterward, another EIV was installed in the pump delivery line.

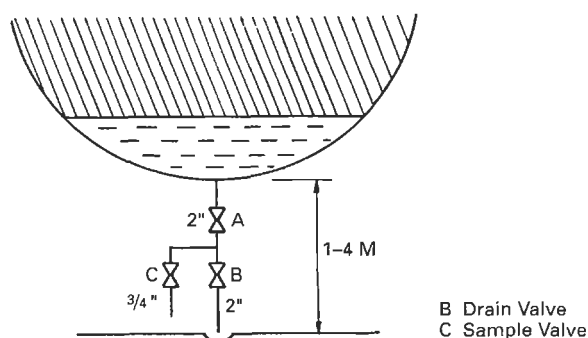
An operator had to drain water from a 1,200-m<sup>3</sup> spherical storage vessel nearly full of propane (Figure 8-1). He opened valves A and B. When traces of oil showed that the draining was nearly complete, he shut A and then cracked it to complete the draining. No flow came. He opened A fully. The choke—presumably hydrate, a compound of water and a light hydrocarbon with a melting point above 0°C—cleared suddenly, and the operator and two other men were splashed with liquid. The handle came off valve A, and they could not get it back on. Valve B was frozen and could not be moved. Access was poor because the drain valves were immediately below the tank, which was only 1.4 m above the ground.

**Figure 8-1.** Drain valves underneath propane tank at Feyzin.
