# WHAT WENT WRONG?

Case Histories of  
Process Plant Disasters

Trevor Kletz

**FOURTH EDITION**

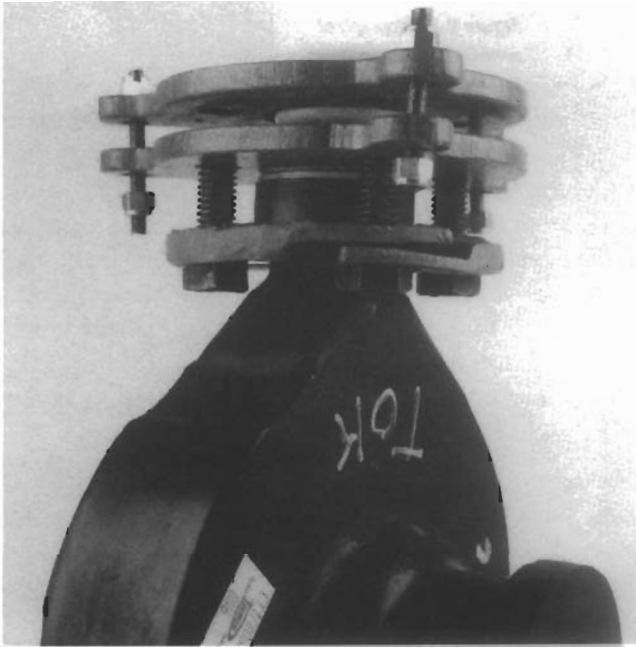
In 1994 a leak of impure ethyl chloride (boiling point 12°C) caught fire, 1½ hours after it started, and damaged the plant so extensively that it had to be rebuilt. Fortunately, no one was killed or injured. The leak started at a flange assembly on the delivery of a pump (Figure 8-3), probably due to corrosion of the flanges but possibly due to failure of a plastic bellows. The official report [23] made the following points:

- The split flanges were badly corroded; their thickness was reduced, and the bolt holes were much enlarged. (Split flanges are not a good feature because they expose twice as much surface to the effects of corrosion.) There was no system for identifying critical items, the failure of which could have serious results, and registering them for regular inspection. Maintenance was on a breakdown basis, and there

**Figure 8-3.** Split flange assembly similar to one that leaked.

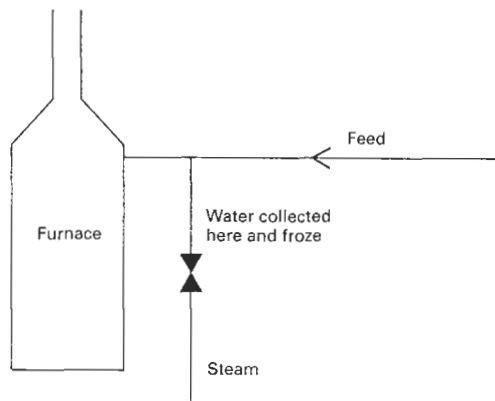
There are other sorts of dead-ends besides pipes that have been blanked. Rarely used valved branches are just as dangerous. The feed line to a furnace (Figure 9-1) was provided with a permanent steam connection for use during de-coking.

**Figure 9-1.** The steam connection to the furnace formed a dead-end.

The connection was on the bottom of the feed line, and the steam valve was not close to the feed line. Water collected above the steam valve, froze during cold weather, and ruptured the line, allowing oil at a gauge pressure of 450 psi (30 bar) to escape.

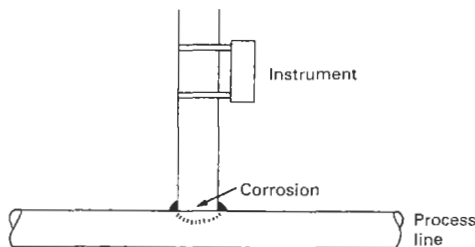
An unusual—and unnecessary—dead-end was a length of 2-in. pipe welded onto a process line to provide a support for an instrument (Figure 9-2). Water collected in the support. Four years after it had been installed, the process line corroded through, and a leak of liquefied gas occurred.

**Figure 9-2.** Water collected in the instrument support and corroded the process line.

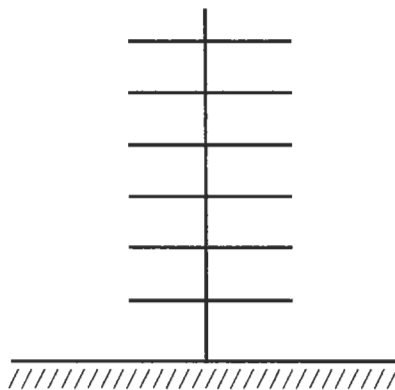
- (h) Eleven pipelines, 2–8 in. (50–200 mm) in diameter, containing hydrocarbon liquids and gases, were supported on brackets of the type shown in Figure 9-5 (a), 2.1 m tall and 6 m apart. The pipes were fixed to two of the brackets and rested on the others. The pipe run passed through a tank farm, and the wind flow through the gaps between the tanks caused the upright part of the supports to incline 2° from the vertical. This was noticed when the pipe run was inspected, but no one regarded it as serious.

As the result of a power failure, the flow through many of the pipes suddenly stopped, and the surge caused the angle of inclination to increase to 6°. The tops of the supports were now 5 in. (125 mm) out of line. The supports were now unstable. Eleven hours after the power failure and three hours after the flows had been restored, the pipe run collapsed over a length of 23 m; 14 tons of gasoline were spilled. Three hours later a further length collapsed. The pipe supports were replaced by the type shown in Figure 9-5 (b).

**Figure 9-5 (a).** The original pipe supports.

**Figure 9-5 (b).** The supports used after the collapse.

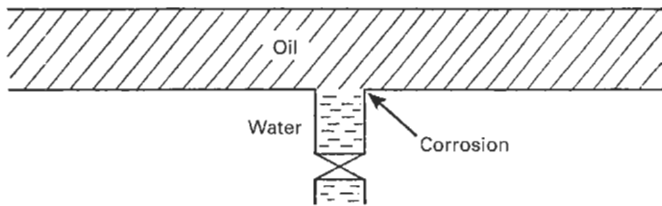
Water was injected into an oil stream using the simple arrangement shown in Figure 9-6. Corrosion occurred near the point shown, and the oil leak caught fire [5]. The rate of corrosion far exceeded the corrosion allowance of 0.05 in. per year.

**Figure 9-6.** Water injection—a poor arrangement.

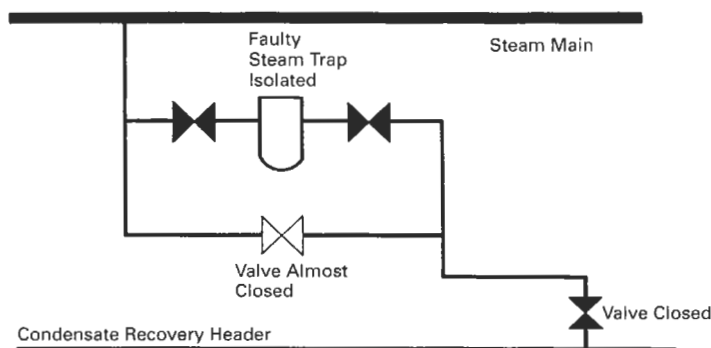
- (a) A 10-in.-diameter steam main operating at a gauge pressure of 600 psi (40 bar) suddenly ruptured, injuring several workers.

The incident occurred soon after the main had been brought back into use after a turnaround. It was up to pressure, but there was no flow along it. The steam trap was leaking and had been isolated. An attempt was made to get rid of condensate through the bypass valve. But steam entered the condensate header, and the line was isolated, as shown in Figure 9-9. Condensate then accumulated in the steam main.

**Figure 9-9.** Arrangement of valves on steam main that was broken by water hammer.

When a flow was started along the steam main by opening a  $\frac{3}{4}$ -in. valve leading to a consuming unit, the movement of the condensate fractured the main [6].

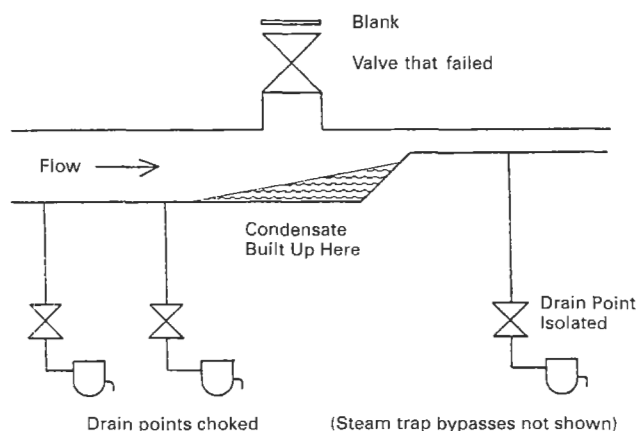
- (b) Figure 9-10 shows how another steam main—this time one operating at a gauge pressure of 20 psi (1.4 bar)—was burst by water hammer.

Two drain points were choked and one isolated. In addition, the change in diameter of the main provided an opportunity for condensate to accumulate. The main should have been constructed so that the bottom was straight and so the change in diameter took place at the top.

**Figure 9-10.** Arrangement of drains on steam main that was broken by water hammer.

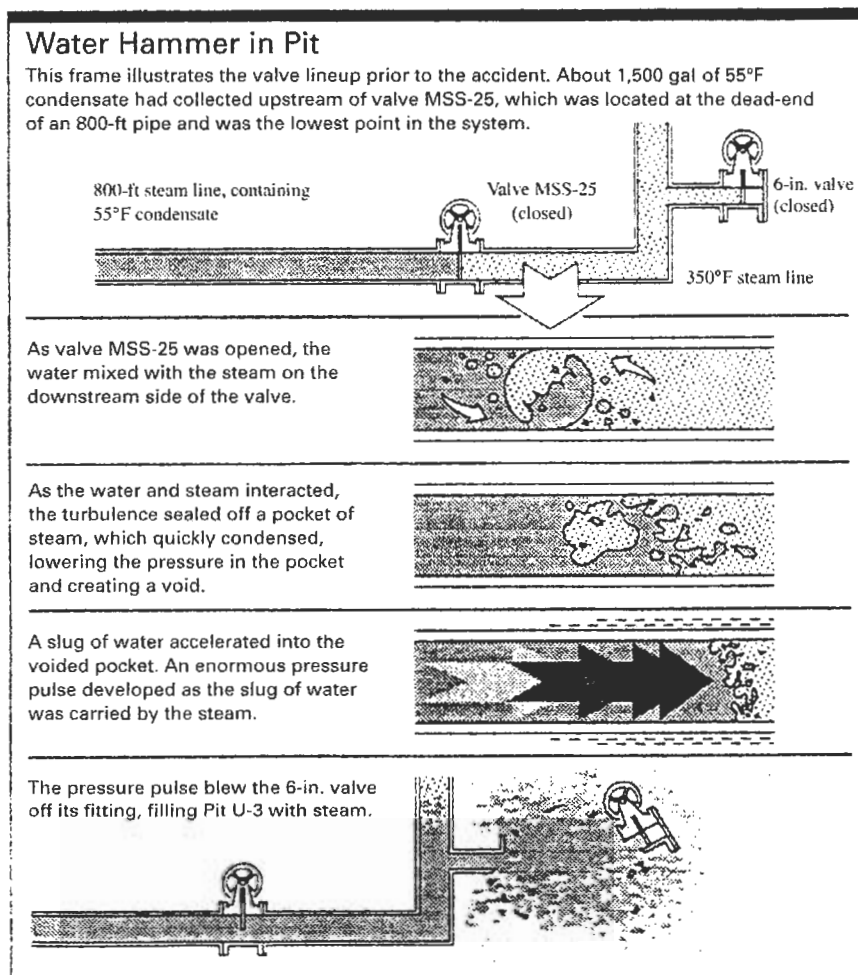
- (c) An operator went down into a pit to open a steam valve that was rarely operated and had been closed for nine months. Attempts to open the valve with a reach rod, 8 m long, had been unsuccessful. The pit was recognized as a confined space, and so the atmosphere was tested, the operator wore a rescue harness, and a stand-by man was on duty outside. The steam main was up to pressure on both sides of the valve, and the gauge pressure was 120 psi (8.3 bar) on the upstream side, 115 psi (7.9 bar) on the downstream side. There was a steam trap on the downstream side of the valve but not on the upstream side, and as the valve was on the lowest part of the system, about 5 tons of cold condensate had accumulated on the upstream side.

The operator took about one to two minutes to open the valve halfway; very soon afterward, there was a loud bang as a 6-in. cast-iron valve on a branch (unused and blanked) failed as a result of water hammer. The operator was able to climb out of the pit, but later died from his burns, which covered 65% of his body [17]. Figure 9-11 explains the mechanism.

**Figure 9-11.** Condensate collected in a steam main. A valve was opened quickly. Sudden movement of the condensate fractured another valve. The figure explains how this occurred.

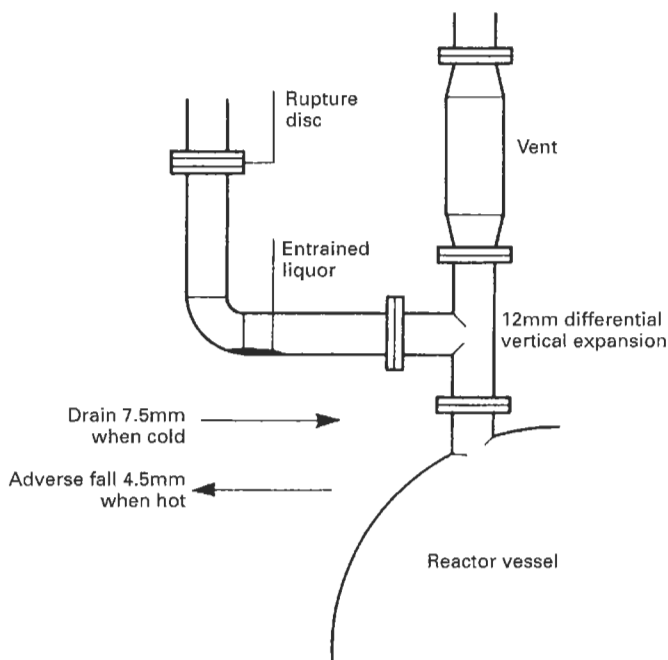
- (g) Figure 9-13 shows the pipework on the top of a reactor. When the pipework was cold, any liquid in the branch leading to the rupture disc drained out; when it was hot, it remained in the branch, where it caused corrosion and cracking [18].

**Figure 9-13.** The vent arrangements at the top of the reactor. Liquid drained out when the pipework was cold but not when it was hot.

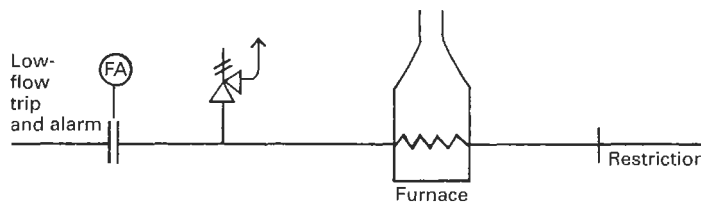
A furnace was protected by a relief valve on its inlet line (Figure 10-1). A restriction developed after the furnace. The relief valve lifted and took most of the flow. The flow through the furnace tubes fell to such a low level that they overheated and burst. The low-flow trip, which should have isolated the fuel supply to the furnace when the flow fell to a low value, could not do so because the flow through it was normal.

**Figure 10-1.** When the relief valve lifted, the flow through the furnace was reduced.

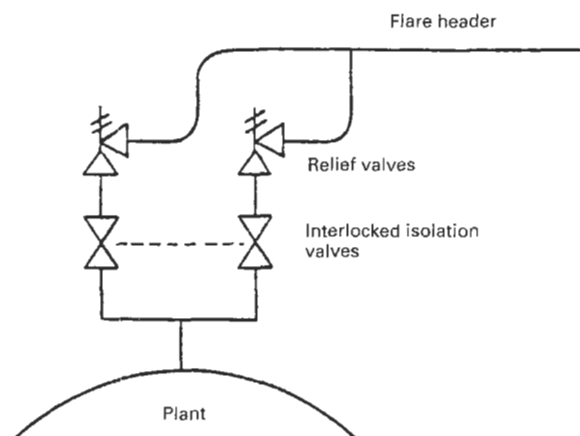
Some vessels are provided with two full-size relief valves so that one can be changed with the plant on line. On the plant side of the relief valves, isolation valves are usually provided below each relief valve, interlocked so that one relief valve is always open to the plant (Figure 10-2). If the relief valves discharge into a flare system, it is not usual to provide such valves on the flare side. Instead the relief valve is simply removed and a blank fitted quickly over the end of the flare header before enough air is sucked in to cause an explosion. Later the blank is removed and the relief valve replaced.

**Figure 10-2.** Two relief valves with interlocked isolation valves. This figure is diagrammatic. If any liquid might be present, the tailpipe should fall, not rise, after it leaves the relief valve. Otherwise, liquid may collect in the dip and produce a back pressure.

Removing a valve and fitting a blank is satisfactory if the operators make sure, before the relief valve is removed, that the plant is steady and that this relief valve or any other is unlikely to lift. Unfortunately, such instructions may lapse with the passage of time. This occurred at one plant. The people there were fully aware that air might get into the flare system. They knew about the incident just described. But they were less aware that oil might get out. While an 8-in. relief valve was being changed, another relief valve lifted, and gasoline came out of the open end. Fortunately it did not ignite.

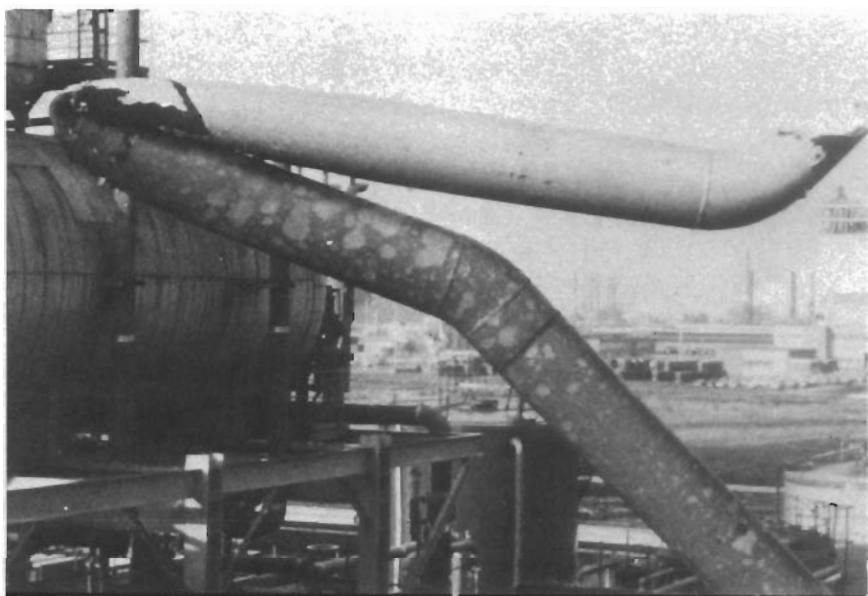
Figure 10-4 shows what happened to the tailpipe of a steam relief valve that was not adequately supported. The tailpipe was not provided with a drain hole (or if one was provided, it was too small), and the tailpipe filled with water. When the relief valve lifted, the water hit the curved top of the tailpipe with great force. Absence of a drain hole in a tailpipe also led to the incident described in Section 9.2.1 (g).

**Figure 10-4.** This relief-valve tailpipe was not adequately supported.

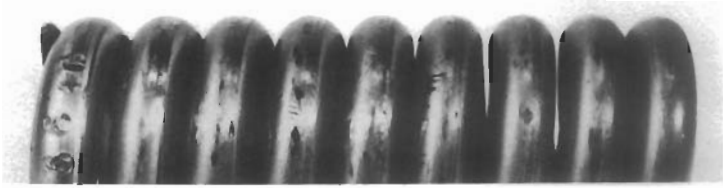
1. Identification numbers stamped on springs, thus weakening them (Figure 10-5).
2. The sides of springs ground down so that they fit.
3. Corroded springs.
4. A small spring put inside a corroded spring to maintain its strength. Sometimes the second spring was wound the same way as the first spring so that the two interlocked (Figure 10-6).
5. Use of washers to maintain spring strength.
6. Welding of springs to end caps (Figure 10-7).
7. Deliberate bending of the spindle to gag the valve (Figure 10-8).
8. Too many coils allowing little, if any, lift at set pressure (Figure 10-9).

**Figure 10-9.** Example of too many coils.

Do not assume that such things could not happen in your company (unless you have spent some time in the relief-valve workshop). All relief valves should be tested and inspected regularly. Reference 3 describes model equipment and procedures. When a large petroleum company introduced a test program, it was shocked by the results: out of 187 valves sent for testing, 23 could not be tested because they were leaking or because the springs were broken, and 74 failed to open within 10% of the set pressure—that is, more than half of them could not operate as required [4].

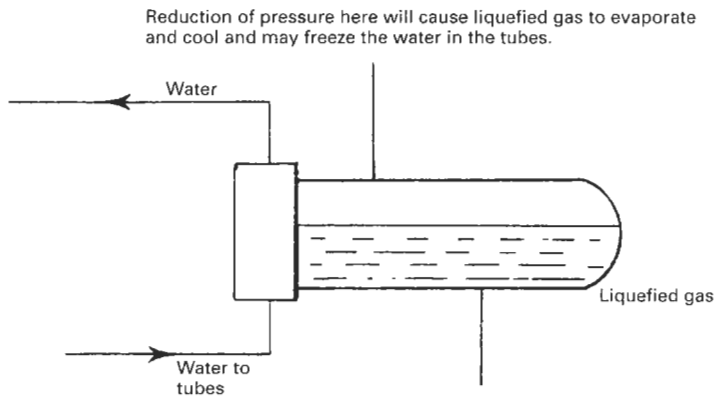
Figure 10-10 illustrates another incident. When a plant was shutting down, the flow of cooling water to the tubes of a heat exchanger was isolated. The propylene on the shell side got colder as its pressure fell. The water in the tubes froze, breaking seven bolts. The operators saw ice forming on the outside of the cooler but did not realize that this was hazardous and took no action. When the plant started up again, propylene entered the cooling-water system, and the pressure blew out a section of the 16-in. (400-mm) line. The gas was ignited by a furnace 40 m away, and the fire caused serious damage.

**Figure 10-10.** Evaporative cooling.

The cooling water should have been kept flowing while the plant was depressured. This would have prevented the water from freezing, provided that depressuring took more than ten minutes.

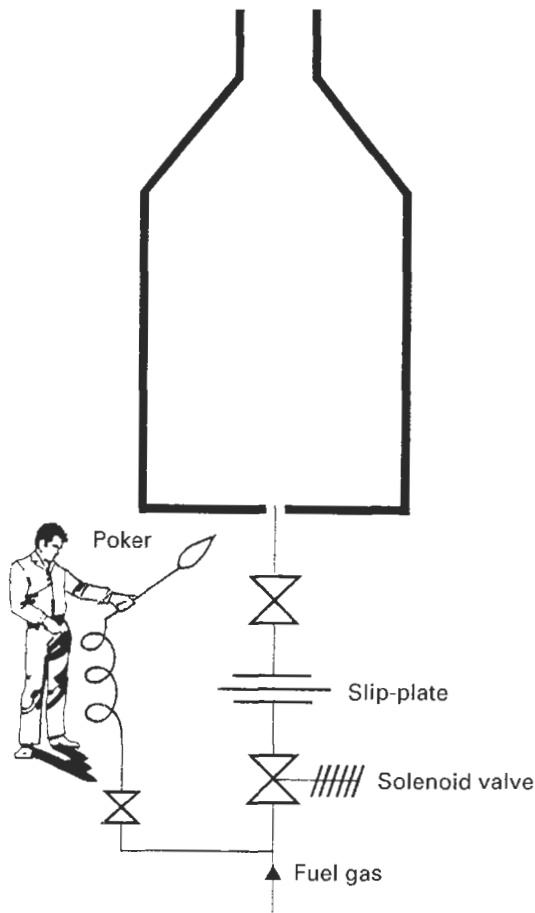
- (a) A foreman tested the atmosphere inside a furnace (Figure 10-12) with a combustible gas detector. No gas was detected, so the slip-plate was removed, and two minutes later, a lighted poker was inserted. An explosion occurred. The foreman and another man were hit by flying bricks, and the brickwork was badly damaged.

The furnace had been lit in an incorrect way for many years before the isolation valve started to leak and an explosion occurred. Never say, "It must be safe because we have been doing it this way for years and have never had an accident."

**Figure 10-12.** Lighting a furnace heated by fuel gas.

1. Test the atmosphere inside the furnace.
2. If no gas is detected, light and then insert the poker (or switch on the electric igniter).
3. Remove the slip-plate (or connect the hose, drain the lute, or change over the double block and bleed valves). If the isolation valve is leaking, the leaking fuel will be ignited by the poker or igniter before it forms an explosive mixture. (The solenoid valve shown in Figure 10-12 should open automatically when the poker is inserted or the igniter is switched on. If it does not, it should be held open until the main burner is lit.)
4. Open the fuel-gas isolation valve.

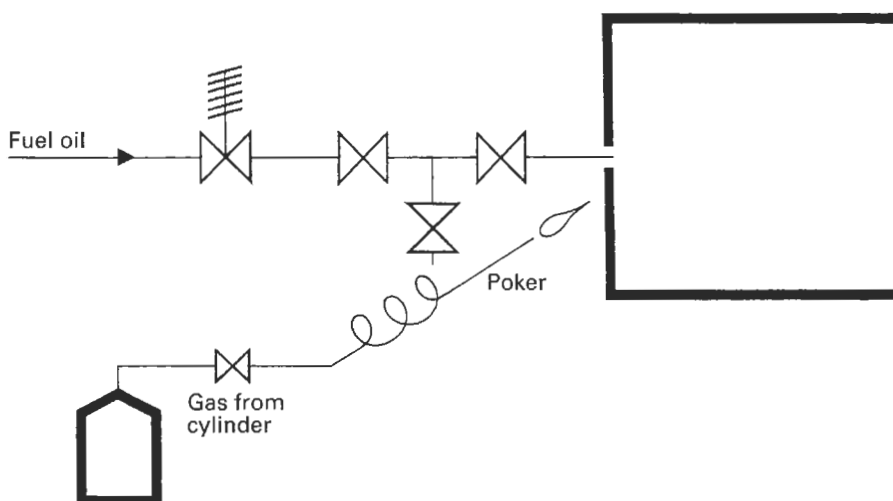
- (b) A reduction in fuel oil pressure caused the burner in an oil-fired furnace to go out, and the flame failure device closed the solenoid valve in the fuel oil line (Figure 10-13). The operator closed the two hand-isolation valves and opened the bleed between them. (The group of three valves is equivalent to the slip-plate shown in Figure 10-12). When the fuel oil pressure was restored, the foreman tested the atmosphere in the furnace with a combustible gas detector. No gas was detected, so he inserted a lighted poker. The fuel oil supply was still positively isolated, but nevertheless an explosion occurred, and the foreman was injured, fortunately not seriously.

**Figure 10-13.** Lighting a furnace heated by heavy fuel oil.

When the burner went out, the solenoid valve took a few seconds to close, and during this time some oil entered the furnace. In addition, the line between the last valve and the furnace may have drained into the furnace. The flash point of the fuel oil was  $65^{\circ}\text{C}$ , too high for the oil to be detected by the combustible gas detector. Even though the oil was vaporized by the hot furnace, it would have condensed in the sample tube of the gas detector or on the sintered metal that surrounds the detector head.

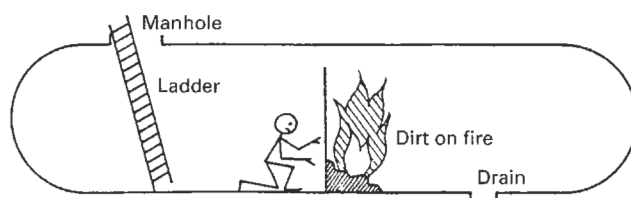
- (a) A vessel was divided into two halves by a baffle, which had to be removed. The vessel was cleaned out, inspected, and a permit issued for a worker to enter the left-hand side of the vessel to burn out the baffle. It was impossible to see into the right-hand half. But because the left-hand half was clean and because no combustible gas could be detected, it was assumed that the other half was also clean (Figure 11-1). While the welder was in the vessel, some deposit in the right-hand half caught fire. The welder got out without serious injury but bruised himself in his haste.

**Figure 11-1.** If part of a vessel cannot be seen, assume it is dirty.

If a part of the vessel cannot be inspected and be seen to be safe, then we should assume the vessel contains hazardous materials.

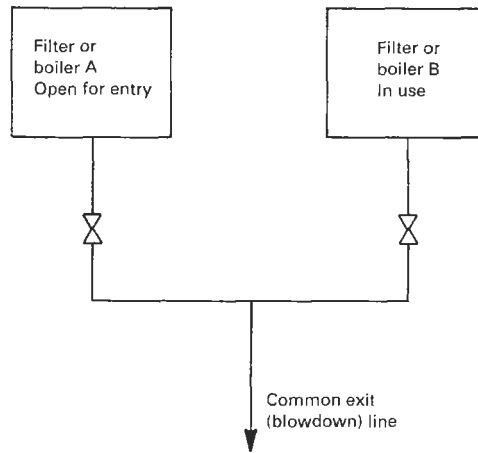
The liquid, after passing through the outlet valve, joined the line from another filter that was in use. It is believed that carbon dioxide gas from the filter liquid passed up the outlet line into the filter that was being inspected (Figure 11-2). A test showed that "contamination was not sufficient to prevent a candle burning."

**Figure 11-2.** Liquid or gas traveled backward from the common line into the vessel that was open for entry.

- (f) Forty-five years later, in the same company, the accident was repeated, and this time a man was killed. While a man was working inside a boiler, the process foreman noticed that the water level in another boiler was too high. He asked an operator to lower the level through the blowdown (drain) valve, which discharged into a common drain line. Steam entered the boiler under repair from this common line. None of the lines had been slip-plated or disconnected, and the blowdown valve had been left open (Figure 11-2).

allowing people to enter a vessel or other confined space, always ask how they will be rescued if they are overcome.

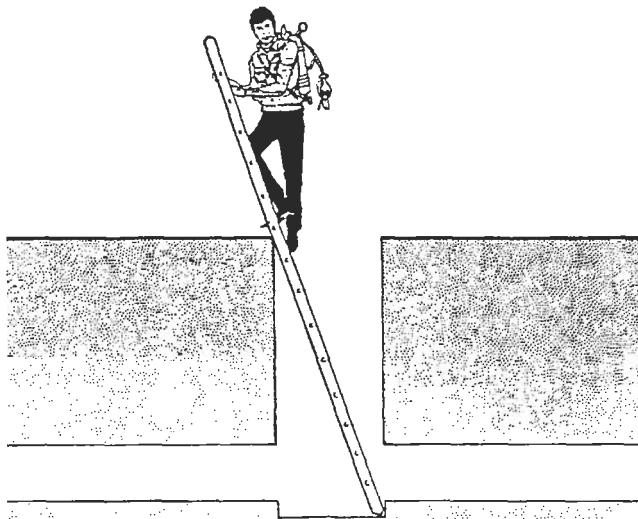
A man was standing on a ladder, ready to go down into a drain manhole to plug one of the inlet lines. The drain contained some hydrogen sulfide, so he had an air mask ready. But he had not yet put it on because he was well outside the manhole. His feet were at ground level (Figure 11-3). He

**Figure 11-3.** A man was overcome by fumes from the manhole.

was about to put on a safety harness when his two companions heard a shout and saw him sliding into the manhole. They were unable to catch him, and his body was recovered from the outfall. He had been overcome by hydrogen sulfide arising from the drains although his face was 1.5 m above ground level.

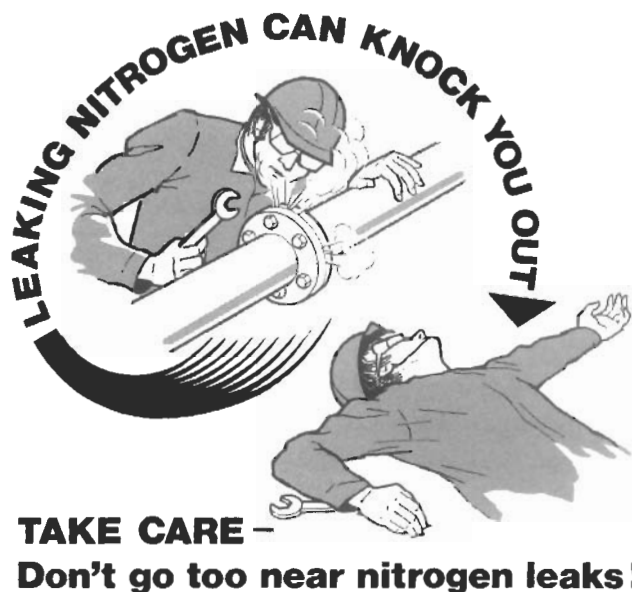
Figure 12-1.

- (a) A member of a cleaning crew decided to recover a rope, which was half inside a vessel and was caught up on something inside. While kneeling down, trying to disentangle the rope, he was overcome by nitrogen. Afterward he admitted that if necessary he would have entered the vessel.
- (b) On several occasions people who were working on or near leaky joints on nitrogen lines have been affected. Although they knew nitrogen is harmful, they did not consider that the amount coming out of a leaky joint would harm them (Figure 12-1).

swept out with nitrogen, when one of them collapsed. The other pulled him free, and he soon recovered. The bottom manhole had already been removed, and it seems that a chimney effect caused nitrogen to come out of the upper manhole [23].

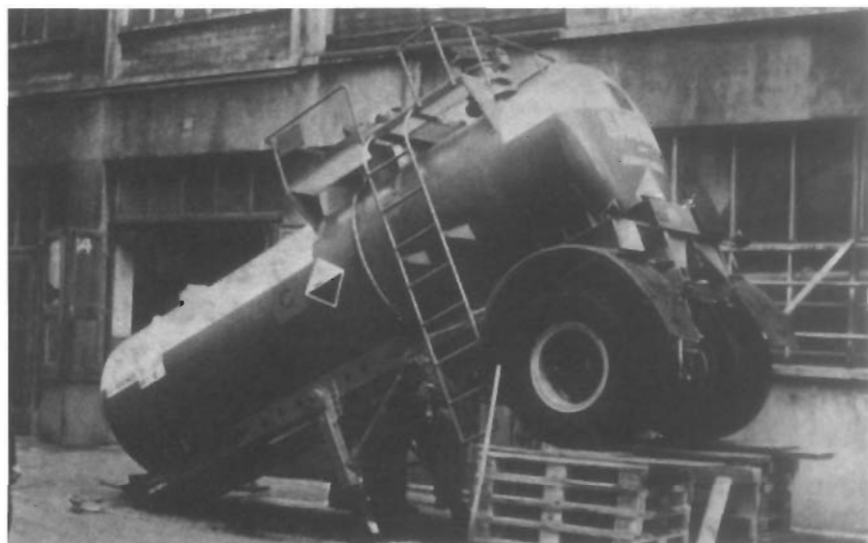
On several occasions tank trailers have tipped up because the rear compartments were emptied first, as shown in Figure 13-1.

**Figure 13-1.** A tank trailer may tip up if the rear compartments are emptied first.

It is not always possible to keep the trailer connected to the truck's unit during loading/unloading. If it is not connected, the front compartments should be filled last and emptied first or a support put under the front of the trailer.

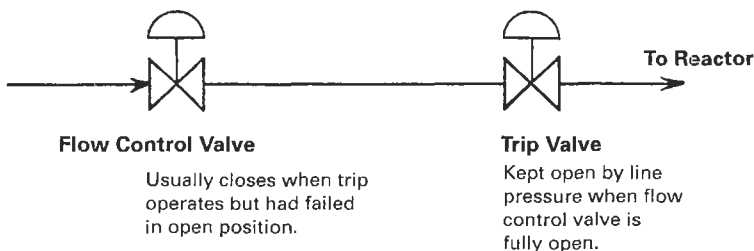
Investigation showed that the pressure drop through the trip valve—a globe valve—was so high that the valve could not close against it. There was a flow control valve in series with the trip valve (Figure 14-1), and the trip normally closed this valve as well. However, this valve failed in the open position—this was the reason for the high temperature in the reactor—and the full upstream pressure was applied to the trip valve.

**Figure 14-1.** When the control valve was open, the pressure prevented the trip valve from closing.

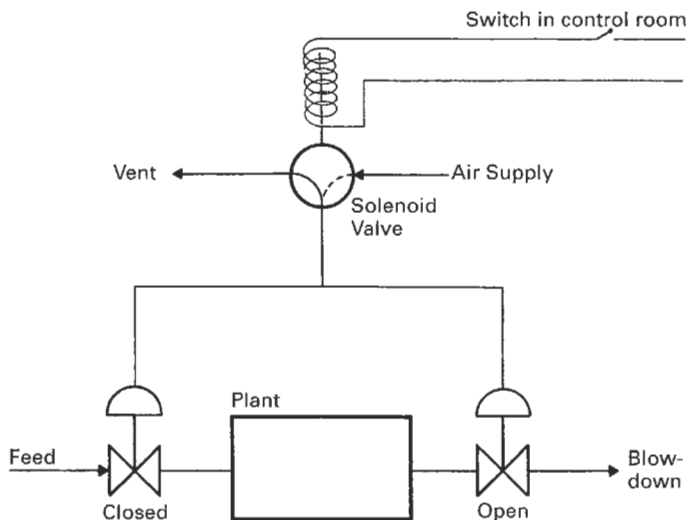
The switch operated a solenoid valve, which vented the compressed air line leading to valves in the feed and blowdown lines (Figure 14-3). The feed valve then closed, and the blowdown valve opened. This did not happen instantly because it took a minute or so for the air pressure to fall in the relatively long lines between the solenoid valve and the other valves.

The operator expected the system to function as soon as he operated the switch. When it did not, he assumed it was faulty. Unfortunately, after operating the switch several times, he left it in its normal position.

**Figure 14-3.** An automatic system, which will take a minute or so to operate.

The operator had tested the system on several occasions, as it was used at every shutdown. However, it was tested in conditions of no stress, and he did not notice that it took a minute or so to operate. The solenoid valve should have been fitted with a latch so that once the switch had been operated, the solenoid valve could not return to its normal position until it was reset by hand.

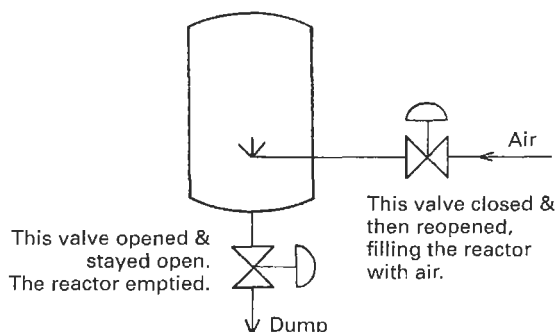
- (b) A liquid-phase hydrocarbon oxidation plant was fitted with a high-temperature trip, which shut off the air and opened a drain valve that dumped the contents of the reactor in a safe place (Figure 14-4). If the air valve reopened after a dump, a flammable mixture could form in the reactor.

One day the temperature-measuring device gave a false indication of high temperature. The air valve closed, and the drain valve opened. The temperature indication fell, perhaps because the reactor was now empty. The drain valve stayed open, but the air valve reopened, and a flammable mixture was formed in the reactor. Fortunately it did not ignite.

**Figure 14-4.** When the air valve reopened after a dump, a flammable mixture formed in the reactor.

The air valve reopened because the solenoid valve in the instrument air line leading to the air valve would not stay in the tripped position. It should have been fitted with a latch.

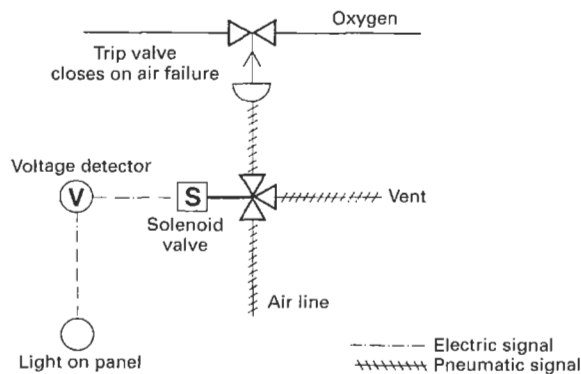
An ethylene oxide plant tripped, and a light on the panel told the operator that the oxygen valve had closed. Because the plant was going to be restarted immediately, he did not close the hand-operated isolation valve as well. Before the plant could be restarted, an explosion occurred. The oxygen valve had not closed, and oxygen continued to enter the plant (Figure 14-5).

Actually the air was not vented. The 1-in. vent line on the air supply was choked by a wasp nest. Whenever possible we should measure directly what we need to know and not some other parameter from which it can be inferred [1].

**Figure 14-5.** The light shows that the solenoid is de-energized, not that the oxygen flow has stopped.

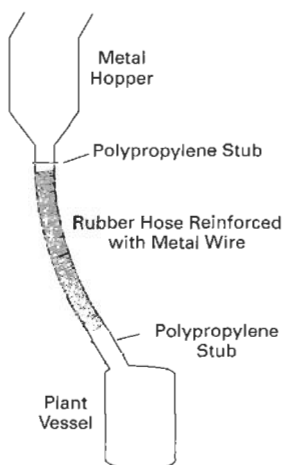
A powder was emptied down a metal duct into a plant vessel. The duct was replaced by a rubber hose, as shown in Figure 15-2. The flow of powder down the hose caused a charge to collect on it. Although the hose was reinforced with metal wire and was therefore conducting, it was connected to the plant at each end by short polypropylene pipes that were nonconducting. A charge therefore accumulated on the hose, a spark occurred, the dust exploded, and a man was killed.

**Figure 15-2.** The flow of powder caused a static charge to collect on the insulated hose.

Hoses and ducts used for conveying explosive powders should be made from conducting material and be grounded throughout. Alternatively (or additionally) the atmosphere can be inerted with nitrogen, the ducts can be made strong enough to withstand the explosion, or an explosion vent can be provided.

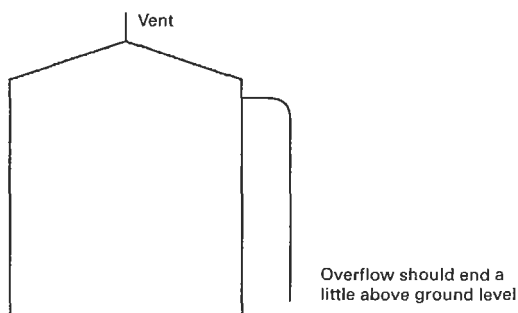
**Figure 16-1.** Acid tanks should be fitted with a high-point vent, as well as an overflow, so that hydrogen can escape.

The tank should have been fitted with a vent at the highest point, as shown in Figure 16-1.

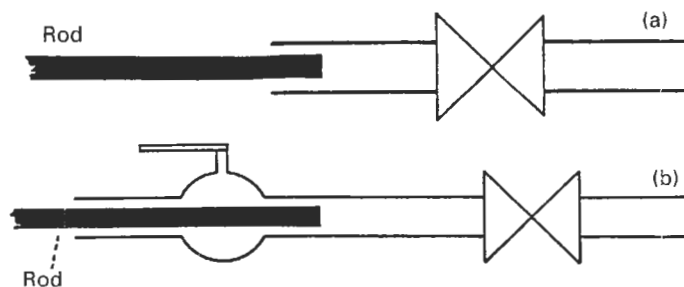
- (a) A man was rodding out a choked  $\frac{1}{4}$ -in. line leading to an instrument (Figure 17-1a). When he had cleared the choke he found that the valve would not close and he could not stop the flow of flammable liquid. Part of the unit had to be shut down.

**Figure 17-1.** The wrong (a) and right (b) ways of clearing a choked line.

Rodding out *narrow bore* lines is sometimes necessary. But before doing so, a ball valve or cock should be fitted on the end (Figure 17-1b). It is then possible to isolate the flow when the choke has been cleared, even if the original valve will not close.

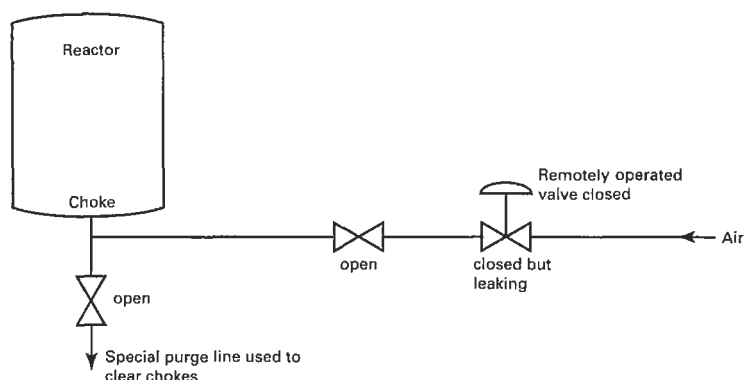
One day the operator closed the remotely operated valve in the air line but did not consider it necessary to close the hand valve as well, although the instructions said he should. The remotely operated valve was leaking, the air met the reactor contents in the feed line, and reaction took place there. The heat developed caused the line to fail, and a major fire followed.

**Figure 17-2.** Liquid purge burned in the drain line.

The air line should have been provided with remotely operated double block and bleed valves, operated by a single button.

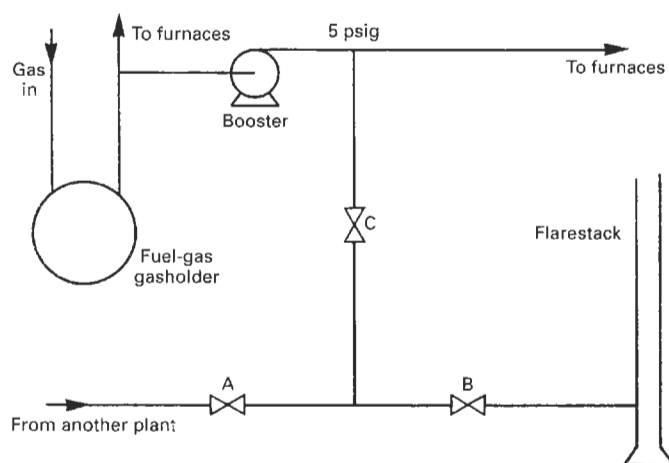
The flarestack shown in Figure 17-3 was used to dispose of surplus fuel gas, which was delivered from the gasholder by a booster through valves C and B. Valve C was normally left open because valve B was more accessible.

One day the operator responsible for the gasholder saw that it had started to fall. He therefore imported some gas from another unit. Nevertheless, a half hour later the gasholder was sucked in.

**Figure 17-3.** Valve B was operated by different operators.

that he could use the “gasholder flarestack.” He had done this before, though not recently, and some changes had been made since he last used the flarestack. He did not realize that his action would result in the gas-holder emptying itself through valves C and B. He told three other men what he was going to do, but he did not tell the gasholder operator. He did not know that this man was concerned.

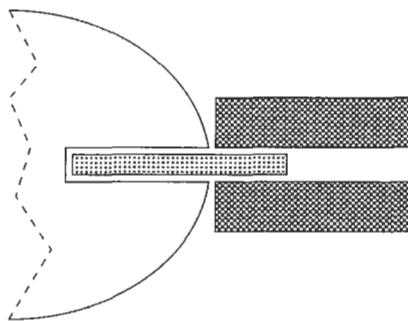
A vessel was fitted with a simple mechanical interlock: a horizontal pin fitted into a slot in the vessel lid; the lid could not be moved sideways until the pin was withdrawn (Figure 17-4). Movement of the pin was controlled by a solenoid. The solenoid could not be activated and the pin withdrawn until various measurements, including the temperature and level of the liquid in the vessel, were within specified ranges.

Nevertheless the lid was moved, although the measurements were not correct. Several possible explanations were considered.

**Figure 17-4.** A simple mechanical interlock: the lid could not be moved until the pin was withdrawn from the slot.

1. The pin might have been seized inside the solenoid. Unfortunately the operator, believing this to be the case, had squirted a lubricant into the solenoid chamber before any investigation could be carried out. A vertical pin would have been less likely to stick.
2. The operator, believing that all measurements were correct, might have assumed that the system was faulty and inserted a thin strip of metal into the end of the slot and moved the pin back into the solenoid. He denies doing this but admits that he did not check the temperature and level readings to make sure they were correct before trying to move the lid.

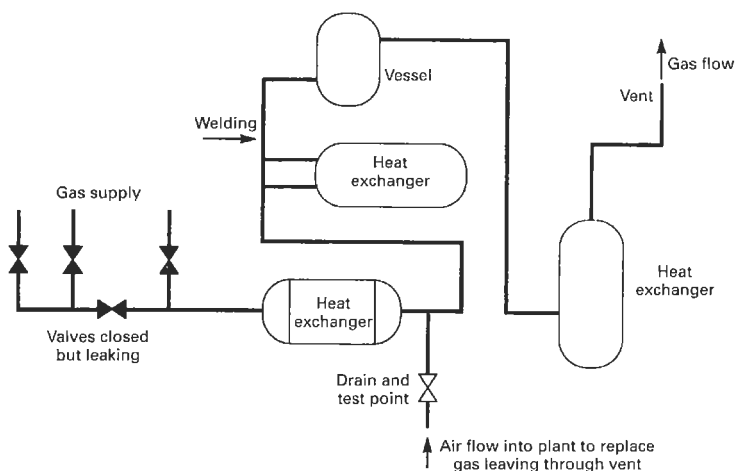
- (a) A distillation column was emptied, washed out, and purged with nitrogen. A manhole cover at the base was removed. While two men were removing the manhole cover at the top of the column, one of them was overcome. The other pulled him clear, and he soon recovered. It seems that due to a chimney effect, air entered the base of the column and displaced the lighter nitrogen [12].
- (b) A hydrogen line, about 12 in. diameter, had to be repaired by welding. The hydrogen supply was isolated by closing three valves in parallel (one of which was duplicated) (Figure 17-5). The line was

**Figure 17-5.** Simplified diagram of plant, showing why hydrogen gas was not detected at the drain point.

purged with nitrogen and was tested at a drain point before welding started to confirm that no hydrogen was present. When the welder struck his arc, an explosion occurred, and he was injured. The investigation showed that two of the isolation valves were leaking. It also showed why the hydrogen was not detected at the drain point: the drain point was at a low level, and air was drawn through it into the plant to replace gas leaving through a vent. The source of ignition was sparking, which occurred because the welding return lead was not securely connected to the plant (another familiar problem) [13].

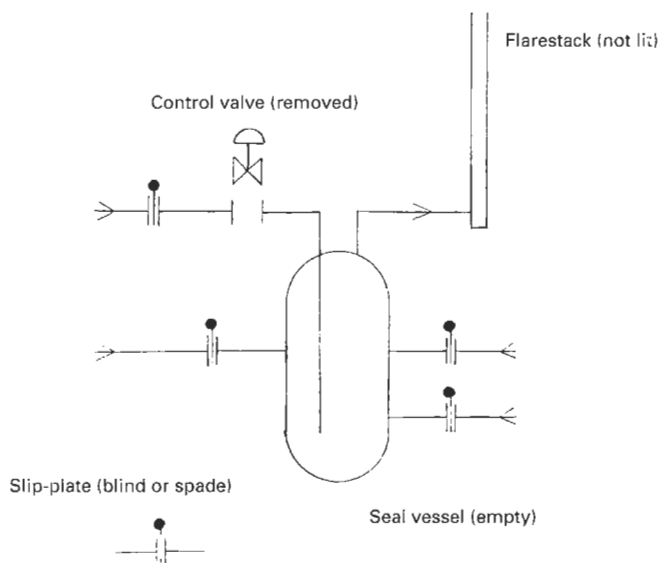
- (c) A flarestack and its associated seal vessel were being prepared for maintenance. The seal vessel was emptied, and all inlet lines were slip-plated (blinded). A control valve located in one of the inlet lines, between the vessel and one of the spades, was removed (Figure 17-6). Five minutes later, an explosion occurred inside the equipment. Thirty seconds later, there was a second explosion, and flames came out of the opening where the control valve had been. As the result of the chimney effect, air had entered the system, and a mixture of air and vapor had moved up the stack. The source of ignition was probably another flarestack nearby [14].

**Figure 17-6.** When the control valve was removed, a chimney effect caused air to enter the system, and an explosion occurred.

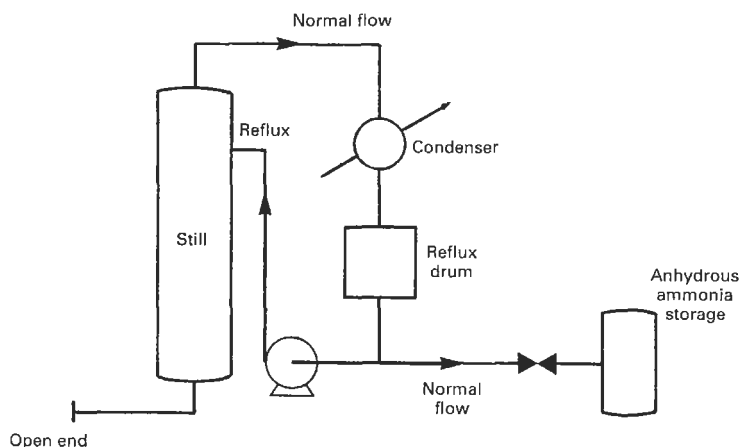
ammonia flowed backward from a storage vessel, through a leaking valve, into a reflux drum, into a still, and out of an open end in the bottoms line, which was open for maintenance (Figure 18-1).

**Figure 18-1.** Reverse flow occurred from the storage vessel to the open end.

If the possibility of reverse flow had been foreseen, then a slip-plate could have been inserted in the line leading to the ammonia storage vessel, as described in Section 1.1.

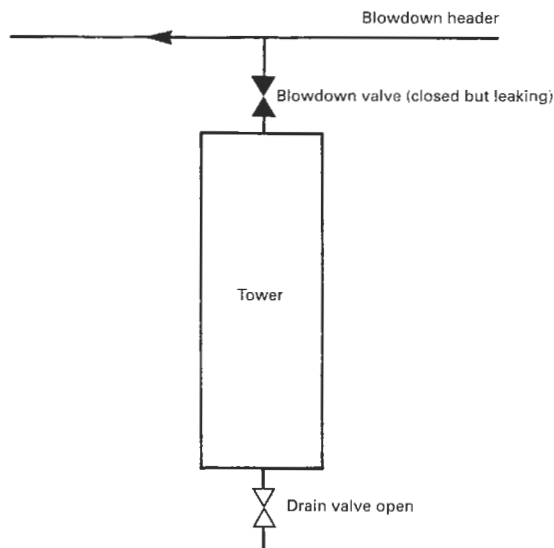
- (b) In another incident a toxic gas in a blowdown header flowed through a leaking blowdown valve into a tower and out of the drain valve. The operator who was draining the tower was killed (Figure 18-2).
- (c) The contents of a reactor were pumped out into another vessel for further treatment. The pump delivery valve should have closed automatically when the reactor was empty, but on this occasion the automatic system was not working correctly and was on manual control. Fifteen minutes passed before it was closed, and during this time steam traveled backward up the transfer line between the treatment vessel and the reactor and heated a heel of reaction product (about 150 kg), left behind in the reactor, from about 100°C to about 175°C. At this temperature the reaction product, a nitro-compound, decomposed explosively, causing extensive damage [12].

**Figure 18-2.** Flow occurred from the blowdown header into the vessel and out of the drain valve.

thought that prompt closing of the valve between the two vessels would prevent it. If it had been considered, a check valve might have been inserted in the line. Hazard and operability studies are only as good as the knowledge and experience of the team. In hazard and operability studies, the team members do not always ask what will happen if the automatic equipment is on manual control. This question should always be asked, as safety may depend on the correct operation of such equipment.

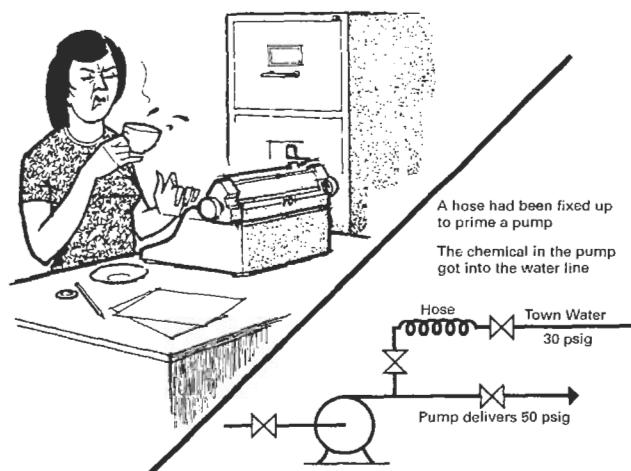
Another incident is illustrated in Figure 18-3. Town water should never be directly connected to process lines by a hose [19] or permanent connections. A break tank should be provided.

**Figure 18-3.** Never connect town water to process equipment.

If a service is used continuously, it may be connected permanently to process lines. If the service pressure is liable to fall below the normal process pressure, then a low-pressure alarm should be provided on the service line. If the process pressure is liable to rise above the normal service pressure, then a high-pressure alarm should be provided on the process side.

In addition, check valves should be fitted on the service lines.

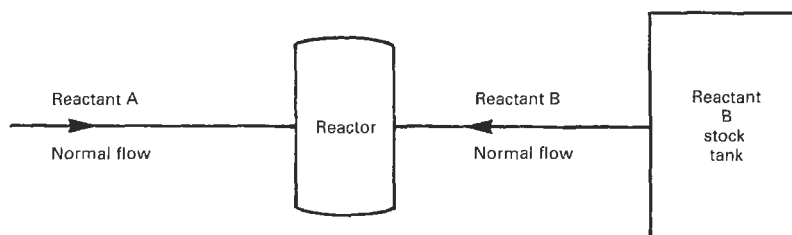
The most serious incidents resulting from reverse flow have occurred when reactant A (Figure 18-5) has passed from the reactor up the reactant B feed line and reacted violently with B.

**Figure 18-5.** Reverse flow of A occurred from the reactor into the B stock tank.

In one incident paraffin wax and chlorine were reacted at atmospheric pressure. Some paraffin traveled from the reactor back up the chlorine line and reacted with liquid chlorine in a catchpot, which exploded with great violence. Bits were found 30 m away [3].

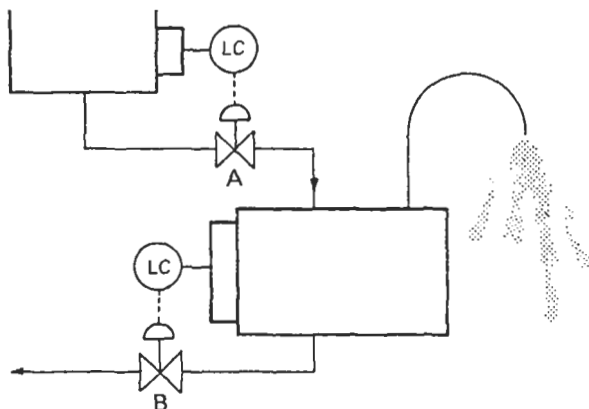
- (a) Figure 18-6 shows part of an old unit. Valve A could pass a higher rate than valve B. Inevitably, in the end the lower tank overflowed.
- (b) Raw material was fed to a unit from two stock tanks, A and B. A was usually used; B was used infrequently. The raw material was pumped to a head tank from which excess flowed back, as shown in Figure 18-7. The system was in use for several years before the

**Figure 18-6.** Valve A could pass a higher rate than valve B, thus making a spillage inevitable.

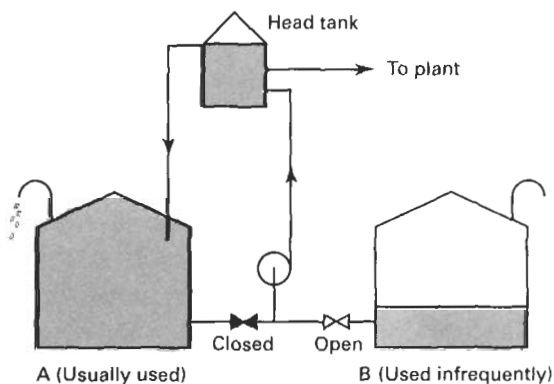
**Figure 18-7.** If A is full and suction is taken from B, A will overflow.

inevitable happened. Tank B was in use; tank A was full, and the flow from the head tank caused it to overflow.

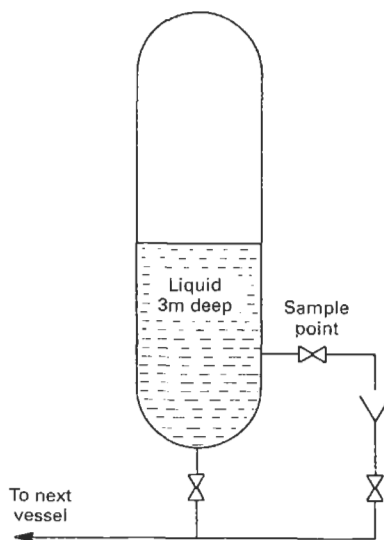
- (c) A funnel was installed below a sample point so that excess liquid was not wasted but returned to the process (Figure 18-8). What will happen if a sample is taken while the vessel is being drained?

**Figure 18-8.** What will happen if the vessel is drained while a sample is being taken?

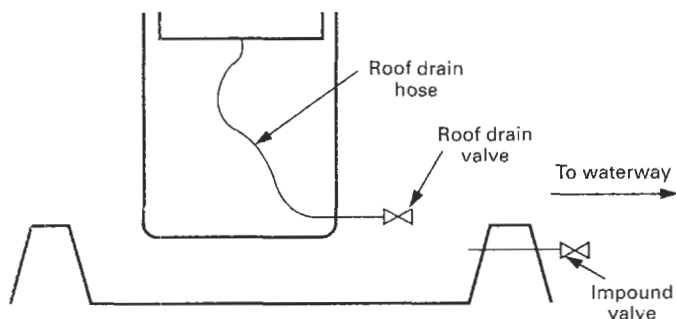
- (a) Figure 18-9 shows a floating-roof tank located in a dike. Rainwater can be drained from the roof into the dike and from the dike into a waterway. The team members are considering whether any substance other than water can get into the waterway. For this to occur, there would have to be a hole in the hose, and both valves would have to be left open. An inexperienced team may decide that a triple failure is so improbable that there is no need to consider it further. Someone with knowledge of the practicalities of plant operation would realize that during prolonged rain the operators may leave both drain valves open, whatever the instructions say, to avoid frequent visits to the tank. Any hole in the hose will then contaminate the waterway with oil [20].

**Figure 18-9.** Liquid other than rainwater can reach the waterway only if there is a hole in the hose and both valves are left open. This is not as unlikely as it seems at first sight.

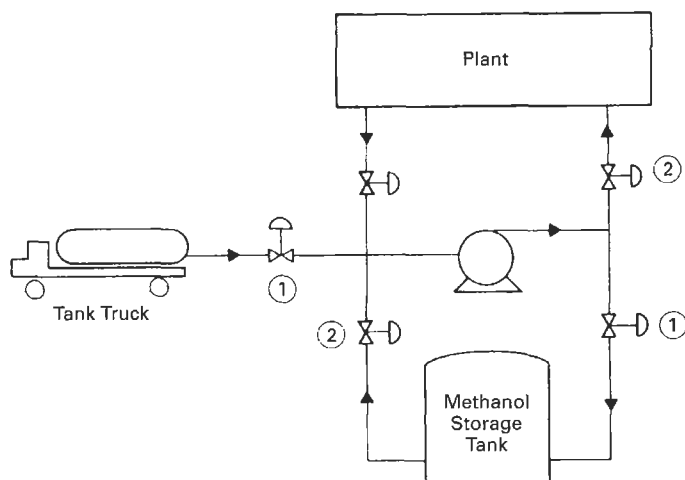
A pump and various pipelines were used for three different duties: for transferring methanol from a tank truck to storage, for charging it to the plant, and for moving recovered methanol back from the plant (Figure 20-1). A computer set the various valves and monitored their positions.

A tank truck was emptied. The pump had been started from the control room but had been stopped by means of a local button. The next job was to transfer some methanol from storage to the plant. The computer set the valves, but as the pump had been stopped manually, it had to be started manually. When the transfer was complete, the computer told the pump to stop; but as it had been started manually, it did not stop, and a spillage occurred [3].

**Figure 20-1.** A pump and lines, controlled by a computer, were used for several different jobs. The pump could also be started and stopped locally. (1) Valves open for first job; others closed. (2) Valves open for second job; others closed.

A thorough hazop probably would have revealed that this error could have occurred. The control system could have been modified, or better still, separate lines could have been installed for the various different movements, thus greatly reducing the opportunities for error. The incident shows how easily errors in complex systems can be overlooked if the system is not thoroughly analyzed. In addition, it illustrates the paradox that we are very willing to spend money on complexity but are less willing to spend it on simplicity [4]. Yet the simpler solution, indepen-

dent lines (actually installed after the spillage), makes errors much less likely and may not be more expensive if lifetime costs are considered. Control systems need regular testing and maintenance, which roughly doubles their lifetime cost (even after discounting), while extra pipelines involve little extra operating cost.

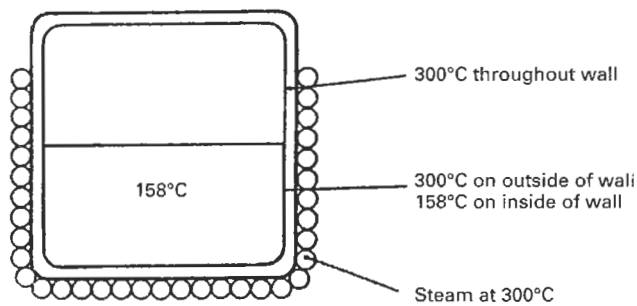
A reactor containing an uncompleted batch of 2,4,5-trichlorophenol (TCP) was left for the weekend. Its temperature was 158°C, well below the temperature at which a runaway reaction can start (believed at the time to be 230°C but possibly as low as 185°C). The reaction was carried out under vacuum, and the reactor was heated by an external steam coil supplied with exhaust steam from a turbine at 190°C and a gauge pressure of 12 bar (Figure 21.1). The turbine was on reduced load, as various other plants were also shutting down for the weekend (as required by Italian law), and the temperature of the steam rose to about 300°C. The temperature of the bulk liquid could not get much above 158°C because of its heat capacity, and so below the liquid level there was a temperature gradient through the walls of the reactor, 300°C on the outside, 158°C on the inside. Above the liquid level, the walls were at 300°C right through.

When the steam was isolated and, 15 minutes later, the stirrer was switched off, heat passed by conduction and radiation from the hot wall above the liquid to the top 10 cm or so of the liquid, which became hot enough for a runaway to start. If the steam had been cooler, 185°C or less, the runaway could not have occurred [11] (see also Section 10.4.6).

**Figure 21-1.** The Seveso reactor.
